AIRPROX REPORT No 2014188

Date/Time: 21 Sep 2014 1411Z (Sunday)

Position: 5320N 00242W
(5.3NM E Liverpool Airport
- elevation 81ft)

Airspace: Liverpool CTR (**Class:** D)

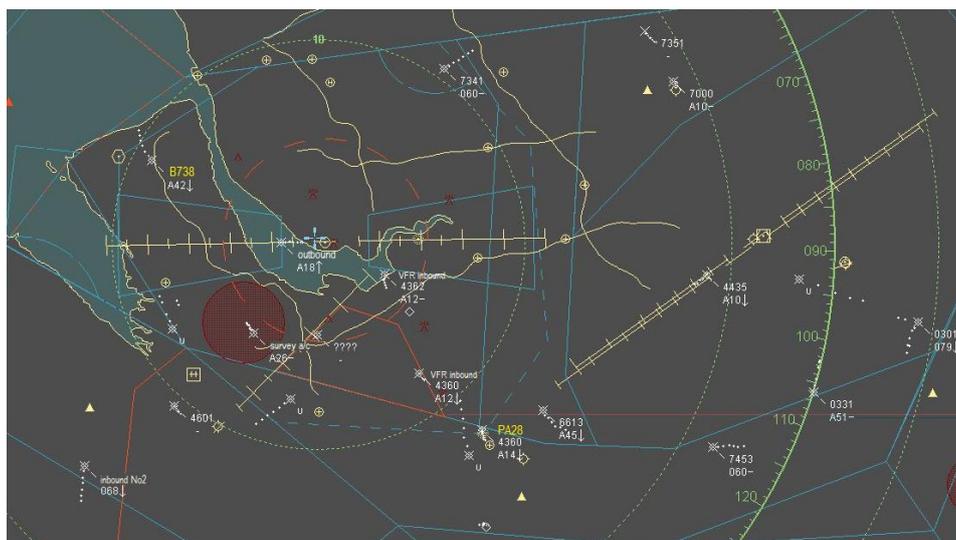
Figure 1 – LPL radar replay at 1404:43

At 1404:43, the PA28 pilot entered CAS at 1400ft and shortly afterwards the B737 pilot was descended to 2500ft downwind right-hand. (Figure 1.)

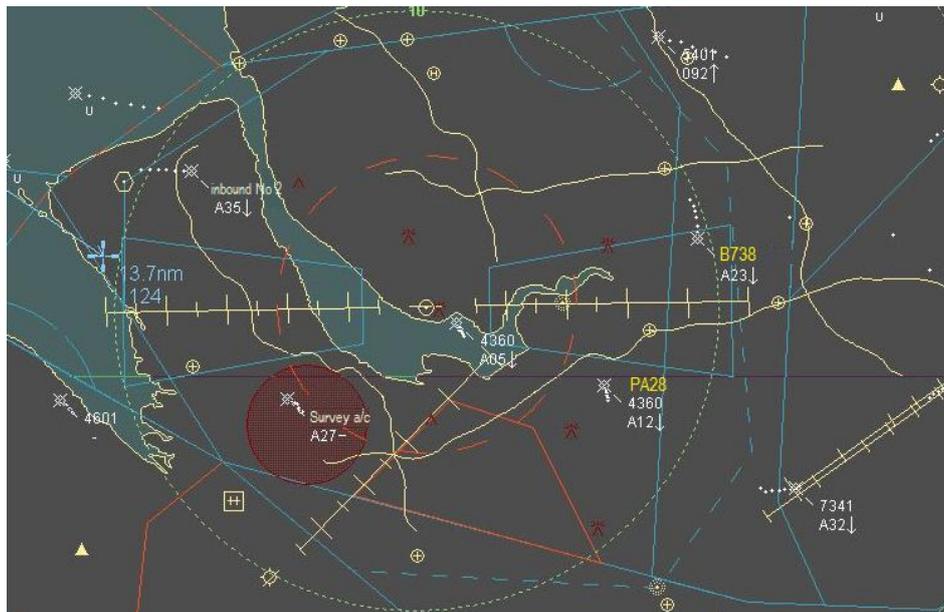
Figure 2 – LPL radar replay at 1409:41

The controller then gave heading and level instructions to the No 2 aircraft in the sequence. Meanwhile a Hunter and Canberra formation at 6000ft called LPL radar looking for a cloud break. The controller did not respond to the call and, at interview, explained that workload was such that he had initially attended to calls of a higher priority. At 1409:40 he gave the B737 pilot a right turn onto a closing heading of 240° and a clearance for the ILS approach. (Figure 2.)

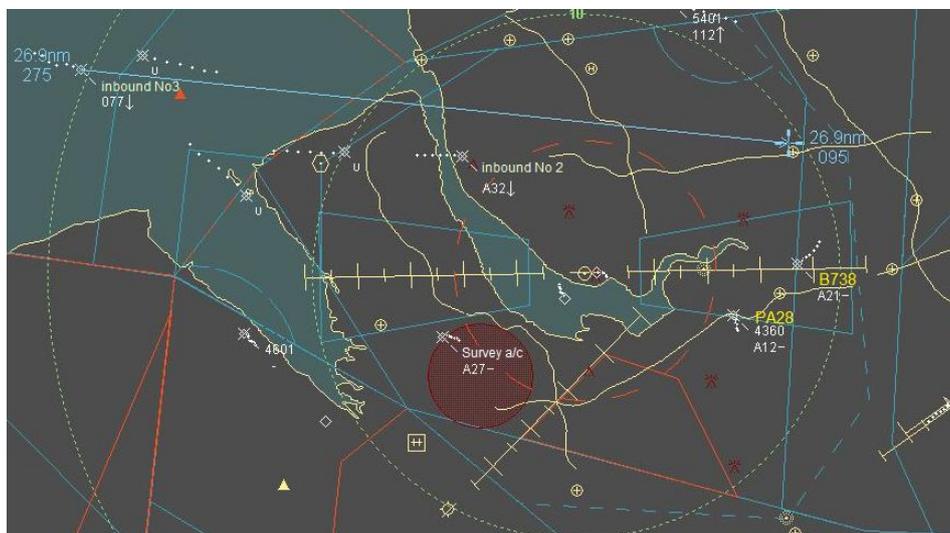
Figure 3 – LPL radar replay at 1410:26

The survey aircraft then called LPL radar requesting a routing further west to hold outside CAS for 10min prior to returning to LPL. This was approved by the controller and, at 1410:26, Hawarden ATC called to advise that their departure was holding on the runway for 2min, which was approved and Hawarden ATC were advised about the survey aircraft's intentions. (Figure 3.)

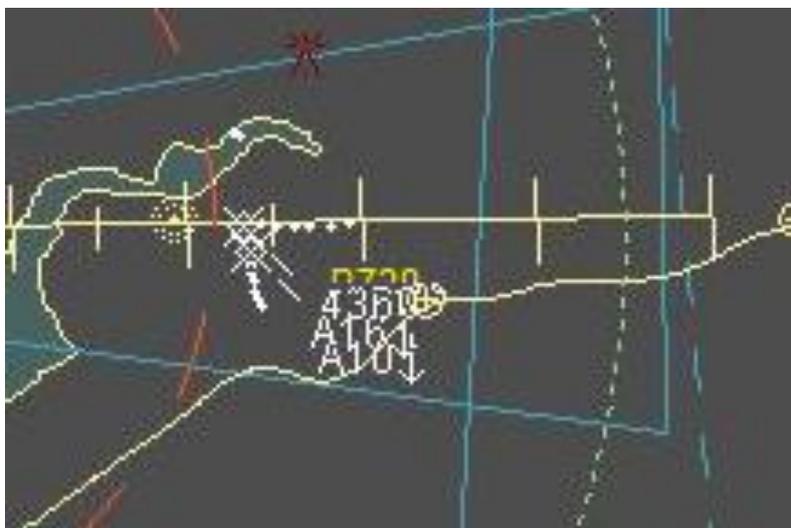
Figure 4 – LPL radar replay at 1411:20

The formation called again and the controller transferred the IFR outbound to Scottish Control. At 1410:50, the B737 pilot reported established. The controller responded “[B737 C/S] *Liverpool radar er roger and er traffic just observed just to the er south of a five mile final er indicating altitude one thousand one hundred feet at the moment tracking northbound eh turn right heading of er three three zero degrees [1411:20]*”. This call was not acknowledged by the B737 pilot. The aircraft labels had merged and at the end of the transmission, the two aircraft had passed abeam (CPA) at a horizontal distance of 0.45nm and a vertical distance of 600ft. (Figure 4.)
