AIRPROX REPORT No 2014192

Date/Time: 28 Sep 2014 1405Z (Sunday)

Position: 5136N 00128W
(1nm W of Grove Disused
Aerodrome)

Airspace: London FIR (Class: G)

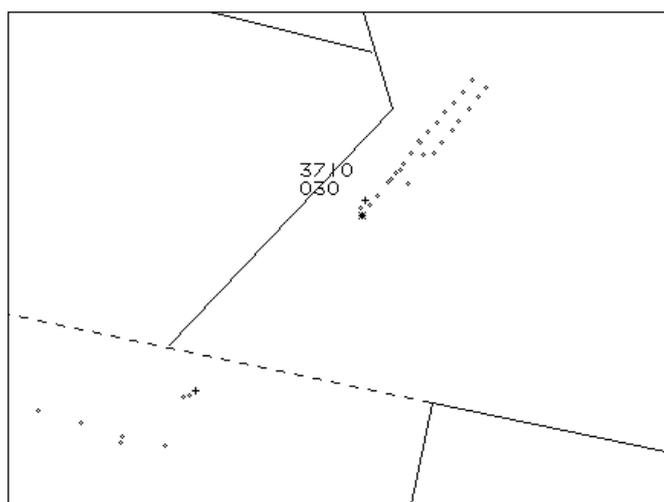
Figure 1: Geometry at 1405:06 (Yak squawk 3710).

The Yak Team were placed under a Basic Service at 1350:22, routing Sywell to Henstridge, via the east of Oxford. The controller had a number of aircraft on frequency with near constant RT. At 1358:36 the controller asked if the formation was tracking through the Brize Control Zone and the pilot responded that the formation would remain clear to the east. Figure 1 shows the geometry at 1405:06 with a primary contact emerging on radar.

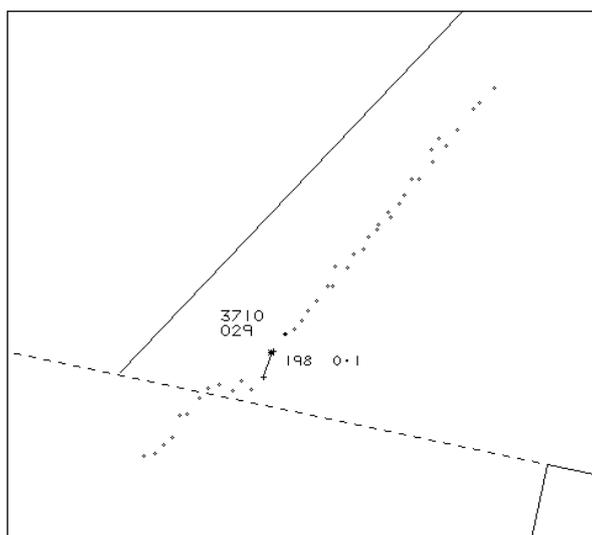
Figure 2: CPA at 1405:47.

The CPA on radar was recorded at 1405:47 (Figure 2), as 0.2nm horizontally, but height information was not available because the glider was a primary radar track. At the time of the CPA, LARS was passing Traffic Information to two separate Tutor callsigns under Traffic Services. The next transmission to the Yak Team was at 1412:13, when the pilot confirmed switching to the next frequency.

Whilst a primary radar return can be seen on the radar recording on a reciprocal track to the Yak formation, it is subject to some track jitter and is lost for one radar-sweep at around the CPA before being regained as the aircraft move apart; consequently, it can be established that the aircraft aspect was head-on, or approximately so, but an accurate CPA distance cannot be established. The aircraft were approaching head-on so both pilots were required to alter course to the right² (notwithstanding their overriding requirement to avoid collision). The No.4 Yak pilot saw the glider at the last moment and decided that turning left and diving was the safest course of action.
