AIRPROX REPORT No 2014218

Date/Time: 15 Nov 2014 1338Z (Saturday)

Position: 5154N 00212W
(1.4nm W Gloucester Airport
- elevation 101ft)

Airspace: Gloster ATZ (Class: G)

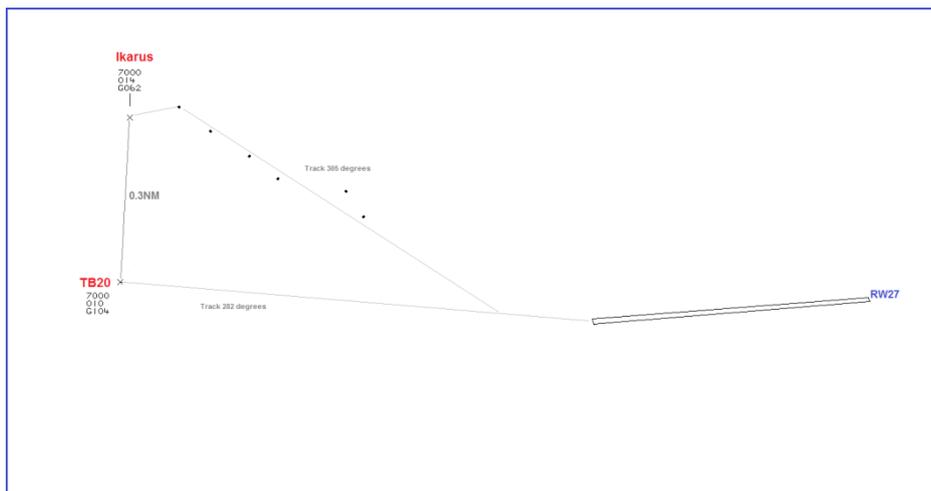
Figure 1 – Swanwick MRT at 1338:07

At 1337:46, the Ikarus started to show on radar, 0.7nm from the end of the runway, indicating FL012 which converts to an altitude of 795ft using the Gloster QNH 998hPa. The Ikarus pilot then started to take up a track of 305°. At 1338:07, the TB20 appeared on radar, 0.9nm west of the airfield, tracking 282°, indicating FL010 (600ft), Figure 1.

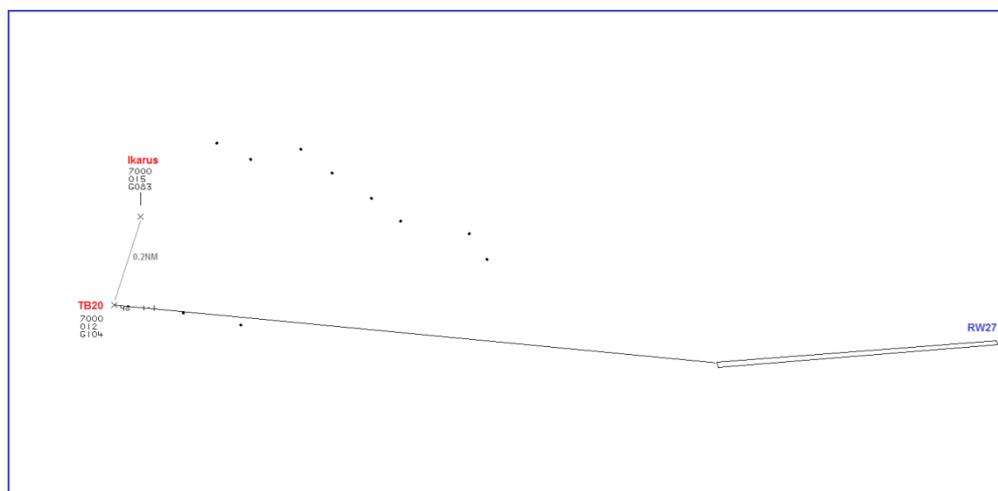
Figure 2 – Swanwick MRT at 1338:15

At 1338:15, the Ikarus pilot had commenced a left turn and was converging with the TB20. The distance between the two aircraft was 0.2nm, Figure 2.

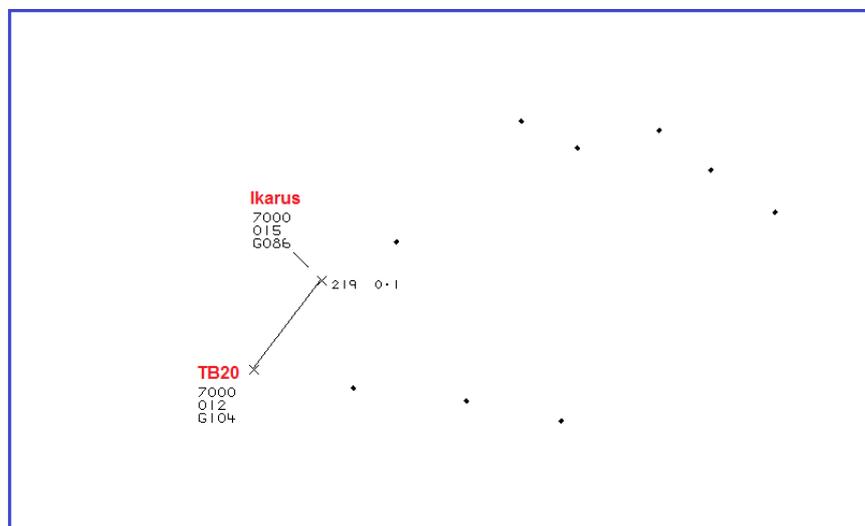
Figure 3 – Swanwick MRT at 1338:19

At 1338:19, the radar showed the Ikarus tracking approximately 240° and 300ft higher than the TB20. The horizontal distance between the two aircraft was 0.1nm and the TB20's groundspeed was 18kt faster than that of the Ikarus, Figure 3.

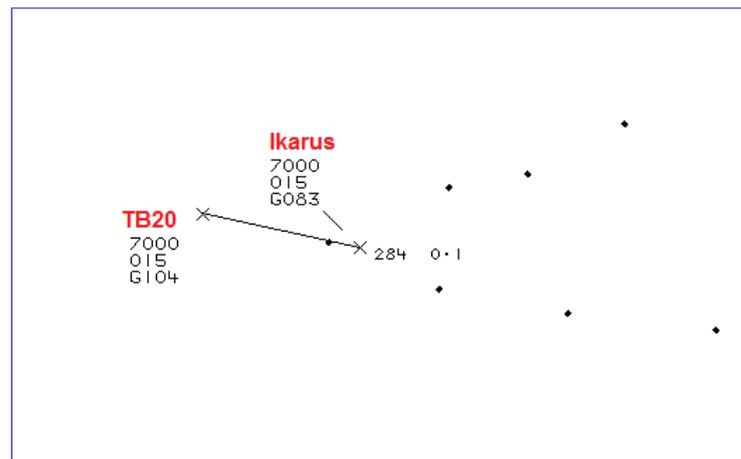
Figure 4 – Swanwick MRT at 1338:27

At 1338:27, both aircraft were indicating FL015 (1100ft) with the TB20 0.1nm ahead of the Ikarus, Figure 4.
