AIRPROX REPORT No 2014219Date/Time: 21 Nov 2014 1252ZPosition: 5400N 00117 W
(Linton-on-Ouse)Airspace: VOY AAIA (Class: G)Aircraft 1 Aircraft 2Type: Tutor TucanoOperator: HQ Air (Trg) HQ Air (Trg)Alt/FL: 1800ft 1900ft
QNH (1016hPa) NK (1019hPa)Conditions: VMC IMCVisibility: 6km 6kmReported Separation:

Recorded Separation: 200ft V/0.4nm H

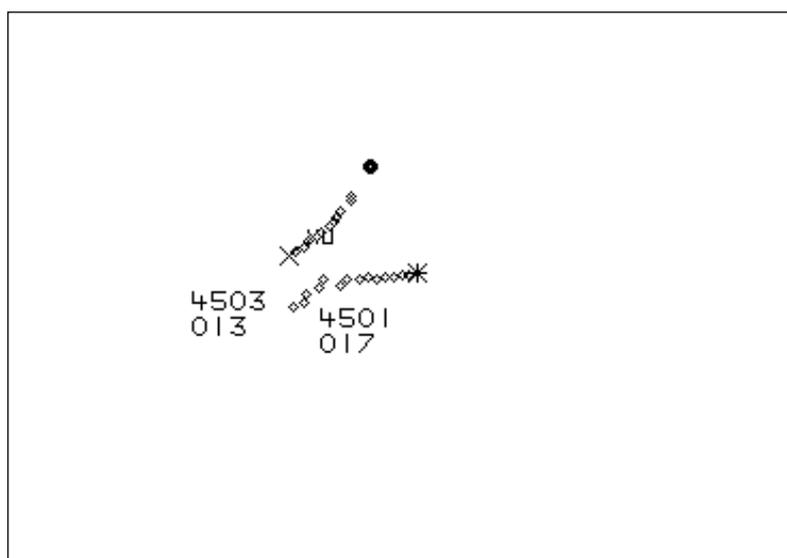
At 1250:34 (Figure 1), the Tutor called airborne passing 1500ft and was placed under a Traffic Service by Director; the standard RTC profile at Linton was to climb on runway track to 2000ft QFE.

Figure 1: Tutor (squawking 4503) climbed out for a Traffic Service at 1250:35.

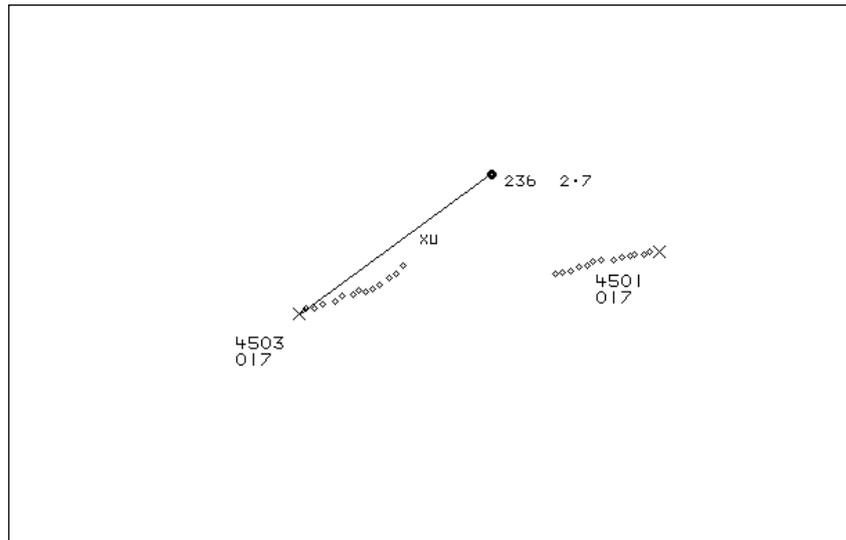
The Tucano was cleared for take-off at 1251:04. At 1251:23, the Tutor was instructed to turn left onto 090°. At 1251:38 (Figure 2), the Tucano was informed to remain on runway track.

Figure 2: Geometry at 1251:38, Tutor 2.7nms upwind and Tucano airborne instructed to remain on runway track.

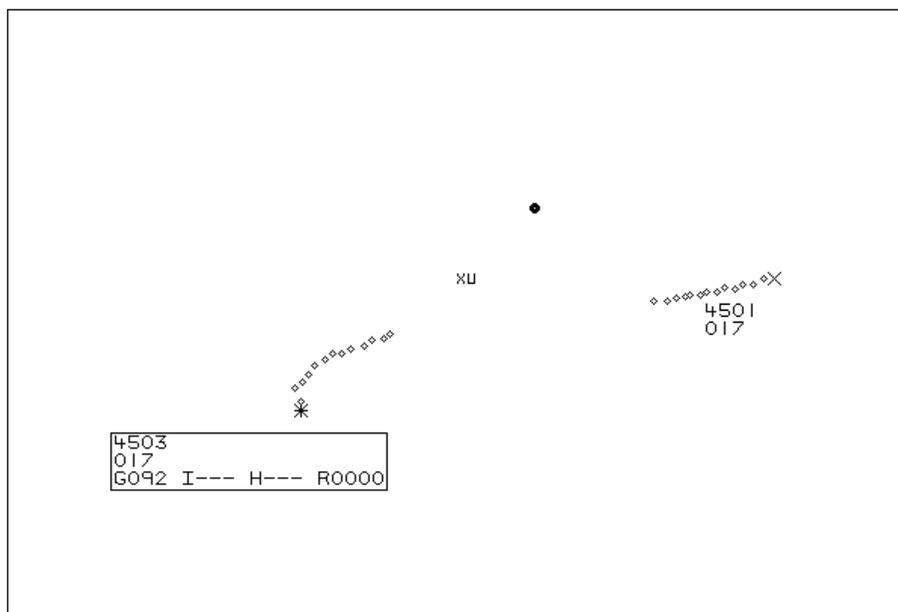
At 1252:00 (Figure 3), the Tucano switched to the Departures frequency and the Tutor can be seen in the left hand turn.

Figure 3: Geometry at 1252:00.

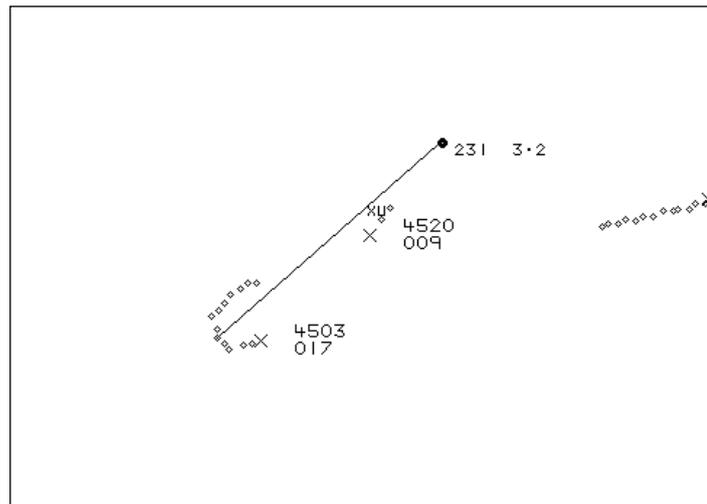
At 1252:22 (Figure 4), the Departures controller identified the Tucano pilot, placed him under a Deconfliction Service and provided an immediate avoiding action onto heading 290°. Traffic Information was called as 12 o'clock, 1nm, crossing right to left, 300ft above.

Figure 4: Identification and avoiding action given to Tucano at 1252:22.

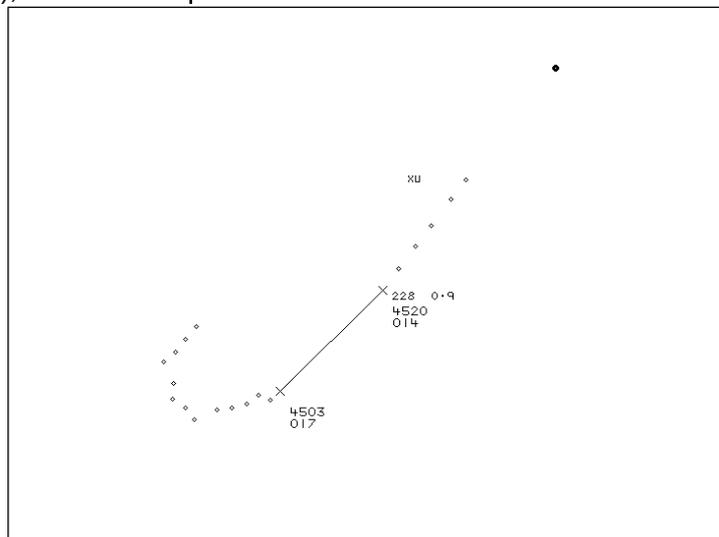
At 1252:34 (Figure 5), the Tutor requested the intentions of the aircraft in the 10 o'clock position.

Figure 5: Tutor request for information on Tucano at 1252:34.

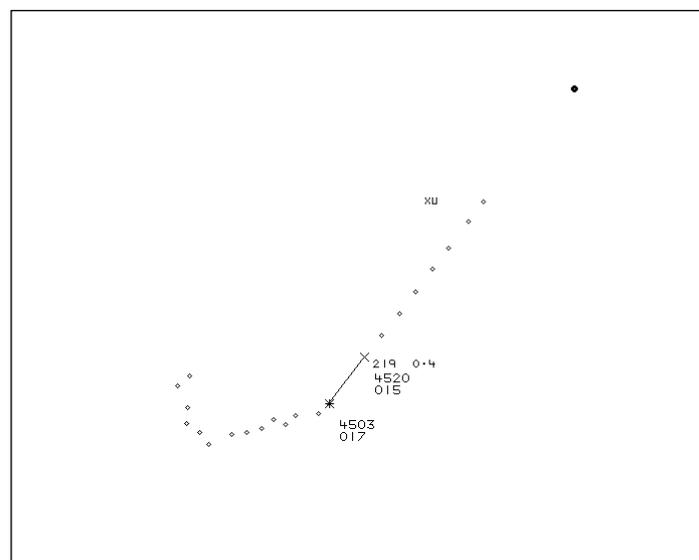
The CPA was at 1252:42 (Figure 6), with 0.4nms and 200ft separation.

Figure 6: CPA at 1252:42.

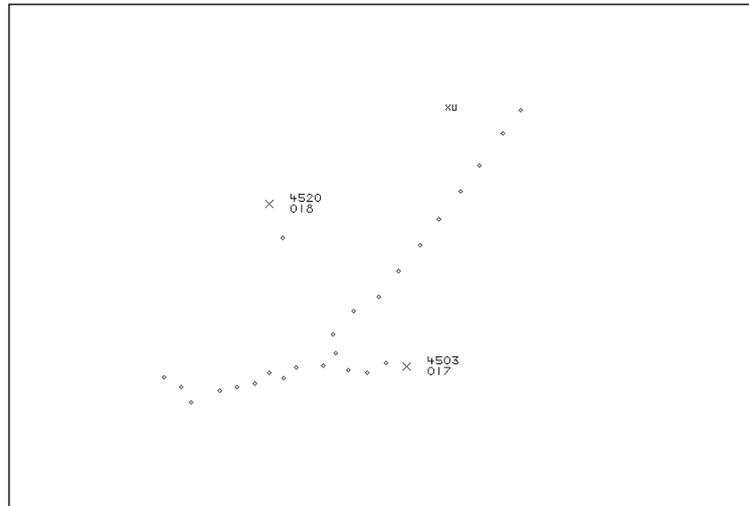
At 1252:56 (Figure 7), the effects of the hard Tucano right hand turn are evident, as both tracks are informed they are clear of traffic.

Figure 7: Geometry at 1252:56.
