AIRPROX REPORT No 2015146

Date: 4 Sep 2015 Time: 1627Z Position: 5331N 00222W Location: Swinton VRP

PART A: SUMMARY OF INFORMATION REPORTED TO UKAB

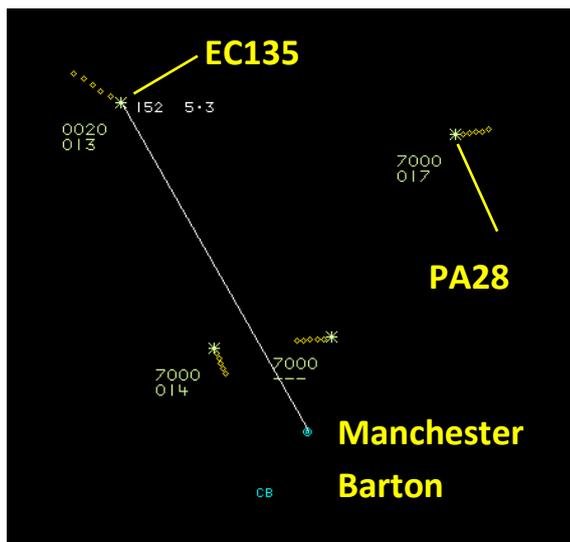
Figure 1: 1625:45

At 1625:45 the EC135 contacted Barton Information, 5.3nm north-west of Manchester Barton airfield (Figure 1).

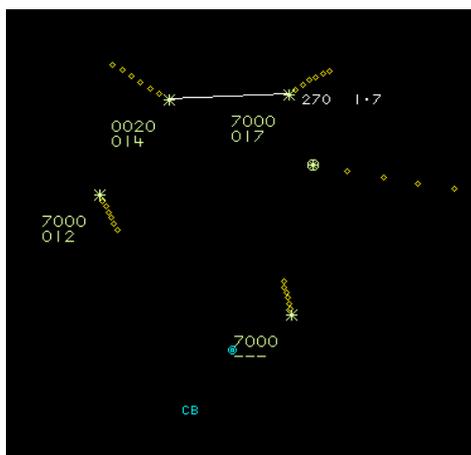
Figure 2: 1626:35

At 1626:35 traffic information was passed by the Aerodrome Flight Information Service Officer (AFISO)¹ at Barton to the EC135 on both the circuit traffic at Barton, and on another aircraft, (the PA28) joining from Bury. At this time the aircraft were tracking towards each other, 1.7nm and 300ft apart. No specific information on type, position or level of the PA28, was passed to the EC135 pilot by the AFISO (Figure 2).

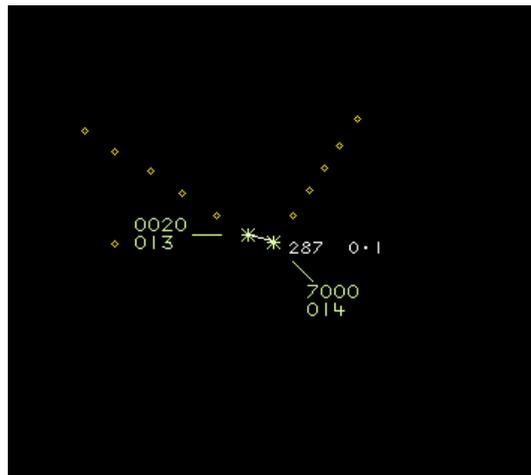
Figure 3: 1627:08

CPA took place at 1627:08, with the PA28 passing 0.1nm ahead of the EC135, and 100ft above (Figure 3).

The Board then discussed the cause of the Airprox and determined that it had been a late sighting by the EC135 pilot and a non-sighting by the PA28 pilot. The Board agreed that the aircraft had been in such proximity that a serious risk of collision had existed, and that luck had played a major part. Therefore, they assessed the risk as Category A.

Cause: A late sighting by the HEMS pilot and a non-sighting by the PA28 pilot.

Degree of Risk: A.
