**AIRPROX REPORT No 2015187**

Date: 10 Oct 2015 Time: 0947Z Position: 5214N 00252W Location: Shobdon

**PART A: SUMMARY OF INFORMATION REPORTED TO UKAB**

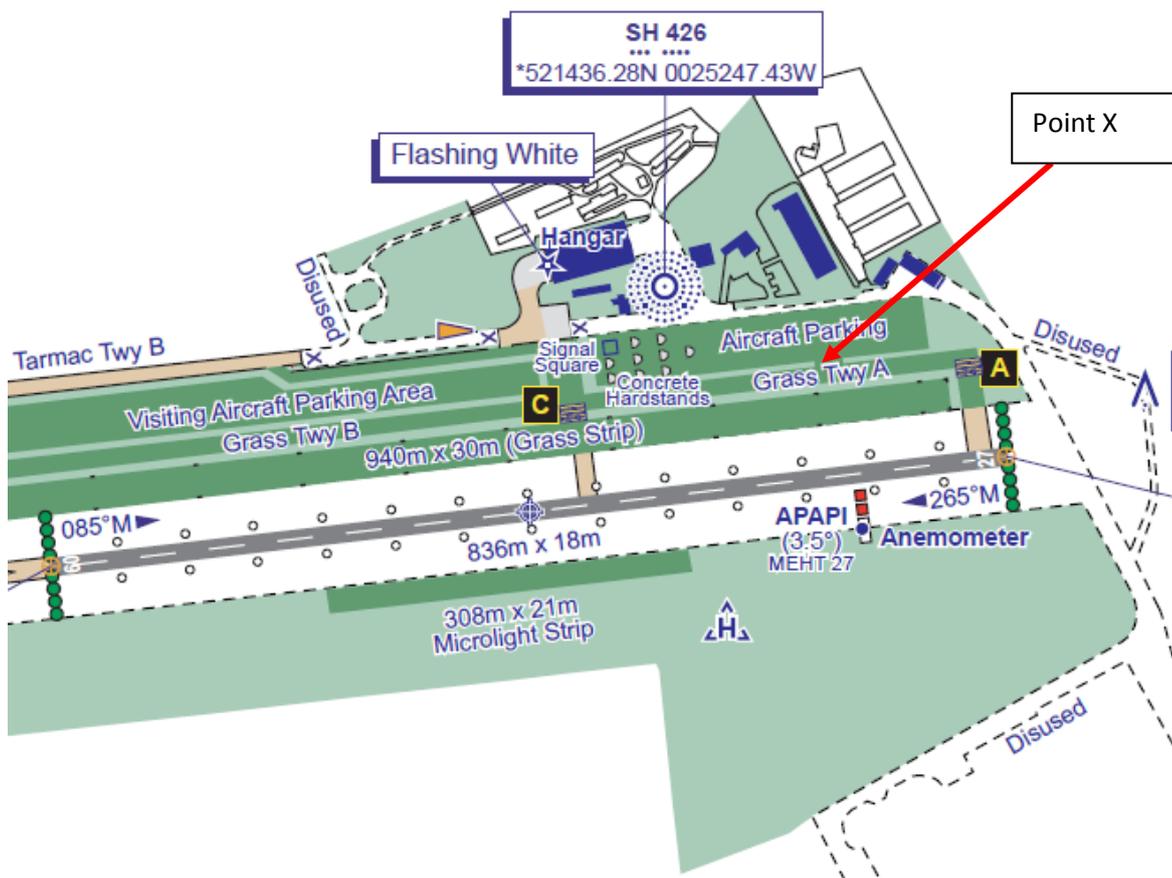
The access point used by the helicopter, known as Point X (X-Ray), and which is not marked on the Shobdon Airfield Chart, was confirmed by a member of Shobdon ATC and is shown at Figure 1.

Figure 1. Shobdon Airfield Chart showing position of Point X-Ray
