**AIRPROX REPORT No 2015193**

Date: 19 Oct 2015 Time: 1110Z Position: 5242N 00048W Location: 15nm N Wittering

**PART A: SUMMARY OF INFORMATION REPORTED TO UKAB**

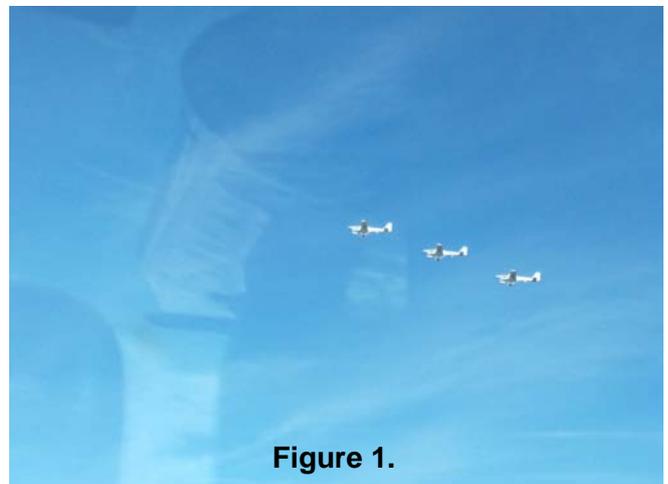
**Figure 1.**

able to take photographs (Figure 1). A short while later he received a message asking him to call Wittering when he landed, which he did and he spoke to the controller concerned, who explained that an Airprox had been reported.

For their part, the Tutors were receiving a Traffic Service whilst operating in a block of airspace. The Traffic Service was appropriate to the conditions; both pilots reported that the visibility was good. The Board noted that the workload for a lead pilot in formation-flying is high, and that this could well have contributed to the Tutor pilot not sighting the C182 when Traffic Information was first given at 5 miles. The Tutors continued to track towards the traffic, and the controller updated the information at 2 miles (about the same time that the on-board TAS also provided information). This time the Tutor pilot was visual and, in accordance with Rules of the Air, he was required to give-way; he did this by turning the formation to the left in front of the C182. Board members wondered why he chose this direction, noting that an aircraft that is obliged to keep out of the way of another shall avoid passing over, under or in front of the other. Some members opined that it would have been better to have turned slightly right to go behind the traffic, although they acknowledged that he may have felt constrained by the reduced manoeuvrability of the formation and didn't want to make a tight right turn. Having turned left, the Board surmised that the Tutor pilot probably lost situational awareness on the exact position of the C182 and expected that the formation would now be clear and perhaps accelerating ahead. As a result, he was surprised and perhaps startled when the C182 suddenly appeared on their left-hand-side. This 'startle-factor' probably caused the pilot to assess the C182 as much closer than it actually was; in his report he assessed it as 50ft and 75m when in fact radar derived separation indicated that it was 400ft and 0.1nm (185m). Although interpreting photographs with unknown focal length can be prone to error, the picture provided at Figure 1 appeared to corroborate the latter assessment of separation.

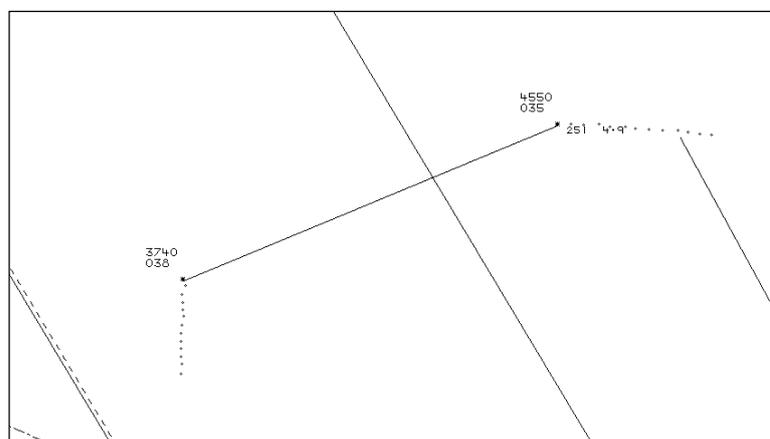
The C182 was released early to East Midlands at 1100:40, 6nm to the northeast of Wittering. Traffic Information was provided to the Tutor pilot at 1107:47 (Figure 2), "[Formation C/S], *further traffic northeast 5 miles, tracking west, indicating slightly below.*" The pilot responded immediately with "not sighted".

Figure 2: Traffic Information at 1107:47.

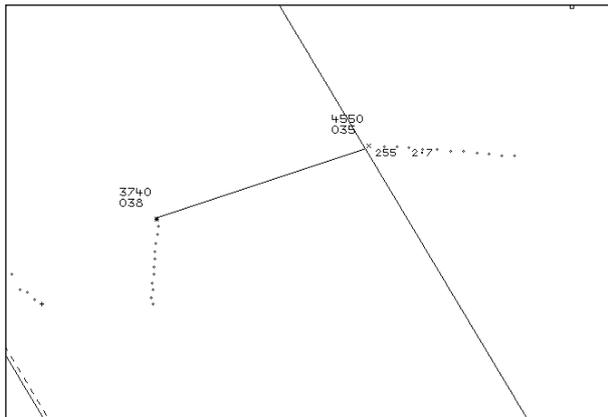
At 1108:38 (Figure 3), Traffic Information was updated to the Tutors, “[Formation C/S], *previously called traffic, northeast 2 miles, tracking west, indicating 300ft below.*” The Tutor pilot reported with, “*Sighted*”. Figure 4 outlines the aircraft geometry at 1109:31.

Figure 3: Traffic update at 1108:38.

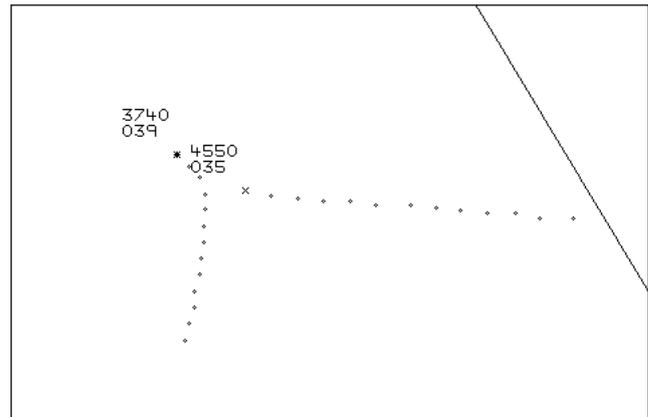
Figure 4: Geometry at 1109:31.

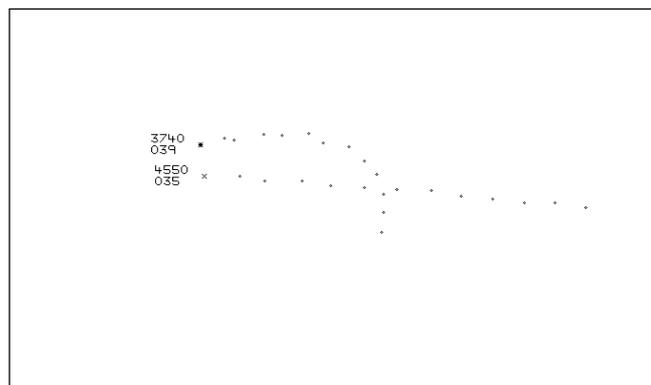
The Tutor formation called visual again with the C182 at 1109:59 (Figure 5); CPA was estimated between 1109:59 and 1110:04 with 400ft height separation and 0.1nm horizontal separation. At 1110:51, the Tutor pilot declared an Airprox.

Figure 5: CPA at 1109:59.
