AIRPROX REPORT No 2015194

Date: 28 Oct 2015 Time: 1317Z Position: 5048N 00115W Location: Lee on Solent ATZ

PART A: SUMMARY OF INFORMATION REPORTED TO UKAB

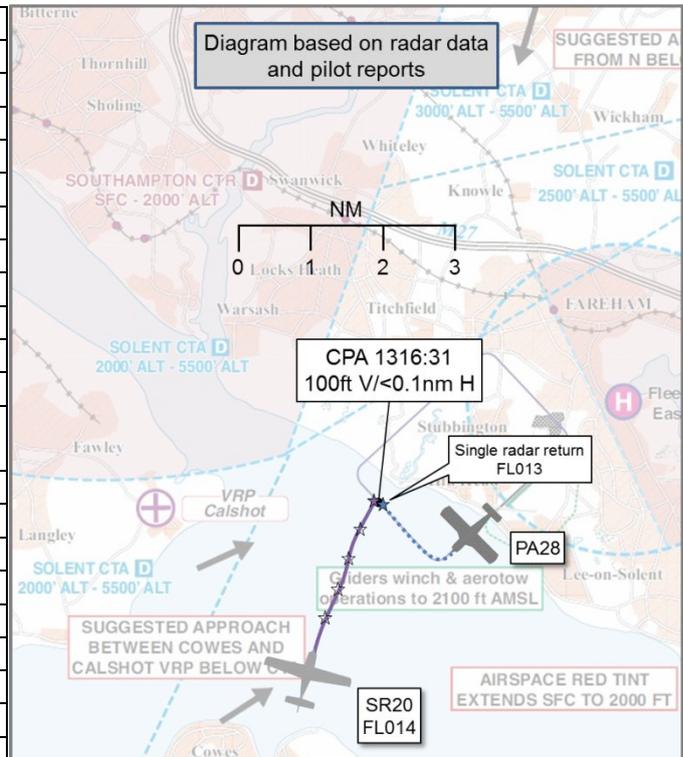
THE PA28 PILOT reports conducting a mutual circuit-training exercise as part of the Flight Instructor course syllabus as PF, seated in the right-hand seat. They were established in the circuit, climbing out on the crosswind leg on the third of three circuits, about to level off at circuit height, when he observed another aircraft closing rapidly from the left at close range, about 100-150ft away. He took immediate avoiding action by rolling the aircraft hard left because he considered there was a real risk of collision. As he took avoiding action the pilot of the other aircraft broke off his radio call of "joining downwind", possibly because he also had just become aware of the proximity of the two aircraft.

THE SR20 PILOT reports approaching Lee on Solent from the west to line-up with the downwind leg [for RW23] straight and level approximately abeam Cowes; he did not fly any further east than the downwind leg position. He did not hear any radio calls from the other aircraft, which converged from the right and carried out a left avoidance roll. The pilot commented that his TAS audio alarm sounded 'Traffic one o'clock low, less than one mile'.

THE AIRFIELD GENERAL MANAGER reports he witnessed the event, noting 2 aircraft on an intercept heading, and that the aircraft on crosswind took avoiding action. He kindly provided the diagram background map for this report, which appears on the airfield website page 'Visiting by Air'¹.

Cause: The SR20 pilot did not integrate effectively with the PA28 in the visual circuit.
