AIRPROX REPORT No 2015199

Date: 31 Oct 2015 Time: 1250Z Position: 5150N 00119W Location: Oxford Kidlington

PART A: SUMMARY OF INFORMATION REPORTED TO UKAB

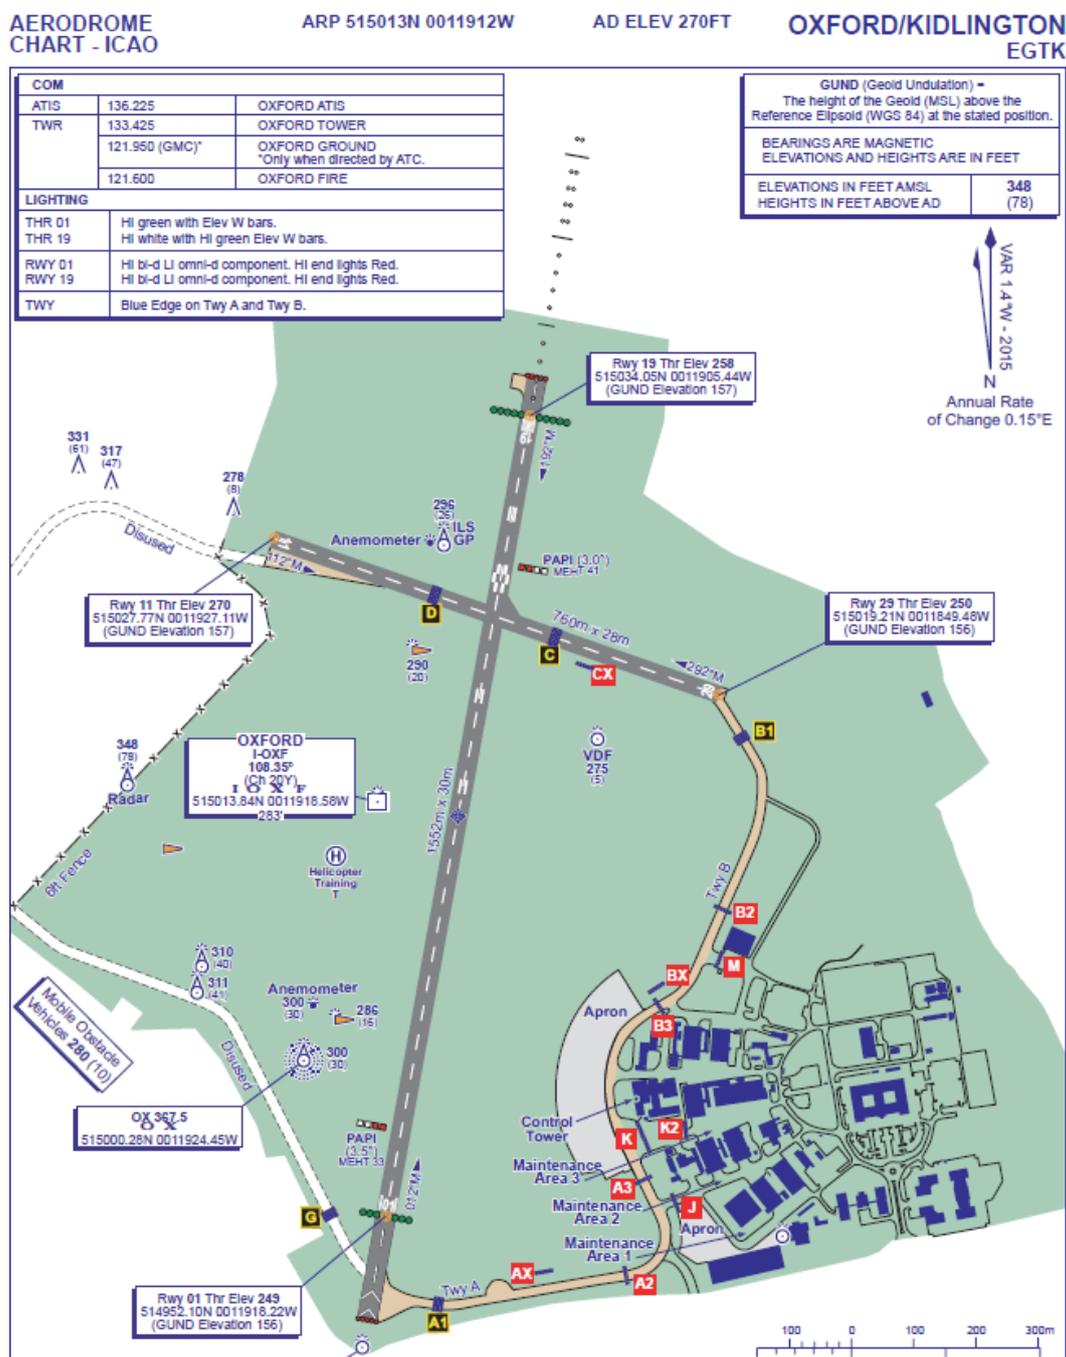
Figure 1.

At figure 1 is a plan of the Oxford/Kidlington airfield depicting points 'D', 'C' and 'B'.
