AIRPROX REPORT No 2015214

Date: 9 Dec 2015 Time: 1503Z Position: 5417N 00039W Location: Vale of York AIAA

PART A: SUMMARY OF INFORMATION REPORTED TO UKAB

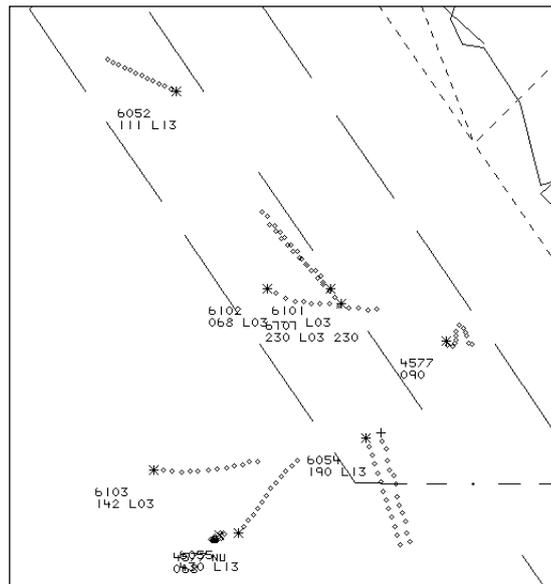
Figure 1: Traffic scenario at 1501:08 (FA20 6052; F15s 6054)

The NE Tac described a 'high' task difficulty with 5 aircraft on frequency. A tactical towline was being established for air-to-air refuelling (AAR), and the F15s were handed over for General Handling prior to routing into LFA11 and, subsequently, more refuelling. The Planner had taken the handover on the FA20 climbing to FL150, and a request to climb higher was refused to remain beneath the AAR towline. The tracks under service were in the vicinity of the AAR activity, and the controller recalled providing vectors to keep a military callsign clear of GAT. The FA20 changed to the Swanwick NE squawk at 1501:08 (see Figure 1); Class G airspace was congested with several military and civil callsigns in the vicinity.

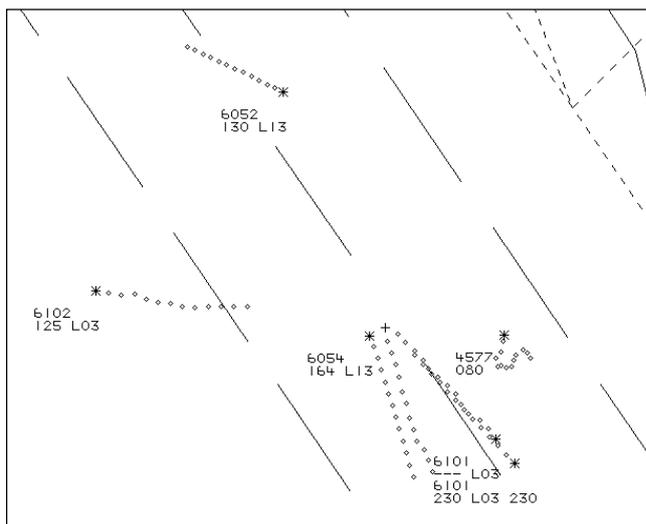
Figure 2: Geometry at 1502:07

The lead F15 element was squawking 6054 and the wingman can be viewed as a primary only track at 1502:07 (Figure 2). The aircraft continued on a closing geometry at 1502:31 (Figure 3).

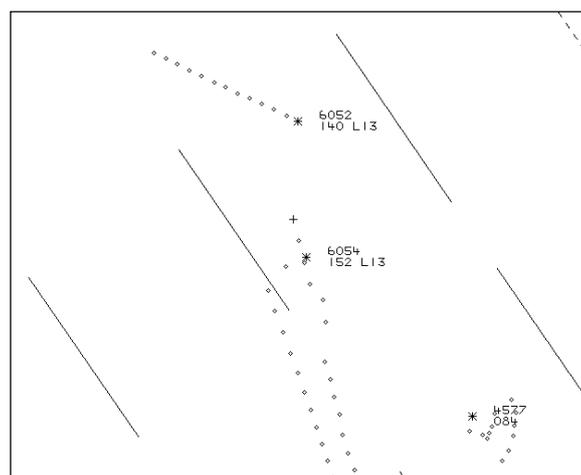
Figure 4: Geometry at 1502:44

The lead F15 element took up a northeast heading at 1502:44 (Figure 4).

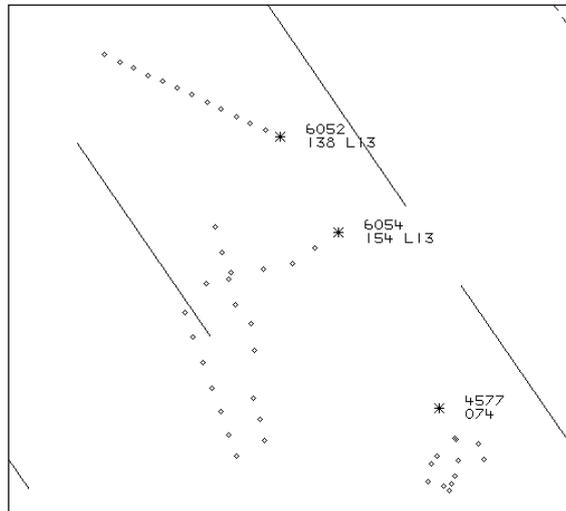
Figure 5: Geometry at CPA at 1503:00

The FA20 pilot advised the Swanwick controller that he was responding to a TCAS RA on the F15s and Traffic Information was then passed. The Swanwick Mil controller reported the FA20 pilot was informed of the F15s at 4nm at FL151 and the F15s were informed of the FA20 3nm to the north, indicating FL138. The CPA was estimated at 1503:00 (Figure 5) with 2.4nm horizontal separation and 1600ft feet altitude separation.
