AIRPROX REPORT No 2015217

Date: 14 Dec 2015 Time: 1223Z Position: 5056N 00239W Location: Yeovil Westland

PART A: SUMMARY OF INFORMATION REPORTED TO UKAB

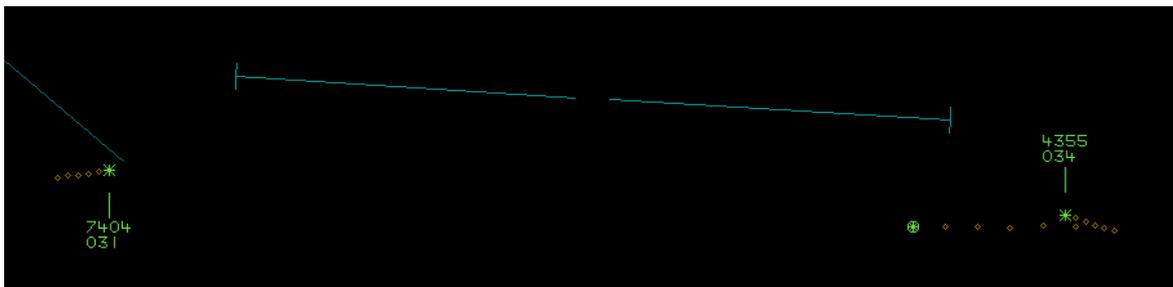
Figure 2 – Swanwick MRT at 1220:02

The BE76 called Westland approach at 1220:02 UTC (Figure 2) and reported in the descent to altitude 3000ft. The Yeovil Westland Controller cleared the BE76 to the YVL at 3000ft and instructed the BE76 to report taking up the hold.

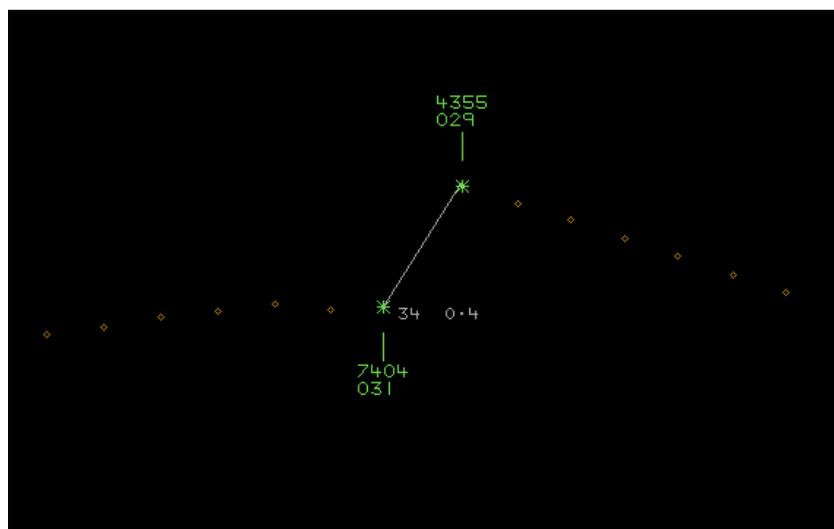
Figure 3 – Swanwick MRT at 1223:11(CPA)

At 1223:06 the Yeovil Westland controller made a general R/T broadcast, warning of unknown traffic that he had observed routing through the aerodrome overhead from west to east. He incorrectly identified the Merlin traffic as an Augusta 109 helicopter and estimated it's level to be 2000ft. CPA occurred at 1223:11 (Figure 3) with the Merlin indicating FL031 (altitude 3100ft Yeovil QNH).

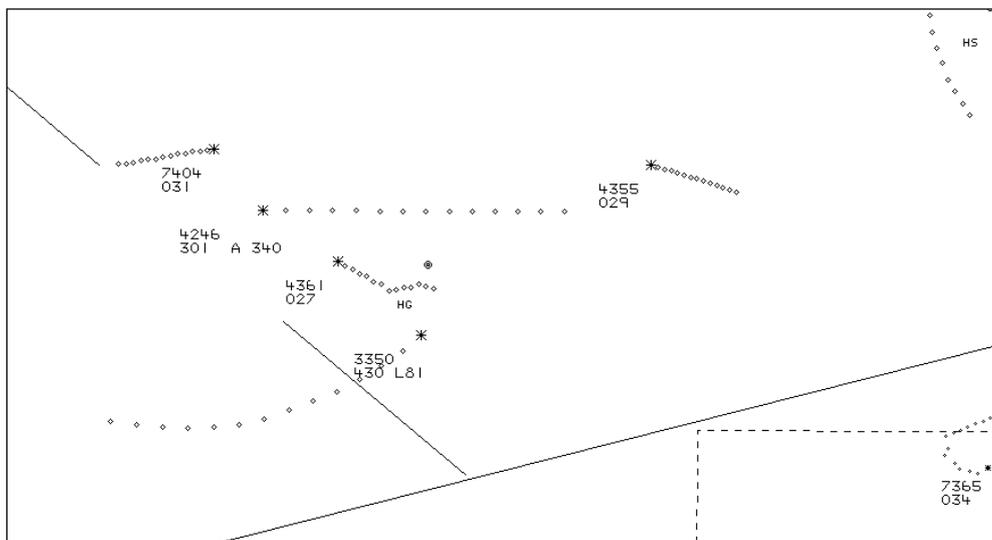
Figure 4: Traffic Information at 1221:09 (Merlin 7404; BE76 4355).

The Yeovilton Approach controller was controlling the Merlin under a Traffic Service and was providing vectors at 3000ft RPS over the YVL (Yeovil Westlands) for an ILS to RW27 at Yeovilton. Traffic Information was called by Yeovilton Approach to the Merlin at 1221:09 (Figure 4).

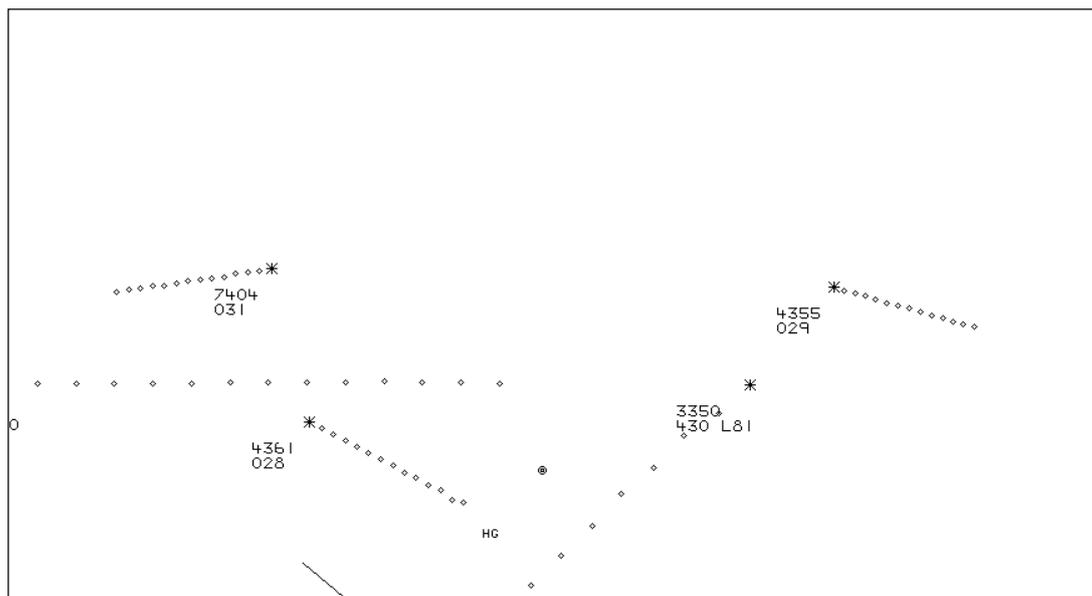
Figure 5: Traffic Information update at 1221:38.

The Yeovilton controller provided an update at 1221:38 (Figure 5).

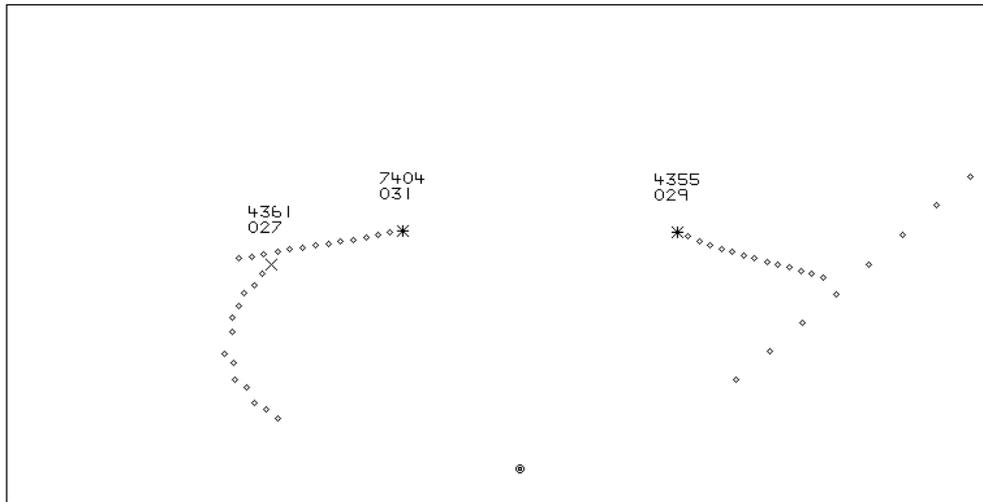
Figure 6: Traffic update at 1222:30.

A further update was provided at 1222:30 (Figure 6).

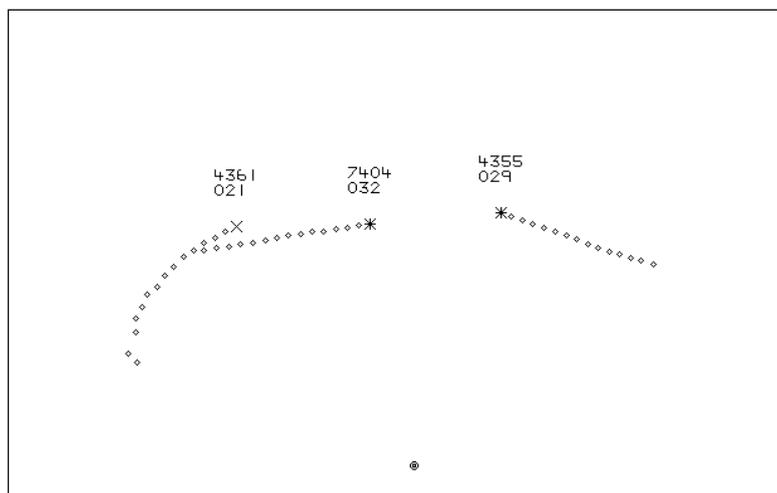
Figure 7: Geometry at the turn onto 120°.

At 1222:46, the Merlin pilot reported happy for a climb for deconfliction and at 1222:50 (Figure 7), the controller provided a vector onto a heading of 120°.

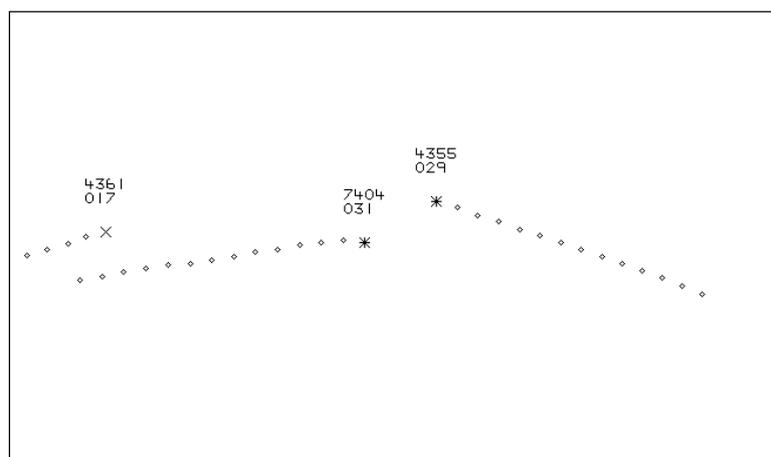
Figure 8: CPA at 1223:10.

The Merlin pilot called visual at 1223:01 and the CPA was estimated at 1223:10 (Figure 8) with 200ft height separation and 0.4nm.
