AIRPROX REPORT No 2016044

Date: 01 Apr 2016 Time: 1757Z Position: 5157N 00145E Location: 46nm NE Southend

PART A: SUMMARY OF INFORMATION REPORTED TO UKAB

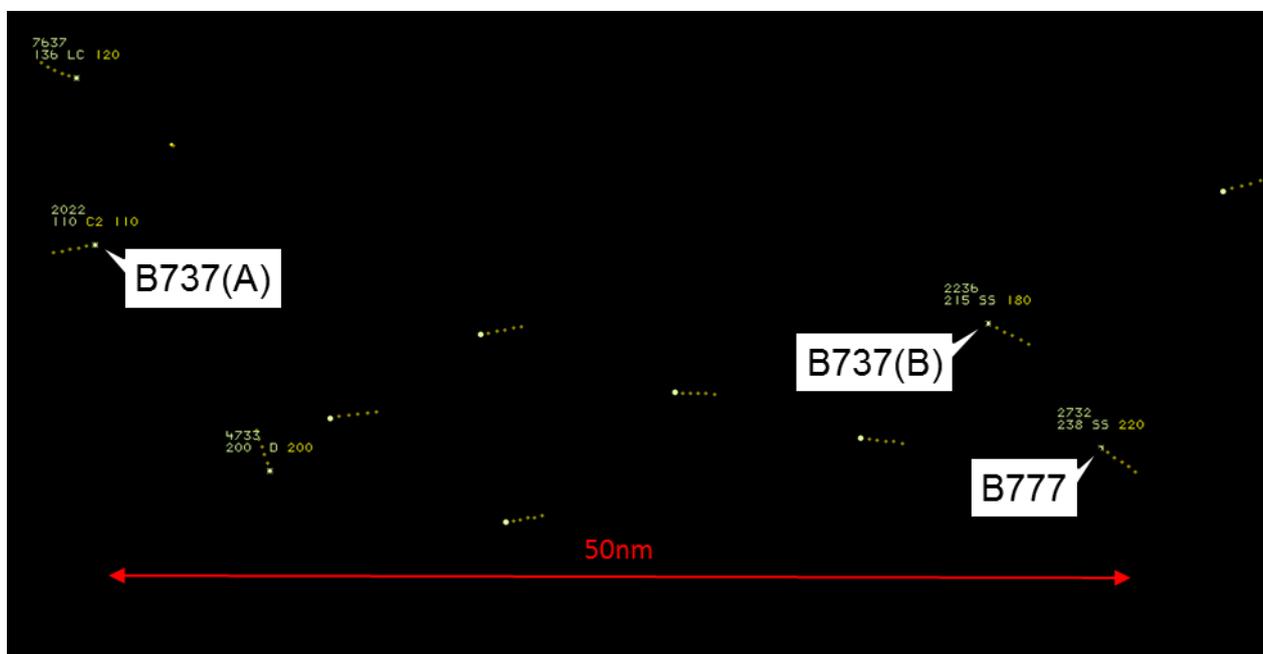
Figure 1 – 1752:35.

At 1751:57, the pilot of B737(A) (transponder code 2022) reported to the controller level at FL110 and on a heading of 080°. The controller then contacted another aircraft before returning to the pilot of B737(A) and instructing him to climb to FL170 which was acknowledged by the pilot. The B777 was transpondering 2732 and was preceded by B737(B) transpondering 2236, both of which were still with the previous sector at this time (Figure 1).

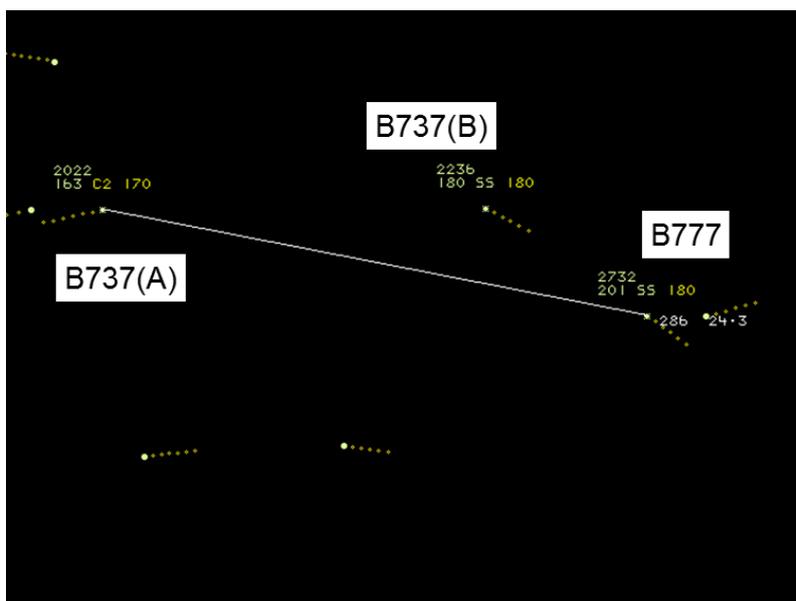
Figure 2 – 1754:50.

At 1754:50 the B777 pilot reported on frequency, level at FL180. The transmission was partly blocked by the preceding B737(B) pilot also reporting on frequency, but was acknowledged by the controller (Figure 2).

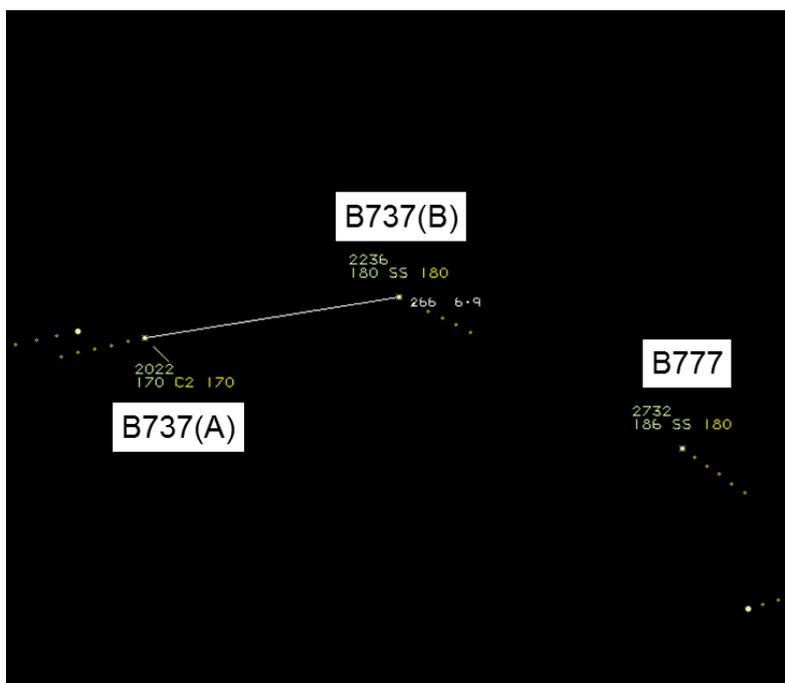
Figure 3 - 1755:38.

Again from 1754:50 until 1755:38, transmissions were continuous. At 1755:38 the controller instructed the B737(A) pilot to climb to FL210 (Figure 3).

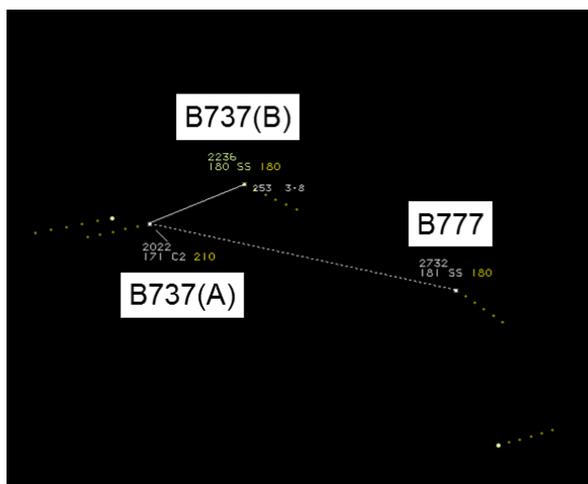
Figure 4 - 1755:55.

At 1755:55 (Figure 4), a low-level Short Term Conflict Alert (STCA) was activated between the B737(A) and the B777 but not against B737(B), which was passing 3.8nm ahead, and indicating 900ft above B737(A). The controller instructed the B737(A) pilot to stop his climb, although he did not complete the transmission and no stop-level was passed. Without pausing, the controller then gave the B777 pilot [using his correct callsign] an avoiding action turn to the left onto heading 250° but this call was wrongly taken by the B737(A) pilot. This error was picked up by the controller who started to give the B737(A) pilot his own turn for avoiding action but did not complete the transmission. The B777 pilot did not acknowledge his avoiding action turn.

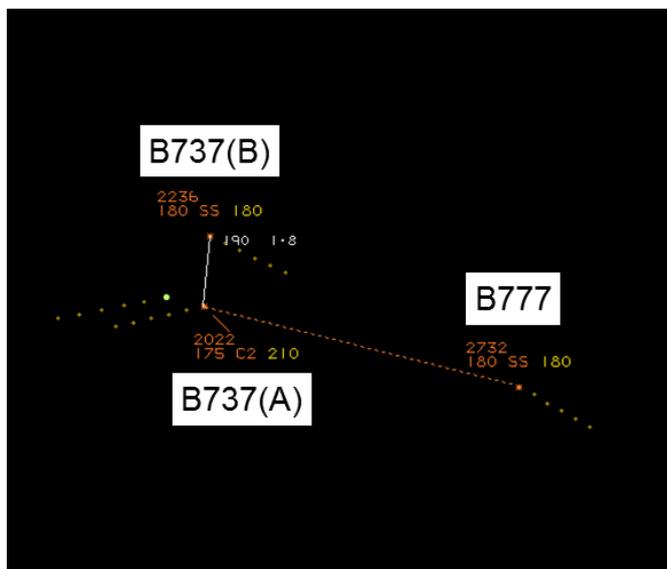
Figure 5 - 1756:10.

At 1756:10, high-level STCA were activated between B737(A) and B737(B) and between B737(A) and the B777. This coincided with a CPA between the two B737s of 500ft vertically and 1.8nm laterally, and a report from the B777 pilot of traffic 400ft beneath and climbing which was acknowledged by the controller (Figure 5).

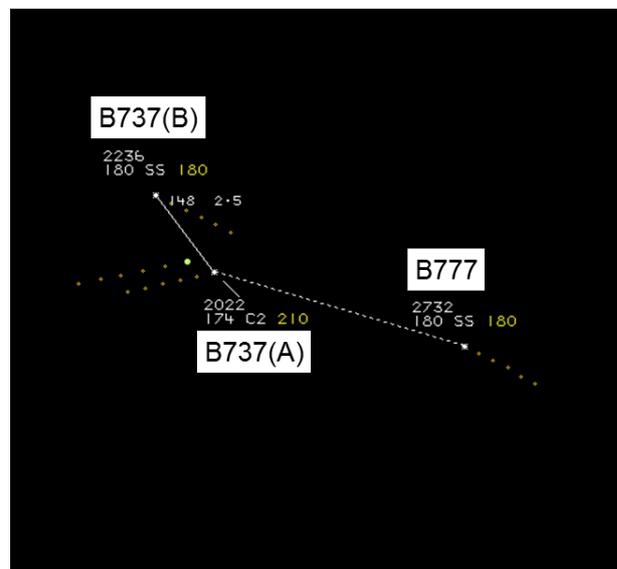
Figure 6 - 1756:20

At 1756:20 the controller again instructed the B777 pilot to make an avoiding action turn, (as previously issued), which this time was acknowledged by the pilot. The STCA between the B737s disappeared and returned to a low-level alert against the B777, with the B737(A) pilot having climbed up to FL175 but in the process of descending to FL173 as the 'altitude hold' selection took effect (Figure 6).

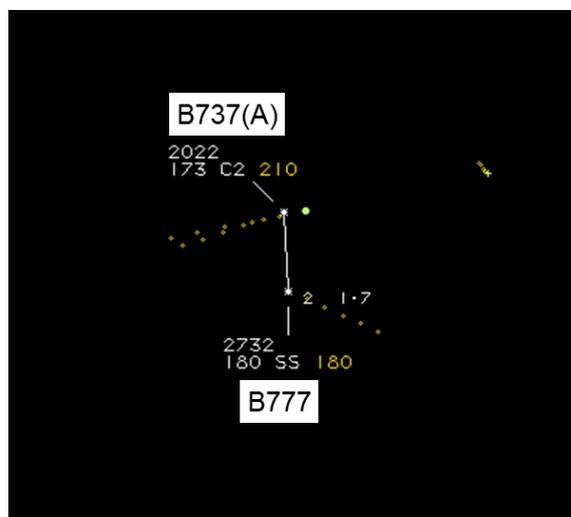
Figure 7 - 1756:50.

CPA between B737(A) and the B777 took place at 1756:50; 700ft vertically and 1.7nm laterally (Figure 7).

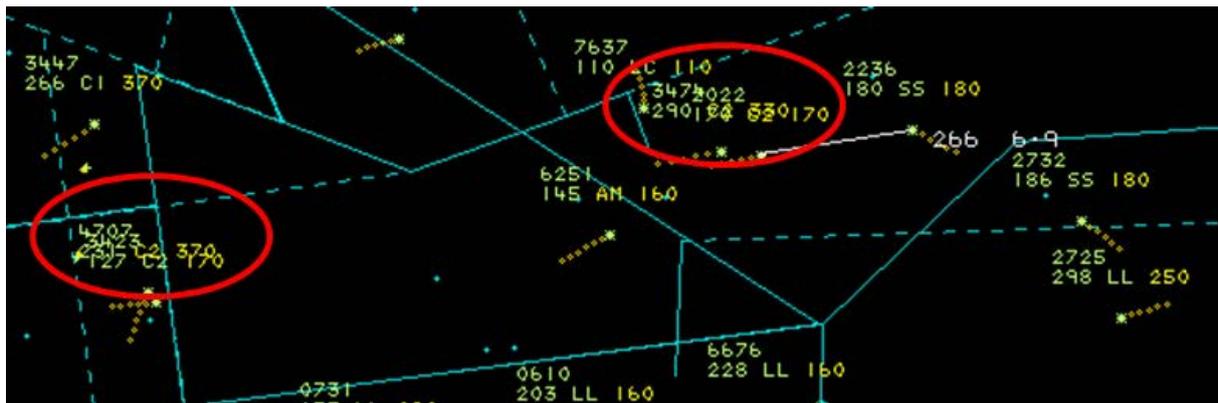
Figure 8 – 1755:38

In the controller's report, he acknowledged mistakenly climbing the B737(A) instead of another aircraft operated by the same company, and therefore with a similar callsign, which was some 20nm astern of B737(A) and on a similar track. At interview he confirmed this and again made reference to the fact that both the B737(A) and the succeeding aircraft callsigns were garbled on the radar screen by other aircraft. Figure 8 is a screenshot taken from a recording of the controller's position at this time, included to show the garbling (both ringed in red), although the callsigns have been converted back to transponder codes, and are therefore not as long.

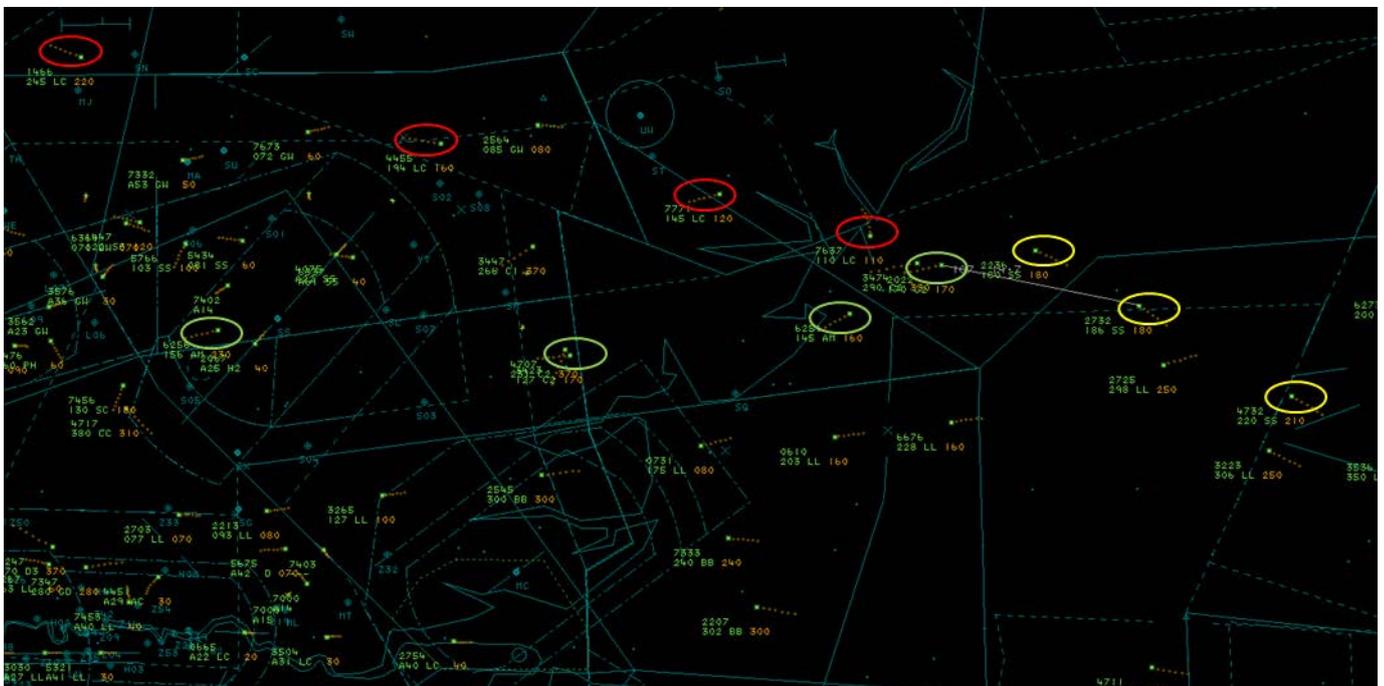
The snapshots used to illustrate the events running up to and including the CPA do not adequately indicate the actual traffic situation presented to the controller at the time. Figure 9 is a screenshot taken from the controller's position at the time he issued the climb instruction to the B737(A) pilot. Points to note are:

The London City inbounds are ringed in red, Stansted/Luton inbounds in yellow, and Stansted/Luton departures in green.

The controller is handling traffic from FL110 up to FL 220, aircraft well above and below these levels is also visible.

There is little/no filtering of traffic by level/track.

The London City inbounds now route significantly further east than pre-LAMP.
