AIRPROX REPORT No 2016102

Date: 10 Jun 2016 Time: 1604Z Position: 5058N 00219W Location: 1nm SW Henstridge

PART A: SUMMARY OF INFORMATION REPORTED TO UKAB

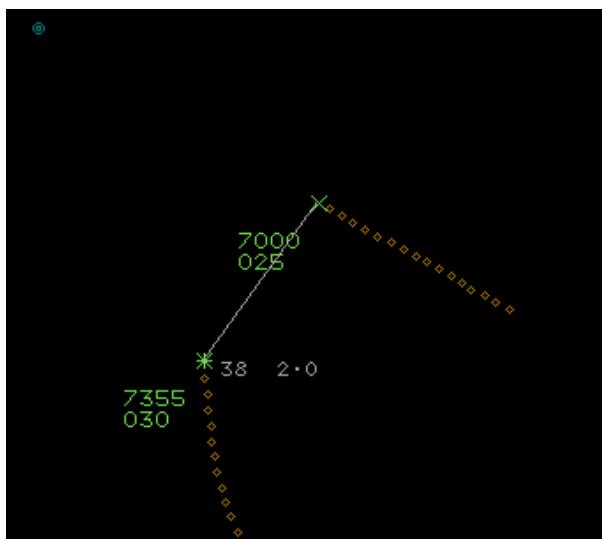
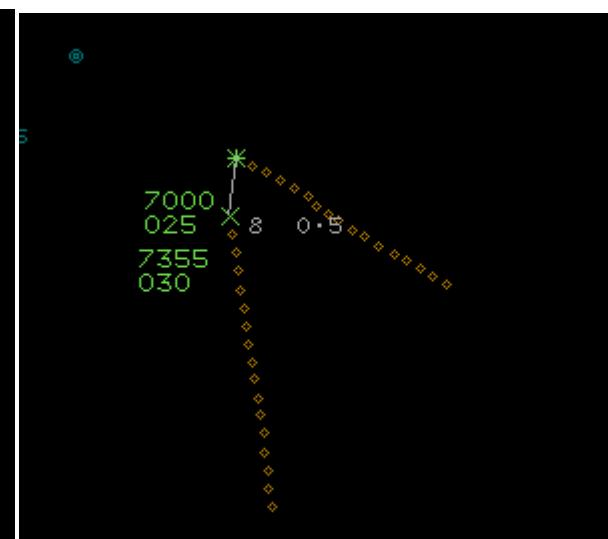
At Figure 1 the NATS radar replay shows the proximity of the SR20 (Squawking 7355) to what is believed to be YAK 1 (Squawking 7000). YAK 2, who in his report describes turning left and then seeing the SR20, does not show on the radar at all. The Yaks are at a range of 2nm from the SR20 which, according to the pilot's report is when Bournemouth gave Traffic Information and he reported visual. Figure 2 is 35 seconds later, the SR20 is still at 3000ft and the distance between the aircraft is 0.5nm. However, shortly afterwards the SR20 can be seen to make a right avoiding action turn, (Figure 3) as described in his report. Therefore, although the radar separation between YAK 1 and the SR20 is known to be 100ft and 0.4nm, the exact separation between YAK 2 and the SR20 is not known.
