**AIRPROX REPORT No 2016130**

Date: 05 Jul 2016 Time: 1438Z Position: 5117N 00020W Location: 8.7nm NNW Gatwick airport

**PART A: SUMMARY OF INFORMATION REPORTED TO UKAB**

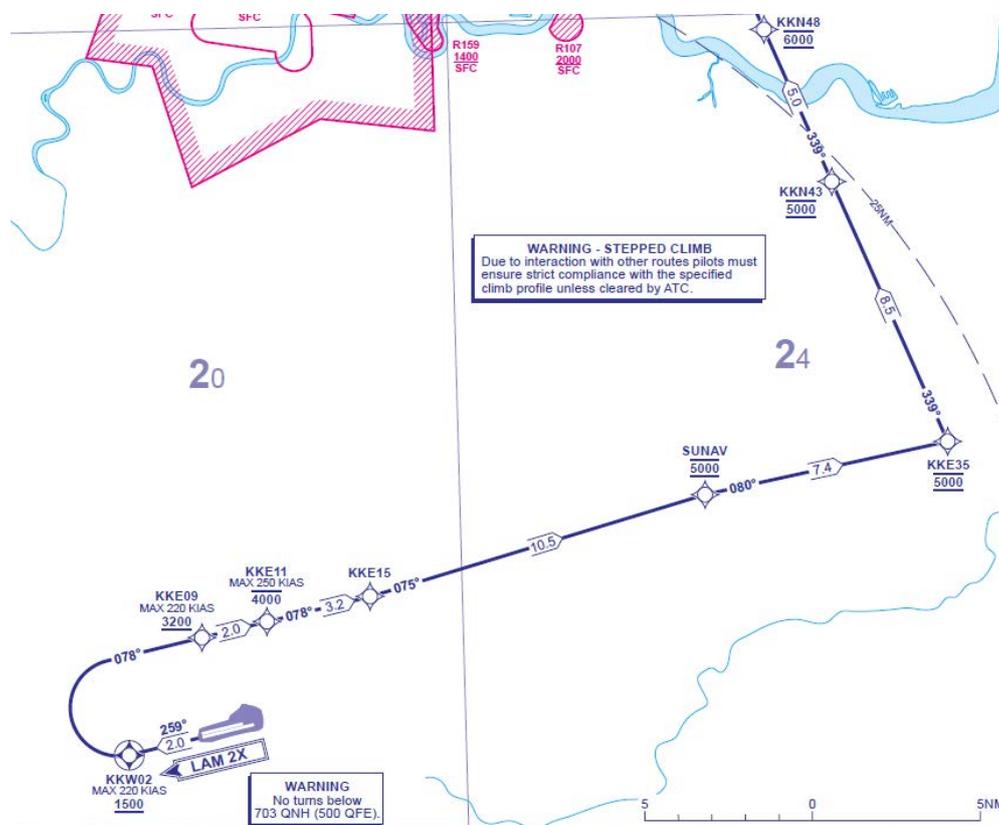
Figure 1 – UK AIP AD 2-EGKK-6-3 LAM2X SID.

At 1434:53, the B767 pilot having departed from RW26L at Gatwick airport contacted the Biggin Sector controller and reported climbing through 2000ft for 6000ft on the LAM2X Standard Instrument Departure (SID) (Figure 1). The Biggin Sector controller instructed the B767 pilot to climb to altitude 5000ft.

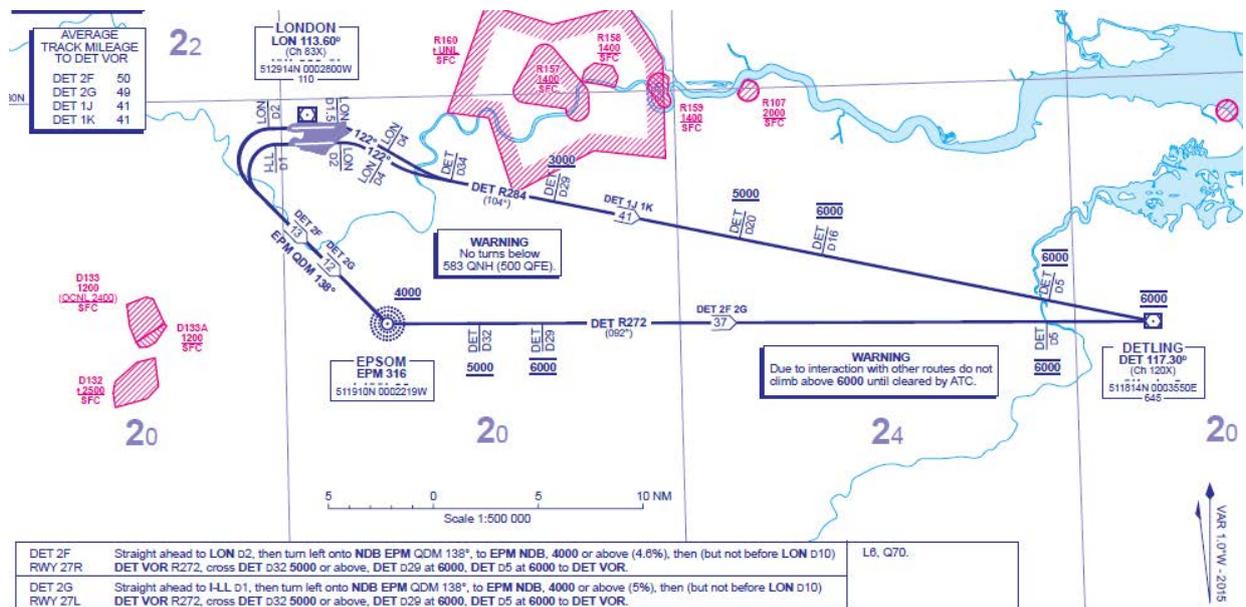
Figure 2 – UK AIP AD 2-EGLL-6-5 DET2G SID.

At 1435:20, the A380 pilot, having departed from RW27L at Heathrow airport, called the Biggin Sector controller and reported climbing through 2600ft for Flight Level(FL) 060 on the DET2G SID (Figure 2). The Biggin Sector controller asked the A380 pilot to confirm that he was climbing to altitude 6000ft which was then acknowledged by the A380 pilot.

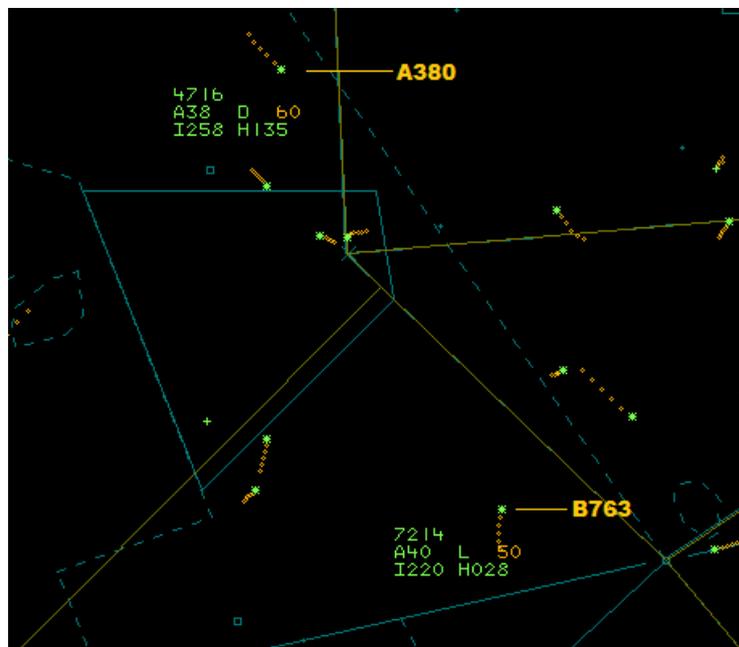
Figure 3 – Swanwick MRT at 1436:09.

At 1436:09 (Figure 3), the Biggin Sector controller instructed the B767 pilot to fly heading 090° and climb to FL130. The B767 pilot read back the heading correctly but asked for the level to be passed once more. The Biggin Sector controller repeated the cleared Flight Level which was then correctly read back.

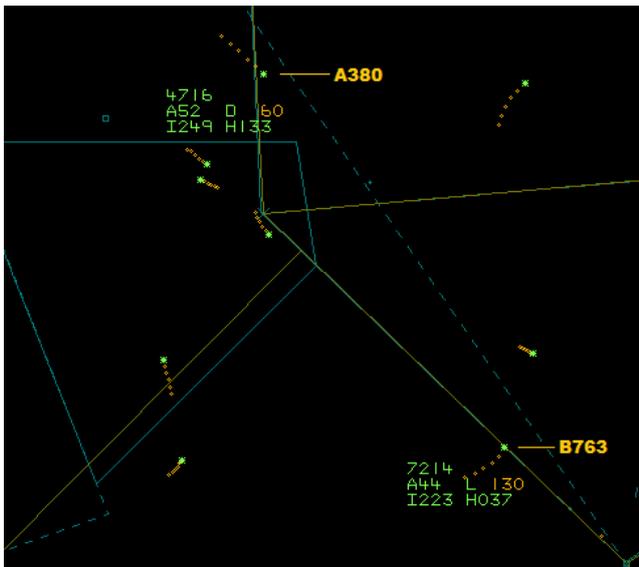
Figure 4 – Swanwick MRT at 1436:45.

At 1436:45 (Figure 4), the B767 had commenced a left-turn, the Mode S derived heading information indicated 037°. This was observed by the Biggin Sector controller and, at 1437:04, he transmitted the following to the B767 pilot: “[B767 C/S] er where are you going you’re meant to be right onto a heading of 090 can you er standby”.

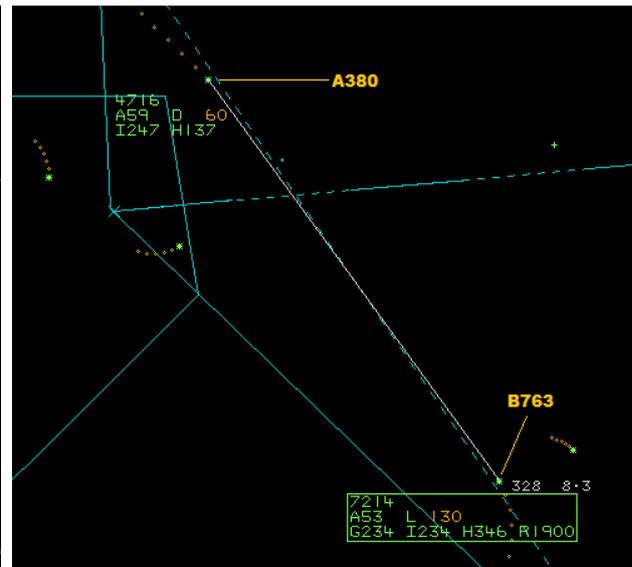
Figure 5 – Swanwick MRT at 1437:11.

At 1437:11 (Figure 5), the Biggin Sector controller issued an avoiding action turn to the A380 pilot transmitting “[A380 C/S] turn left on to heading of zero eight zero this is avoiding action”.

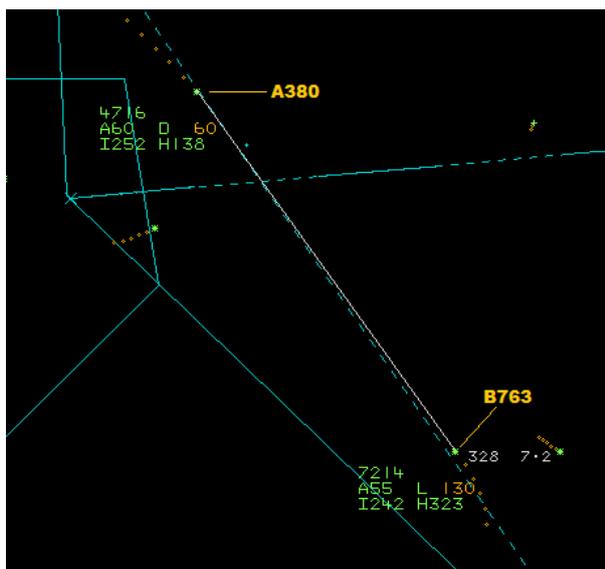
Figure 6 – Swanwick MRT at 1437:18.

At 1437:18 (Figure 6), the Biggin Sector controller issued an avoiding action turn to the B767 pilot transmitting “[B767 C/S] heading two seven zero degrees avoiding action”.

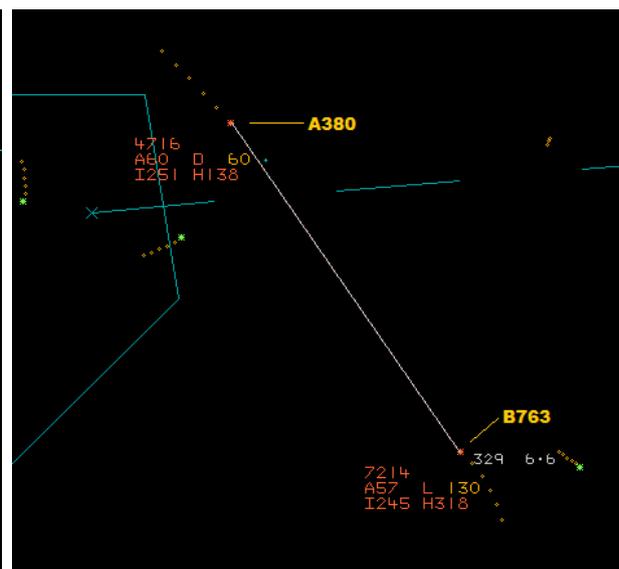
Figure 7 – Swanwick MRT at 1437:24.

At 1437:24 (Figure 7), the Short Term Conflict Alert (STCA) activated. At this time the horizontal distance between the B767 and the A380 was 6.6nm, the vertical distance was 300ft.

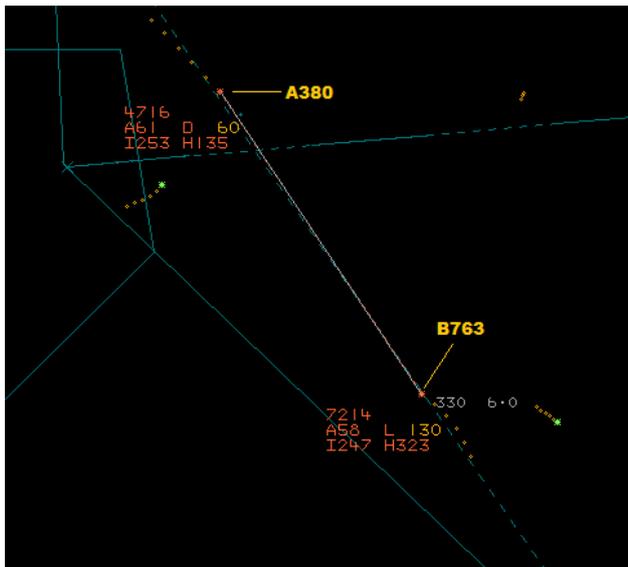
Figure 8 – Swanwick MRT at 1437:26.

At 1437:26 (Figure 8), the B767 had reversed the left turn, the Mode S derived heading information indicated 323°. The Biggin Sector controller then transmitted the following to the B767 pilot: “[B767 C/S] are you on a heading of 270?”

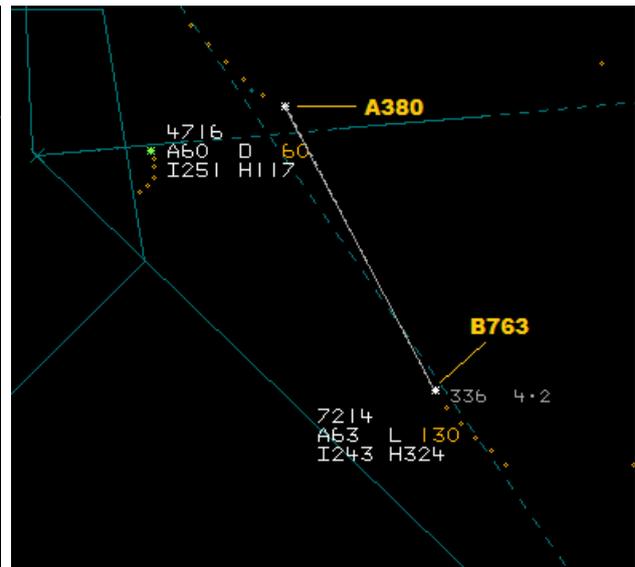
Figure 9 – Swanwick MRT at 1437:39.

At 1437:39 (Figure 9), the B767 pilot responded with “310 [heading] we are turning left we have traffic in sight”.

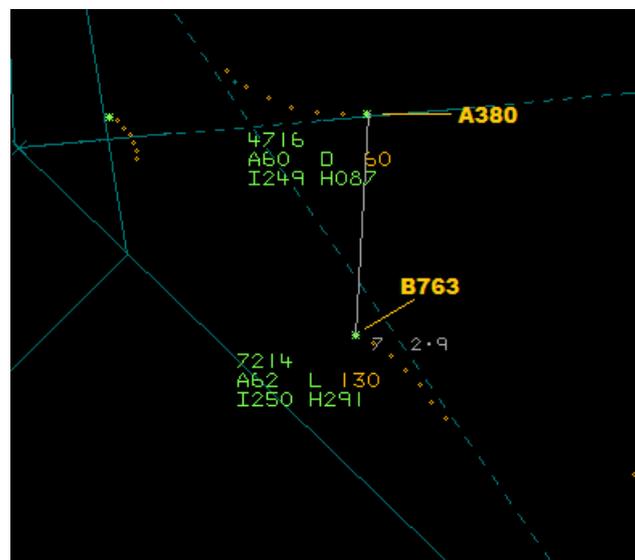
Figure 10 – Swanwick MRT at 1437:54 (CPA).

CPA occurred at 1437:54 (Figure 10), with a minimum horizontal distance of 2.9nm and a minimum vertical distance of 200ft.
