AIRPROX REPORT No 2016171

Date: 17 Aug 2016 Time: 0950Z Position: 5744N 00318W Location: Lossiemouth

PART A: SUMMARY OF INFORMATION REPORTED TO UKAB

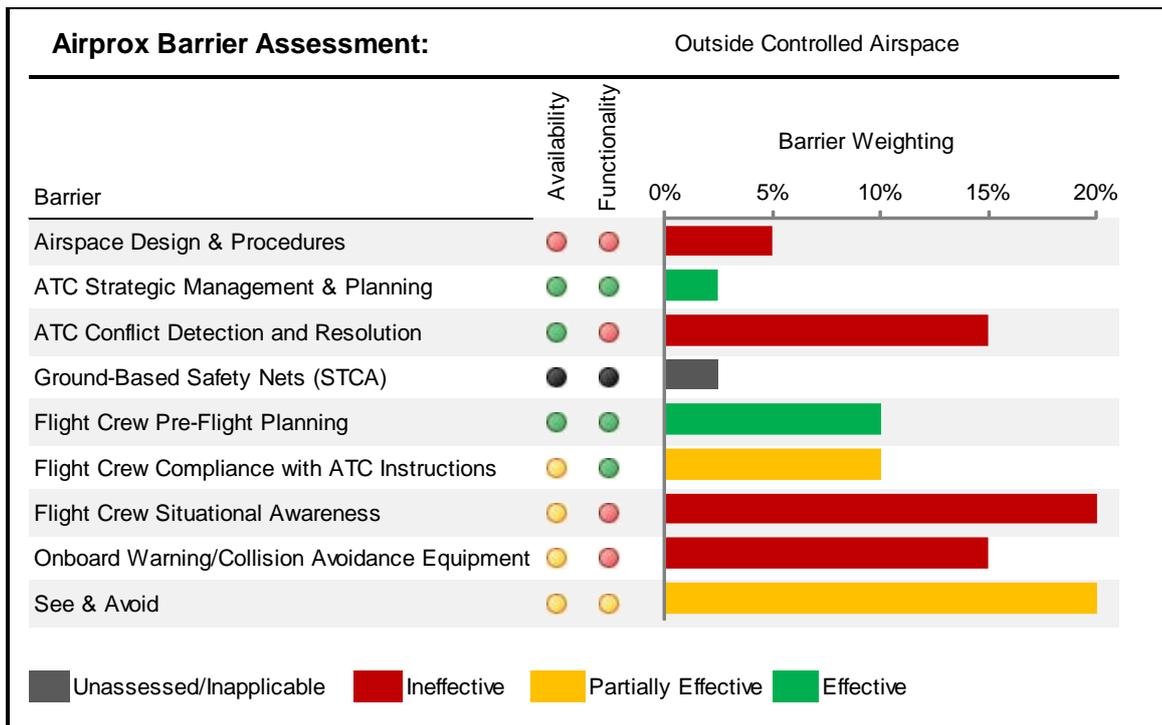
- **Airspace Design and Procedures** were **ineffective** because the circuit direction at Lossiemouth required extended breaks to be conducted for larger formations, which introduced a conflict with aircraft departing.

- **ATC conflict and detection** was not effective because the controller did not pass Traffic Information on the Tornado departure details to the Typhoons.

- **Flight Crew Compliance with ATC Instructions** was only **partially effective**, because ATC had not given specific Traffic Information and so instructions and/or procedures pertinent to the scenario were only partially available or were generic only.

- **Flight Crew Situational Awareness** was **ineffective** because the Typhoon No4 pilot did not know the Tornado No4 was getting airborne and departing into conflict.

- **TCAS** was **ineffective**, probably due to the Tornado system's warm-up time.
- **See and Avoid** was **partially effective**; the Typhoon pilot saw the Tornado and managed to take avoiding action, albeit late.
