AIRPROX REPORT No 2016173

Date: 16 Aug 2016 Time: 1521Z Position: 5038N 00131W Location: SW Newport, Isle of Wight

PART A: SUMMARY OF INFORMATION REPORTED TO UKAB

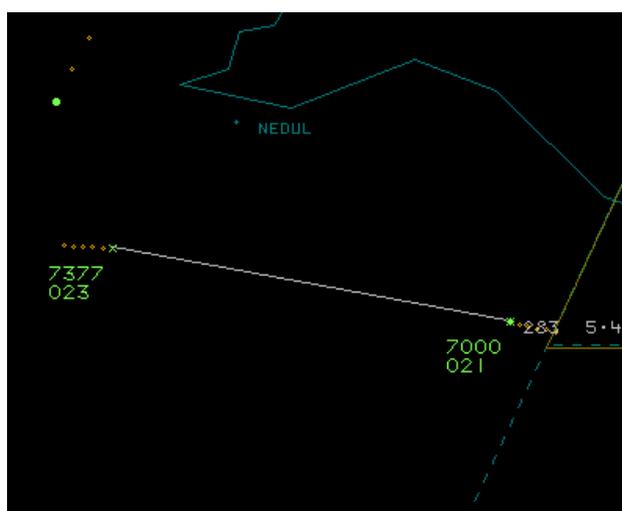
Figure 1 – 1519:45

At 1519:45 (Figure 1), the PA28 contacted Bournemouth Approach and requested a Basic Service. The Bournemouth Approach controller acknowledged the transmission and instructed the PA28 pilot to stand-by. The R/T loading on the Bournemouth Approach frequency around this time was relatively high with the controller engaged in providing services to mixed IFR and VFR traffic including one aircraft engaged in a SAR task.

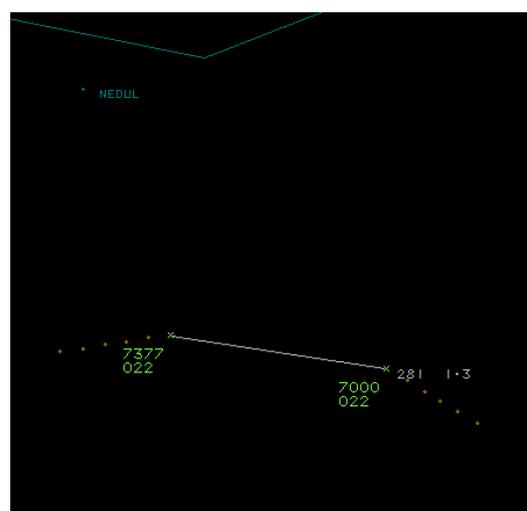
Figure 2 - 1520:47

At 1520:47 (Figure 2), the Bournemouth Approach controller instructed the PA28 pilot to pass his message. Coincident with the PA28 pilot passing his details, the transmission was partially

blocked by another station; consequently, the controller requested that the PA28 pilot pass his position, level and routing again. The PA28 pilot then reported 4nm south-east of The Needles at altitude 2300ft on QNH 1019 routing across Christchurch Bay to Swanage.

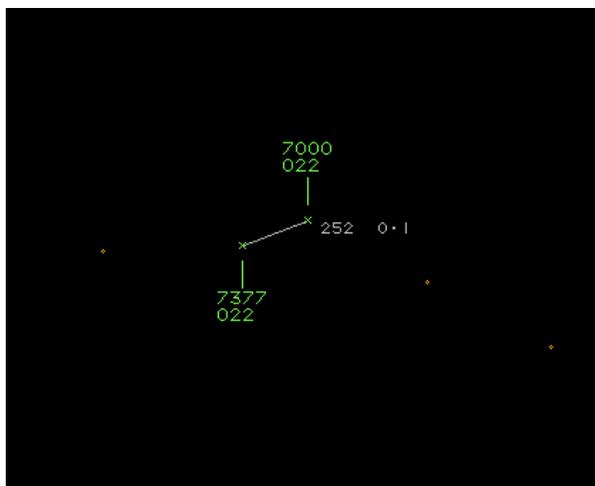
Figure 3 – 1521:06

CPA occurred between 1521:06 (Figure 3) and 1521:11 (Figure 4) with a minimum horizontal distance of less than 0.1nm. Between these times both aircraft were indicating FL022.

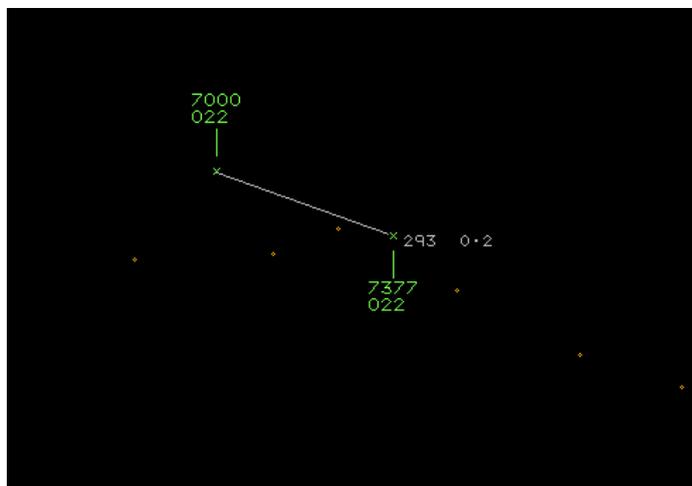
Figure 4 – 1521:11

At 1521:26 both aircraft had by this time passed each other and the Bournemouth Approach controller agreed a Basic Service with the PA28 pilot.

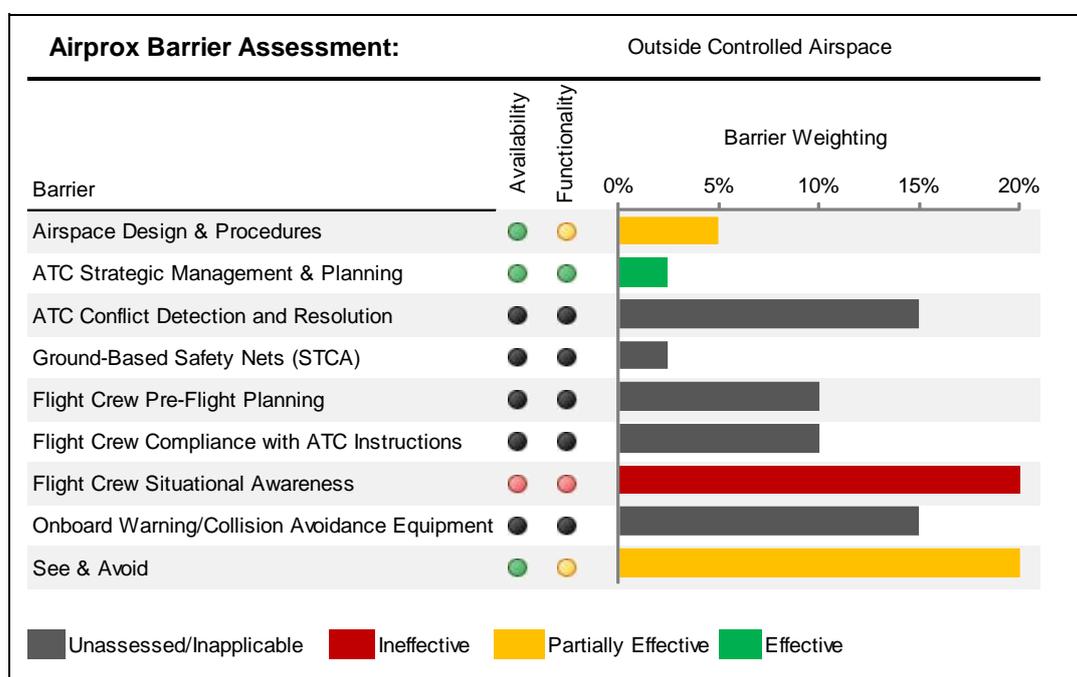
- **Airspace Design and Procedures** was considered only **partially effective** because radar cover at the normal operating levels for traffic in this area often resulted in only intermittent radar returns; this meant the controllers may not be able to provide the best service to aircraft in the area.

- **Flight Crew Situational Awareness** was **ineffective** because, although the C182 and PA28 were both on the same frequency at concurrent times, neither seemed to have registered the other's route or level. Although both pilots were aware that the area was very busy, their distraction by in-cockpit tasks resulted in both pilots not fully assimilating the information that was available.

- **Onboard Warning/Collision Avoidance Equipment** was **inapplicable** because neither aircraft was fitted with the equipment. The Board agreed that because both aircraft were transponding, if this barrier had been available to at least one of the pilots it could have alerted them to the presence of the other aircraft early enough to carry out actions to increase separation.

- **See and Avoid** was **partially effective** because both pilots saw the other late and both took emergency avoiding action.
