AIRPROX REPORT No 2016181

Date: 24 Aug 2016 Time: 1435Z Position: 5324N 00034W Location: N of Scampton

PART A: SUMMARY OF INFORMATION REPORTED TO UKAB

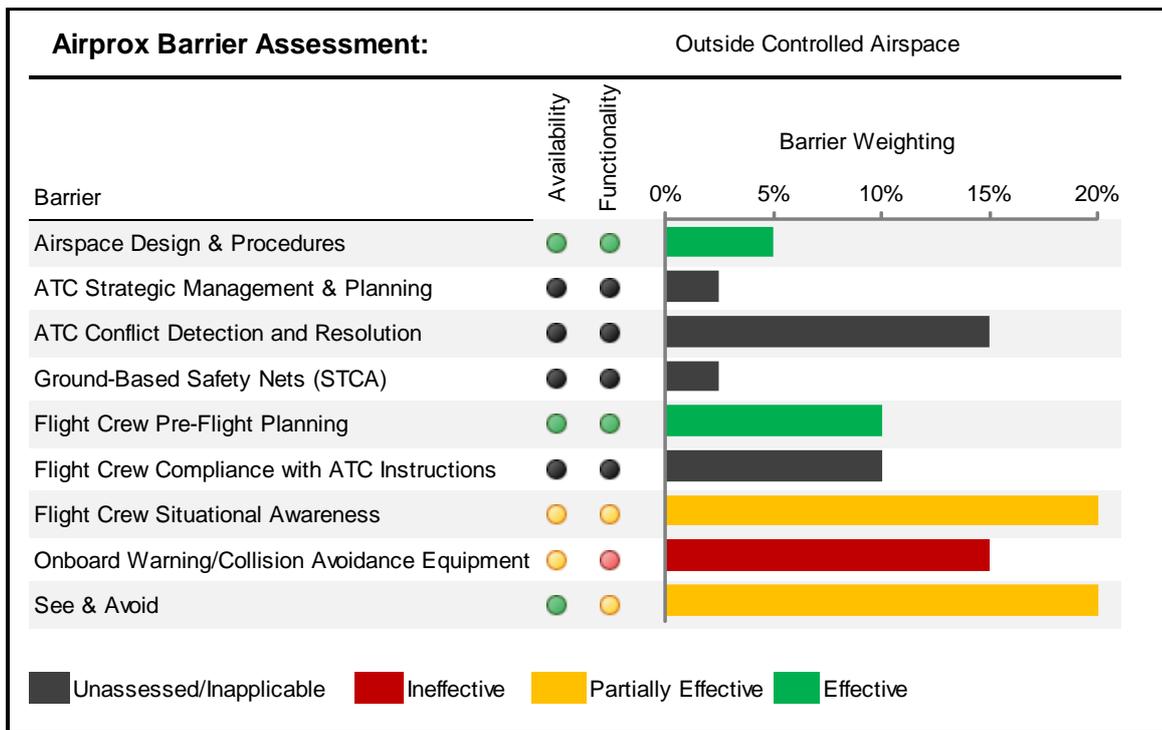
Barrier assessment:

- **Situational Awareness** and **See-and-Avoid** had both only been **partially effective**; the Tornado pilot had not been aware of or seen the glider until he had effectively passed it.
- **Onboard Warning/Collision Avoidance Equipment** had been **ineffective**; the lack of transponder signals from the glider/aircraft had meant that the Tornado TCAS could not provide warnings.
