AIRPROX REPORT No 2016196

Date: 01 Sep 2016 Time: 1329Z Position: 5109N 00036E Location: Lashenden/Headcorn Airfield

PART A: SUMMARY OF INFORMATION REPORTED TO UKAB

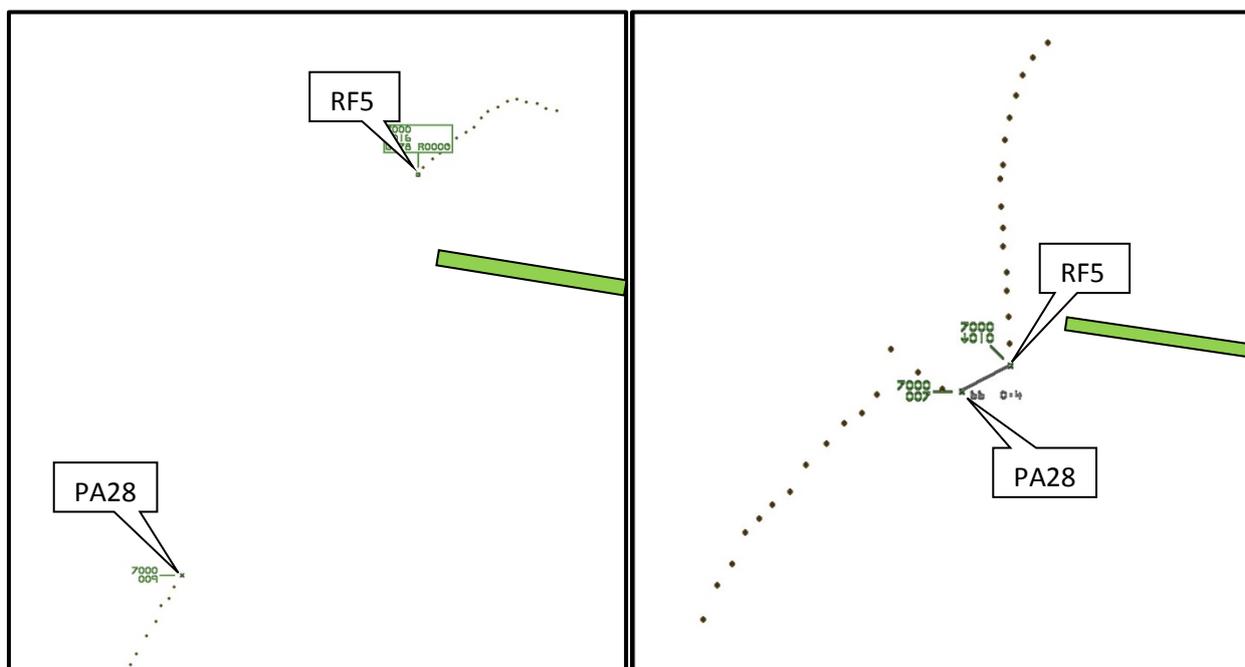
Figure 1: 1327:19³Figure 2: 1328:41³

The RF5 joined from the North and the PA28 joined from the South West. At 1327:19 (Figure 1), each aircraft has the other in his 12 o'clock. The RF5 turns crosswind when the aircraft are 3.5nm apart; at this stage the PA28 still has the RF5 in his 12 o'clock whilst the RF5 has the PA28 on his right. The RF5 passes through the PA28's 12 o'clock as the PA28 turns downwind, and at this point the RF5 is still flying crosswind 0.4nm ahead of the PA28 (Figure 2). The radar returns on the radar replay garble at this point; however, when the radar returns separate, the RF5 is downwind and the PA28 is to the South in a right hand orbit as described in both pilots' reports. The RF5 continues downwind with the PA28 turning right to reposition downwind behind the RF5.

³ Note: The green rectangle is an approximate indication of RWY 28/10 at Headcorn, not to scale, to assist in denoting the positions of the RF5 and PA28 when they joined the visual circuit.

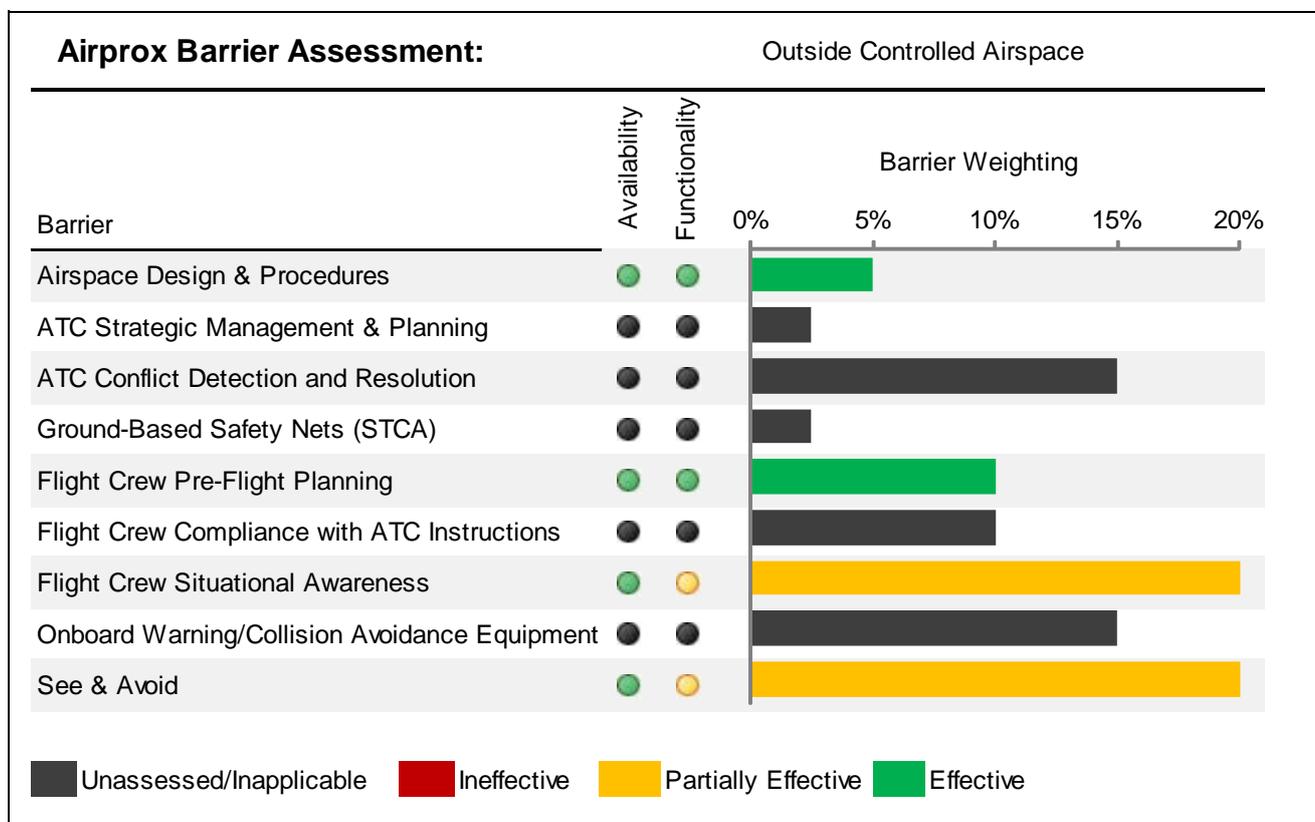
- **Flight Crew Situational Awareness** was considered **partially effective** because: although the PA28 pilot was aware of the RF5, he had not assimilated its intentions or given it sufficient clearance; and the RF5 pilot was not aware of the PA28 and had inadvertently associated the PA28 pilot's downwind call with the Cessna.
- **See and Avoid** was also considered **partially effective** because: the RF5 pilot did not see the PA28 until it flew beneath his aircraft; the PA28 pilot did not actively maintain sight with the RF5; and the PA28 pilot did not sufficiently avoid the RF5.

Modern safety management processes employ the concept of safety barriers that prevent contributory factors or human errors from developing into accidents. Based on work by EASA, CAA, MAA and UKAB, the following table depicts the barriers associated with preventing mid-air-collisions. The length of each bar represents the barrier's weighting or importance (out of a total of 100%) for the

type of airspace in which the Airprox occurred (i.e. Controlled Airspace or Uncontrolled Airspace).⁴ The colour of each bar represents the Board's assessment of the effectiveness of the associated barrier in this incident (either Fully Effective, Partially Effective, Ineffective, or Unassessed/Inapplicable). The chart thus illustrates which barriers were effective and how important they were in contributing to collision avoidance in this incident.
