AIRPROX REPORT No 2016206

Date: 20 Sep 2016 Time: 1720Z Position: 5346N 00240W Location: Preston

PART A: SUMMARY OF INFORMATION REPORTED TO UKAB

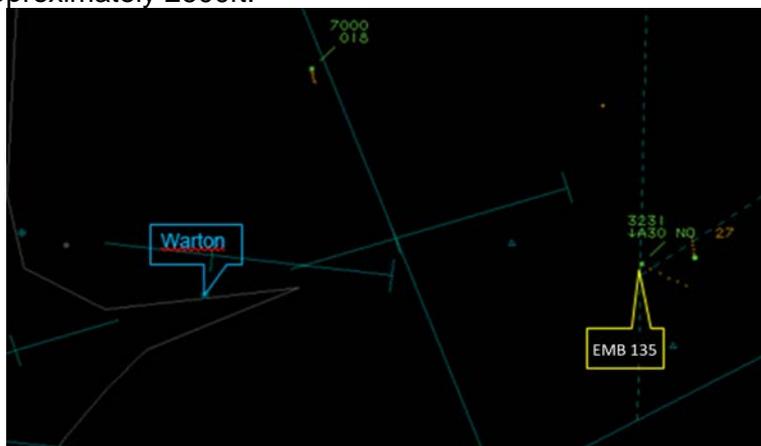
Figure 1 –1718:58 (Prestwick Area Radar)

The radar controller subsequently issued headings to the EMB135 as tactical avoiding action from unknown traffic which may have potentially affected the planned tracking for the ILS. This unknown (transpondering) traffic turned away, and the controller was able to vector the aircraft back towards the centreline. As the EMB135 settled on heading the pilot reported a balloon in sight. The Warton radar controller had received information from the Tower controller at Warton about a balloon which had been sighted from the VCR and was estimated to be in the vicinity of Preston Cathedral at approximately 1000ft. No R/T contact with either Warton Radar or Warton Tower had been received from the balloon. At 1718:58 (Figure 1) the EMB135 pilot reported commencing a left turn to avoid the balloon. During this avoidance the pilot reported the height of the balloon to be approximately 2600ft.

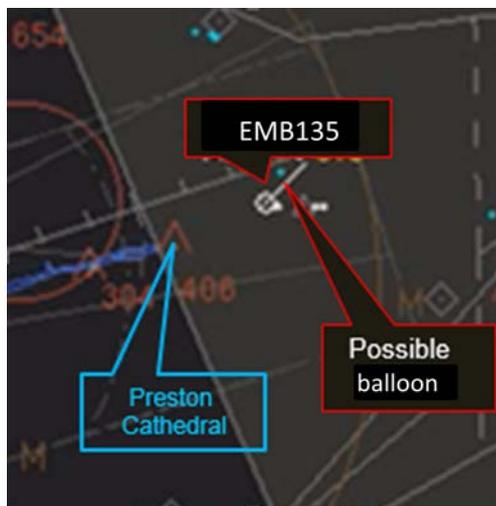
Figure 2 1720:02 Warton Radar image

Once clear of the balloon the pilot accepted further vectors for the ILS approach. Figure 2 (1720:02), shows the Warton Radar picture with a faint primary return (in blue) which may have been the balloon just to the north of the EMB135. The controller reported that there had been no previous evidence of the balloon on the radar, and the Prestwick Area radar that ATSI have reviewed, also had no evidence. In Figure 2 the position of Preston Cathedral can be seen on the Warton Radar image.

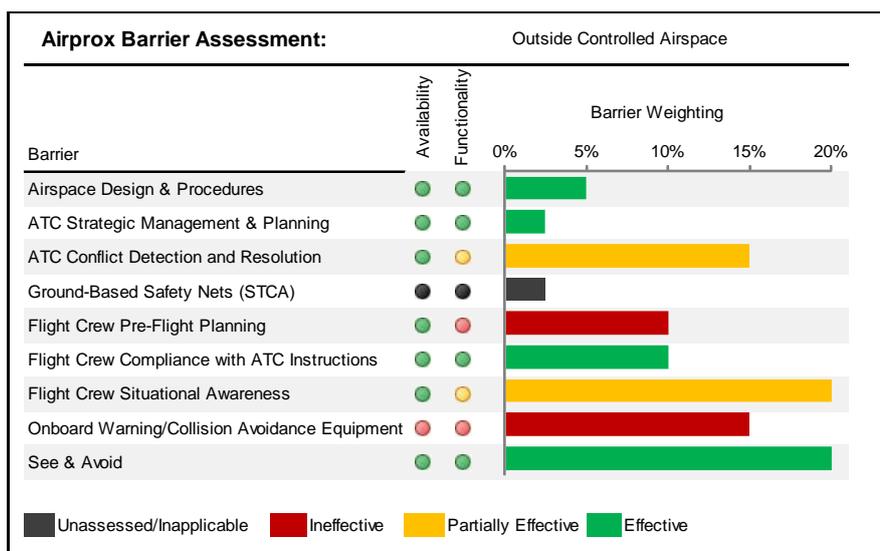
- **ATC Conflict Detection and Resolution** had only been **partially effective** because the balloon had not painted on radar and the visual report from the VCR had introduced a false mental picture of the balloon's location in the mind of the Warton Radar Approach controller.
- **Flight Crew Pre-flight Planning** was considered to have been **ineffective** because the balloon pilot had not assimilated that his flight might cause conflict with Warton radar traffic.
- **Flight Crew Situational Awareness** was also only **partially effective** because the EMB135 pilot was only given generic information about the balloons, and this information did not include the height and accurate location of the specific balloon that came into conflict.
- **Onboard Warning/Collision Avoidance Equipment** was assessed as **ineffective** because there was no system available on the hot-air balloon.
