AIRPROX REPORT No 2016218

Date: 23 Sep 2016 Time: 1331Z Position: 5143N 00251W Location: USK Glider Site

PART A: SUMMARY OF INFORMATION REPORTED TO UKAB

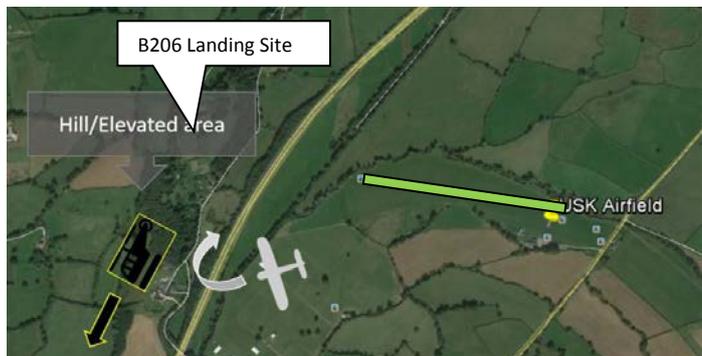
Figure 1: RF5 Pilot's Submitted Diagram

THE RF5 PILOT reports that he was on a go-round when he saw a helicopter travelling south west across his path, directly in front of his climb-out at about 500-600ft. He took an avoiding turn to the right and completed a circuit as intended. The helicopter was very near where gliders typically operate, near the high key and winch release areas, although there were no glider launches at the time. He did not know if the helicopter saw him.

He assessed the risk of collision as 'High'.

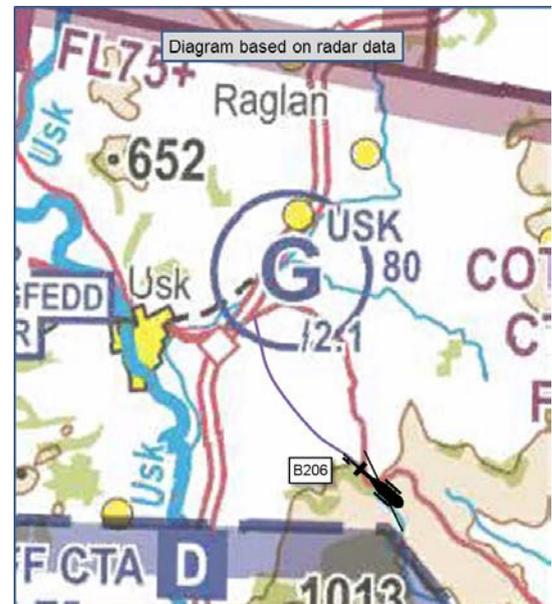
Figure 2: B206 Radar Data Diagram

The private site that the B206 was routing to is within the marked area of the Usk gliding site. The B206 can be seen on radar recordings prior to the Airprox routing to the private site from the north. The B206 radar contact then fades, presumably whilst it is in the hover, and then is not seen again until after climbing out of the private site and after the reported Airprox. The B206 reappears on the radar recording passing 800ft in the climb and passing to the south of the Usk gliding site (Figure 2). The RF5 does not display on the radar recordings at all.

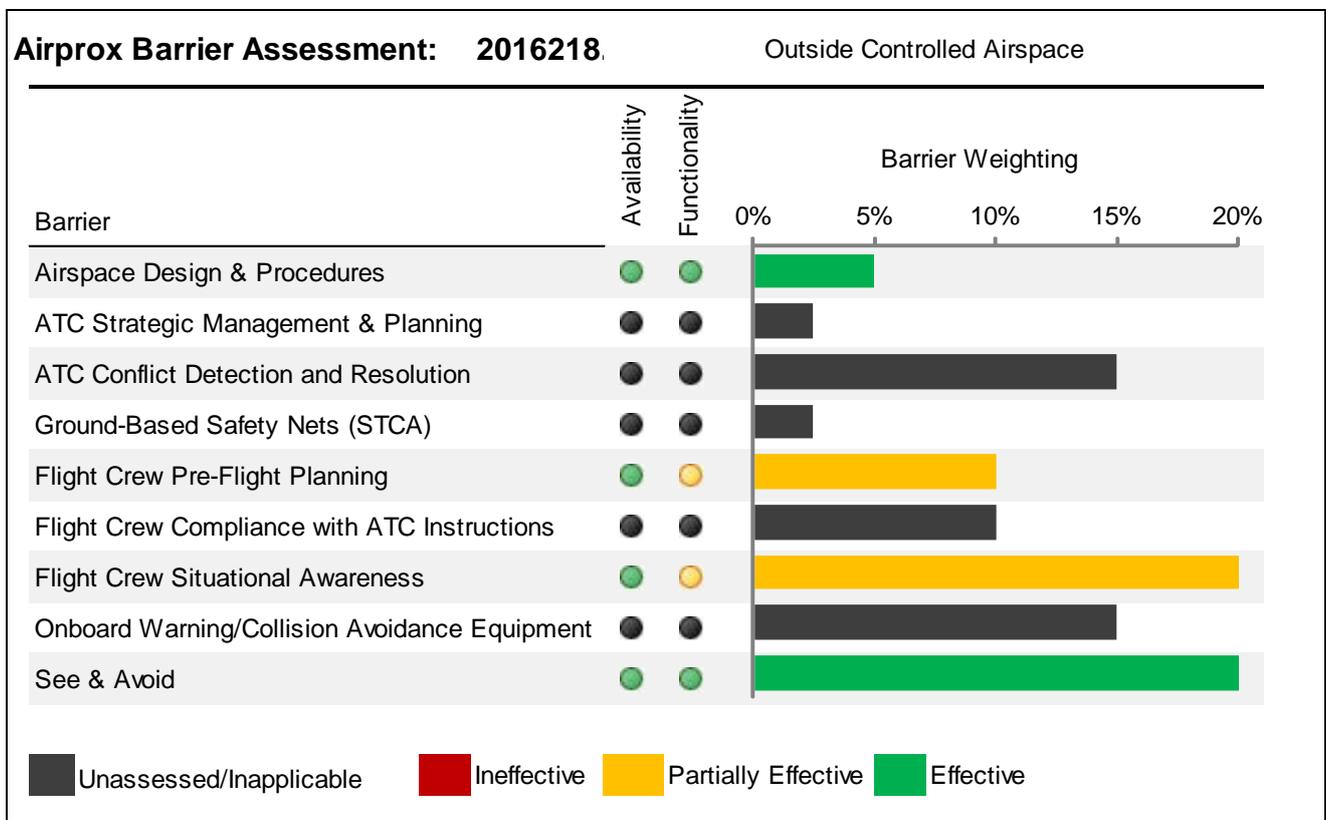
- **Flight Crew Pre-Flight Planning** was considered **partially effective** because the B206 pilot had not made contact with the Usk Glider club prior to his flight to the private site close to Usk Glider site.
- **Situational Awareness** was also assessed as being only **partially effective** because the B206 pilot was not monitoring the Glider frequency either to gain information on the Usk circuit traffic or inform them of his presence and intentions.

Modern safety management processes employ the concept of safety barriers that prevent contributory factors or human errors from developing into accidents. Based on work by EASA, CAA, MAA and UKAB, the following table depicts the barriers associated with preventing mid-air-collisions. The length of each bar represents the barrier's weighting or importance (out of a total of 100%) for the type of airspace in which the Airprox occurred (i.e. Controlled Airspace or Uncontrolled Airspace).⁴ The colour of each bar represents the Board's assessment of the effectiveness of the associated barrier in this incident (either Fully Effective, Partially Effective, Ineffective, or Unassessable/Absent). The chart thus illustrates which barriers were effective and how important they were in contributing to collision avoidance in this incident.
