AIRPROX REPORT No 2016260

Date: 08 Dec 2016 Time: 1628Z (Twilight) Position: 5114N 00049W Location: 3nm SW Farnborough

PART A: SUMMARY OF INFORMATION REPORTED TO UKAB

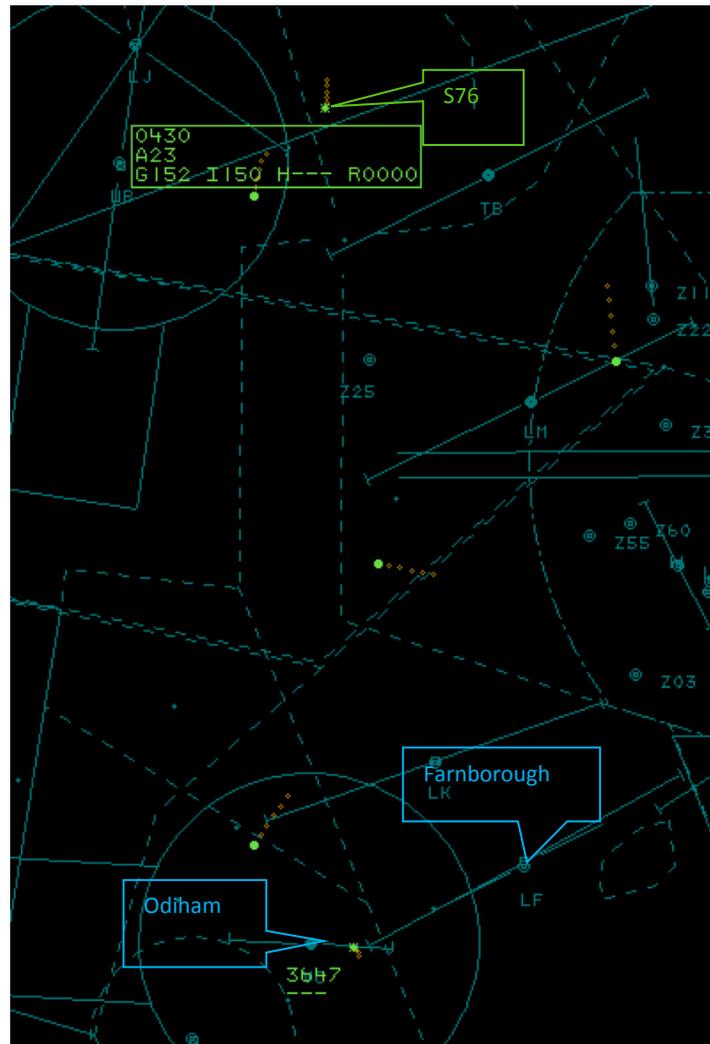
Figure 1 (1607:10).

At 1607:10 the Farnborough controller initiated co-ordination with Odiham with respect to the S76 and its inbound details. The S76 (SSR code 0430) was approximately 25nm north of Odiham at this point (Figure 1), and, taking into account other traffic that Farnborough was working at the time, an agreement was made to route the S76 via the overhead at Odiham (in order to remain

clear of the Farnborough traffic). The S76 would be released to Odiham prior to the reaching the Odiham overhead.

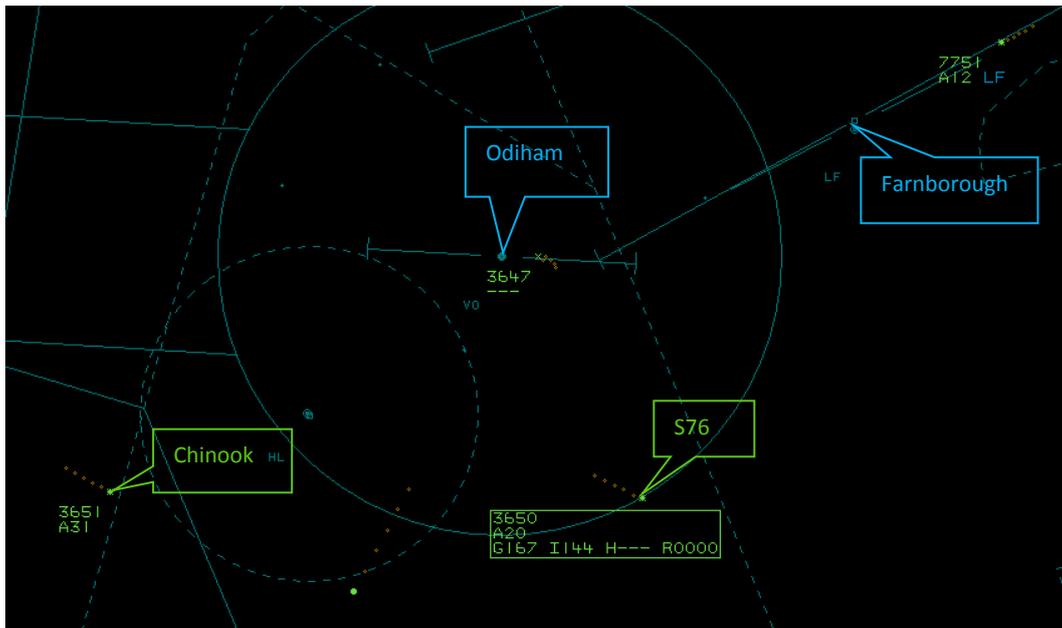
Figure 2 (1618:45).

At 1618:45 (Figure 2) the Farnborough Radar controller called the Odiham controller to discuss the pending departures from Farnborough. The Farnborough controller said they could see the Odiham pattern was active with an aircraft with code 3651 as well as the S76 which they already knew about. The Odiham controller explained that the 3651 code was a Chinook, which was also for an approach to RW27. The Farnborough controller arranged to call the Odiham controller back and indicated that they may be able to get ahead with the first of their departures (which was due to route to the north).

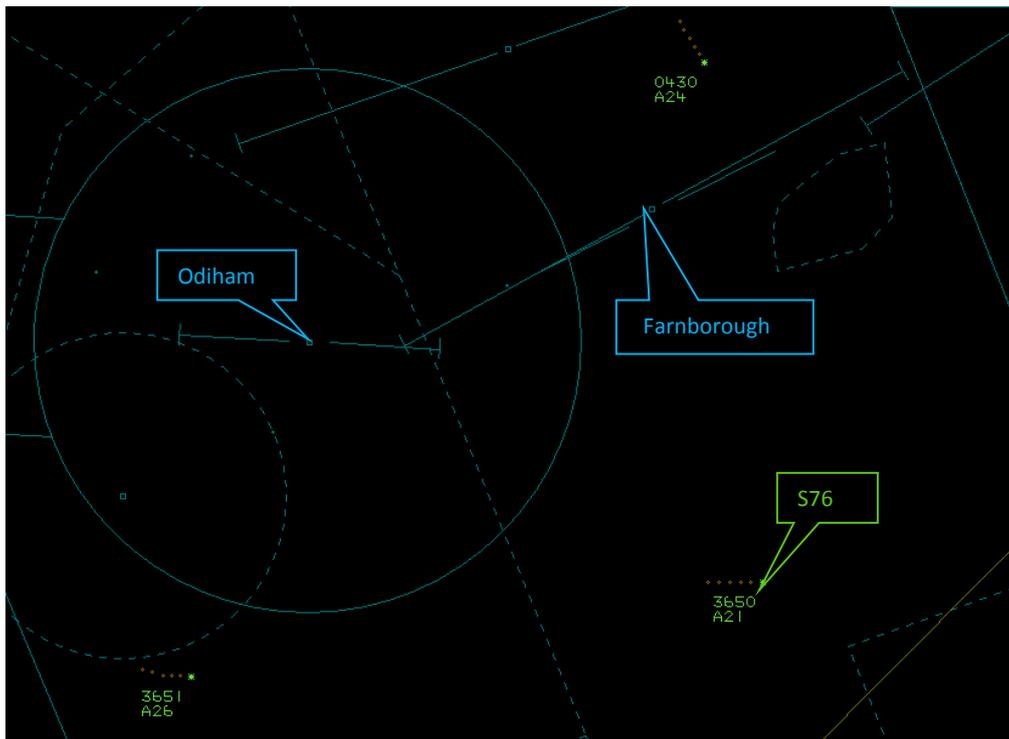
Figure 3 (1620:42).

At 1620:42 (Figure 3), Farnborough called Odiham and coordinated further traffic (code 0430) which might affect the Odiham ILS traffic. An arrangement was made whereby Odiham would extend the S76 downwind both to avoid the 0430 code and to enable Farnborough to depart traffic to the north (routing via Compton (CPT)) ahead of the S76 (code 3650).

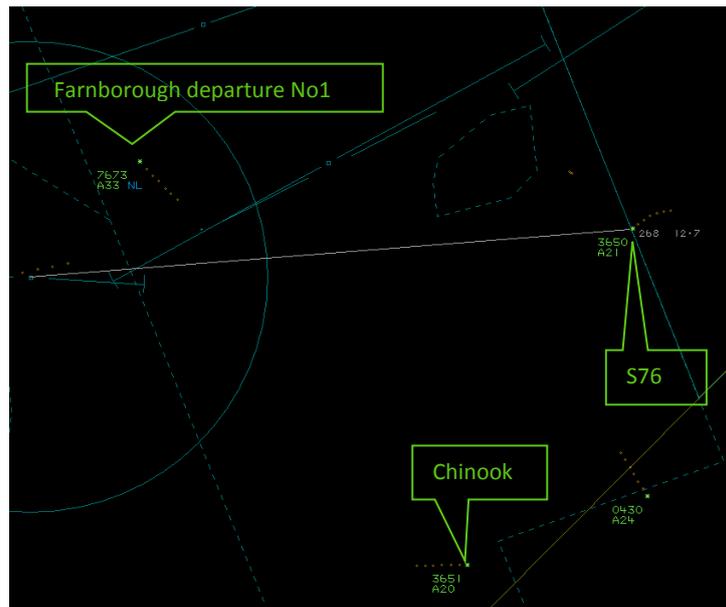
Figure 4 (1624:55).

At 1624:55 (Figure 4), the Farnborough Radar controller called the Odiham supervisor and advised them that they had a ‘HAZEL’ departure, ready for departure, and would they be able to depart this traffic ahead of the S76. The Odiham supervisor confirmed that if Farnborough were able to depart before the S76 then this would be OK. The Farnborough controller replied: “Roger, I’ll go now, I’ll be well ahead”.

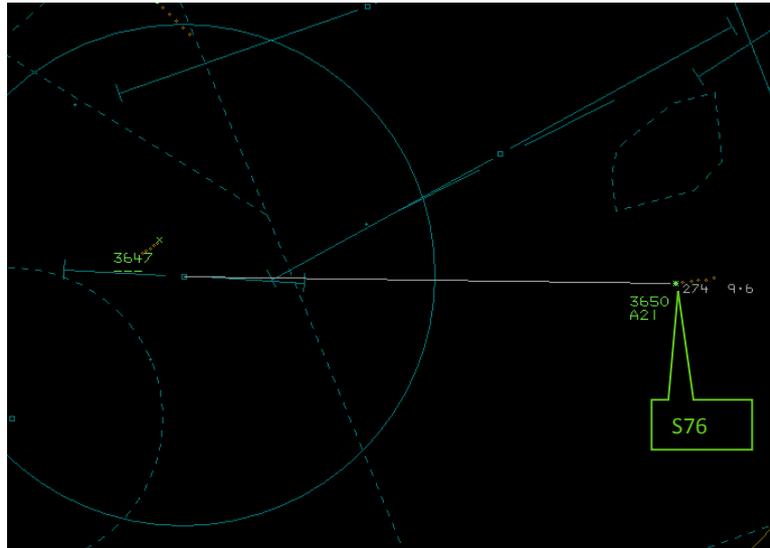
Figure 5 (1626:20).

At 1626:00 a controller handover was commenced in the Farnborough Radar position. During this handover, at 1626:20 (Figure 5) the Aerodrome controller called the Radar controller to advise that the CRJ2 was being very slow to depart. After a pause, the Aerodrome controller asked the Radar controller for further climb and the (outgoing) Radar controller offered 3400ft. The S76 was on a 9.6nm final for RW27 at Odiham at this time.

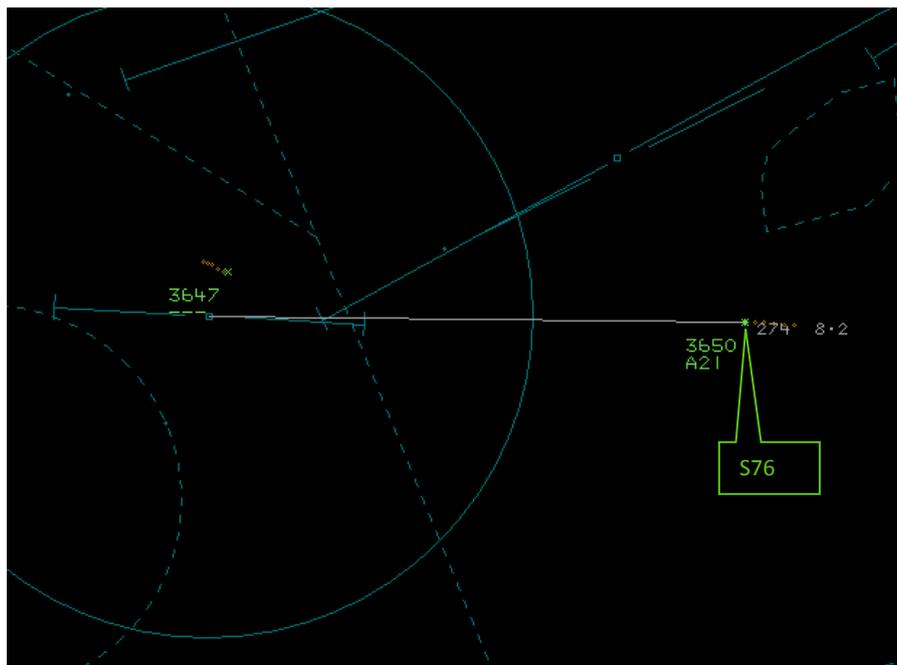
Figure 6 (1627:00).

At 1627:00 (Figure 6) the new Farnborough Radar controller called Odiham to advise them that the next departure would be climbing to 3400ft towards the south. The Odiham controller asked if 'Visual separation' was being applied to which the Farnborough controller replied "*I'm assuming so...*"

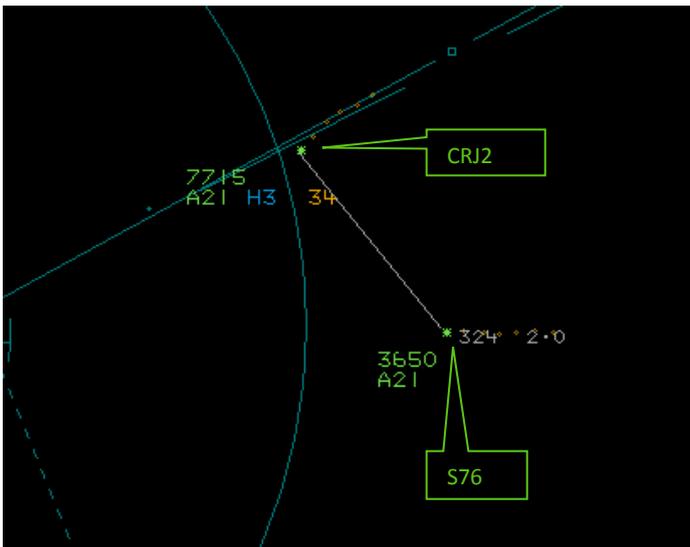
Figure 7 (1627:50)

At 1627:50 (Figure 7) the CRJ2 pilot first called the Farnborough Radar controller. The controller acknowledged the call and asked him to "*squawk ident*" in order to identify the aircraft.

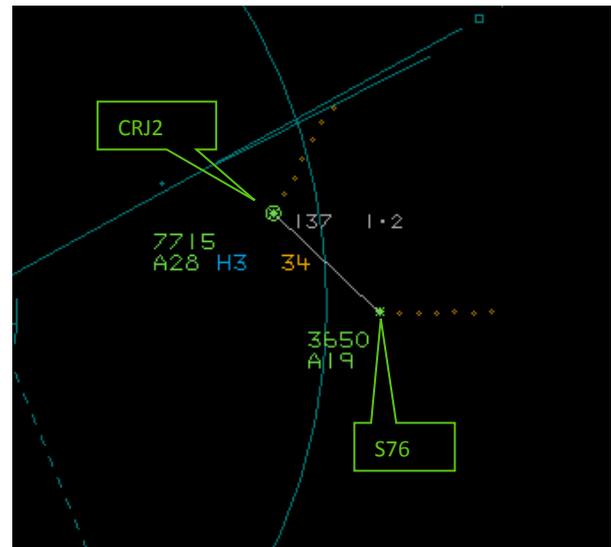
Figure 8 (1628:11).

At 1628:11 (Figure 8), CPA occurred with the CRJ2 and S76 separated by 1.2nm horizontally and 900ft vertically. The 'ident' function had just started to display.

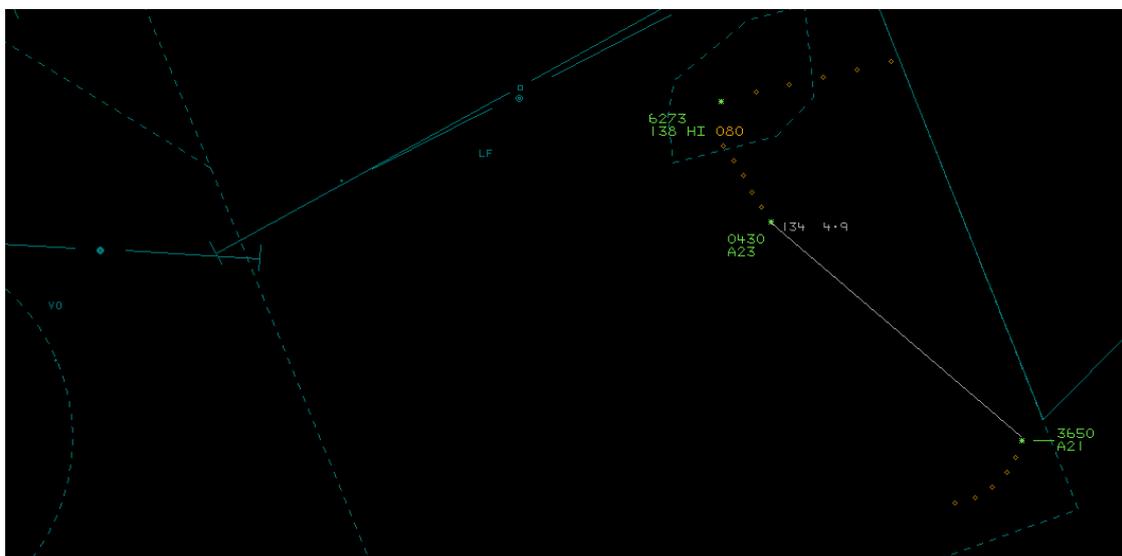
At 16:22:47 (Figure 9), the Odiham Approach controller passed Traffic Information to the S76 pilot on traffic north-west, range 5nm, tracking south-east, indicating 300ft above. The S76 pilot reported initially that they were not visual, then visual with the traffic. When asked if they were happy to turn inbound against the traffic, the pilot responded in the negative due to entering IMC.

Figure 9: Geometry at 16:22:47 (S76 3650; CRJ2 not yet airborne).

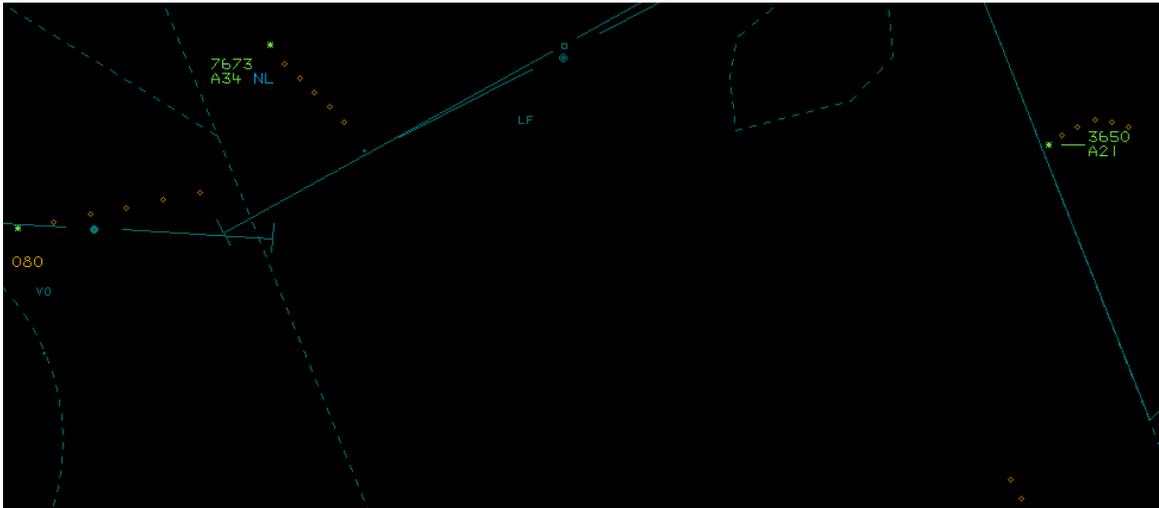
At 16:24:57 (Figure 10), the Farnborough Approach controller spoke with the Odiham Supervisor, stating that there was a HAZEL departure lined up on RW24. They asked if Odiham ATC were happy for the departure to proceed ahead of the S76. The Odiham Supervisor stated that the S76 was establishing on the ILS and that the departure should go straight away. The Farnborough Approach controller iterated that the departing traffic would go now and be well ahead of the S76.

Figure 10: Geometry at 16:24:57 (S76 3650; CRJ2 ready to depart).

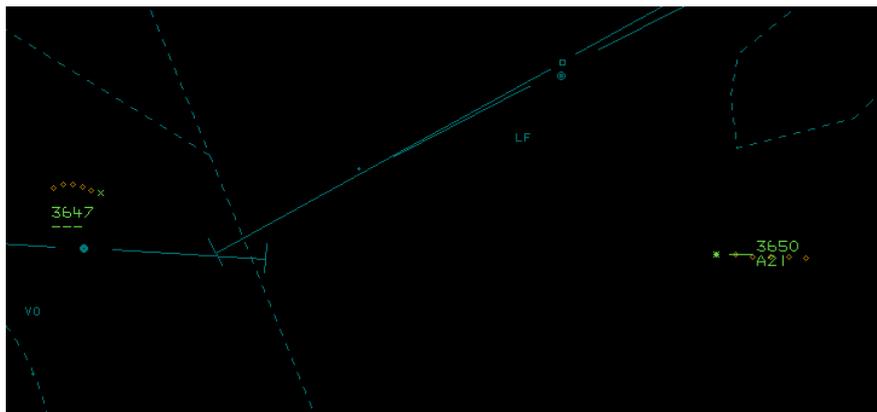
At 16:26:57 (Figure 11), the Farnborough Approach controller called the Odiham Approach controller and stated that the departure to the south (still not airborne) was slowly moving and would be climbing to 3400ft. The Odiham Approach controller read back the altitude and asked for confirmation that the pilot would be taking visual separation against the S76, who was by this time on the Odiham PA frequency. The Farnborough Approach controller replied that they presumed so.

Figure 11: Geometry at 16:26:57 (S76 3650; CRJ2 rolling).

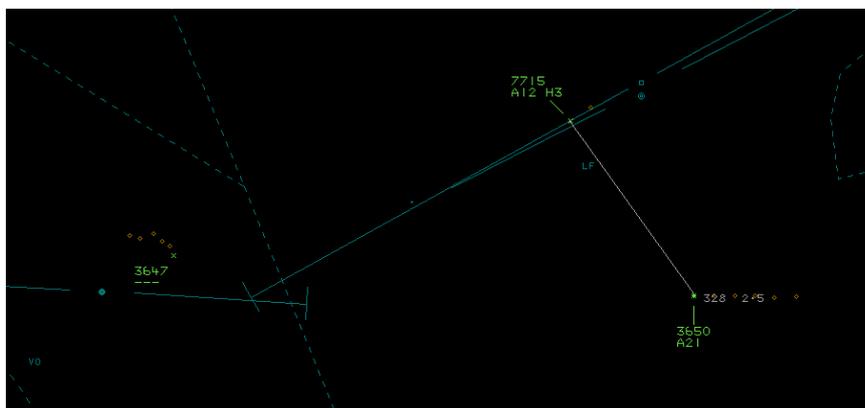
At 16:27:38 (Figure 12), the S76 pilot transmitted to the Odiham PA controller, stating that there appeared to be traffic climbing out in their 2 o'clock. The pilot asked for confirmation that it was from Farnborough. The Odiham PA controller responded that it was and then asked the Approach controller if the traffic was visual with 'you'?

Figure 12: Geometry at 16:27:38 (S76 3650; CRJ2 7715).

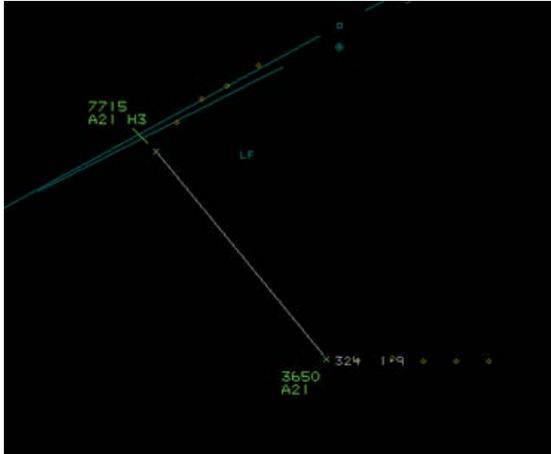
Figure 13: Geometry at 16:27:52

At 16:27:52 (Figure 13), the S76 pilot asked whether the traffic was coordinated, to which the Odiham PA controller responded that the CRJ2 was taking 'reduced separation', and that the CRJ2 pilot was visual with the S76. The S76 pilot stated that the CRJ2 pilot was not taking visual separation because they were in cloud. At 16:28:19, the Odiham PA controller passed Traffic Information to the S76 pilot on the traffic, now in their right, 1 o'clock, estimated 300ft above.

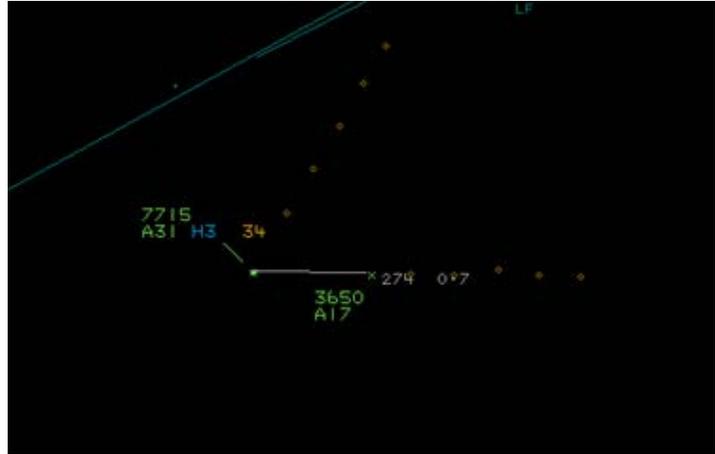
Figure 14: Geometry at 16:28:30
(S76 3650; CRJ2 7715).

At 16:28:30 (Figure 14), the S76 and CRJ2 passed 0.7nm laterally and 1400ft vertically apart. The Odiham Approach Controller reported that they were instructing a controller under training and operating band-boxed as Approach and Director. There had been consistently heavy IFR traffic throughout the session, with the S76 and another pilot on frequency at the time of the occurrence. The controller reported that, when the S76 was downwind, Farnborough rang to ask if the aircraft could extend downwind to facilitate the first of two departures. This was not deemed likely to delay the S76 due to its location at the time. When the S76 was further downwind, the Approach controller reported seeing conflicting traffic, so passed Traffic Information to the S76 pilot. He was reported to have called visual, but that he was entering cloud, therefore a vector away from the conflicting traffic was issued. Once the S76 was established on the ILS and handed over to Odiham PA controller for ILS monitor, the Farnborough Approach controller called again to say that the second departure [the CRJ2] was rolling. As that was likely to put the 2 aircraft into direct conflict, the trainee Approach controller reported asking Farnborough if the departure was taking 'reduced separation', a procedure employed between the 2 units to allow for expedition during good weather. The Farnborough controller reported that they assumed so, but given the weather conditions it seemed unlikely to the Odiham Approach controller that the CRJ2 pilot would be able to see the S76 from the ground (a requirement of the procedure). He reported that the S76 pilot was informed of the CRJ2 taking 'reduced separation', to which he responded that he was in thick cloud and it was unlikely that the aircraft was visible to the CRJ2 pilot.
