AIRPROX REPORT No 2017042

Date: 25 Mar 2017 Time: 1420Z Position: 5620N 00331W Location: 8nm SW Perth

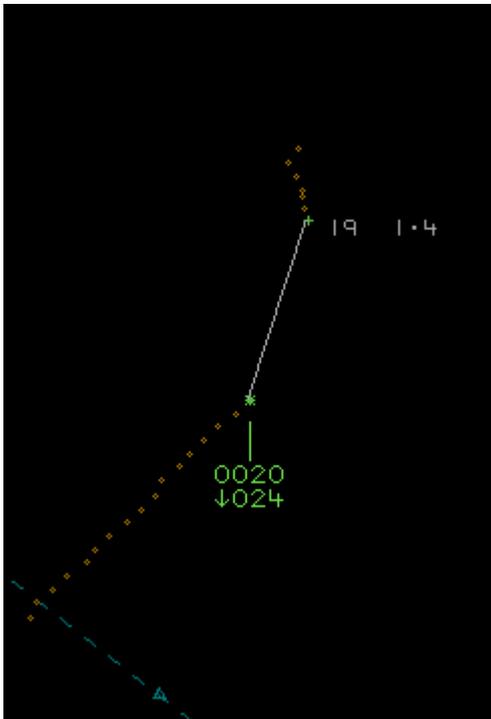
Figure 1 1419:00

Figures 1 and 2 are screen shots of the radar data showing the EC135, squawking 0020 and an unidentified primary only track. At Figure 1 the two aircraft are 1.4nm apart and at Figure 2 they are less than 0.1nm apart.

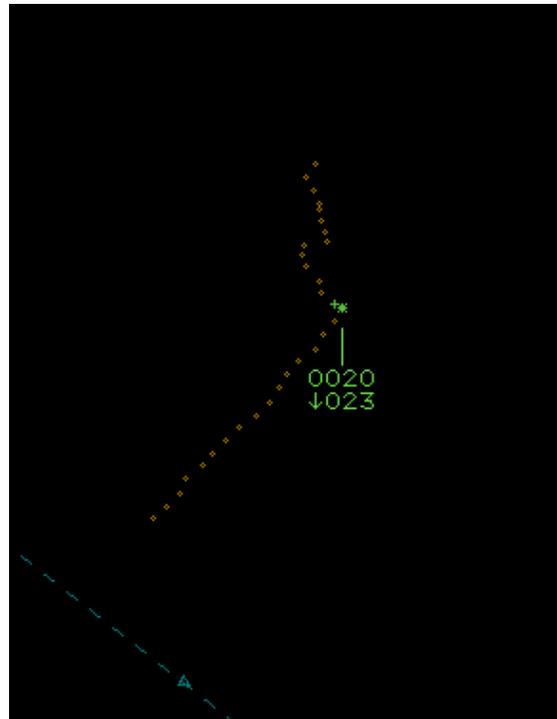
Figure 2 1419:27

In assessing the cause of the Airprox, the Board quickly agreed that this had been a late sighting by the EC135 pilot; unfortunately, they could make no assessment of whether the motor-glider pilot had seen the EC135. Based on the radar recording and the EC135 pilot's description of the incident, they assessed the risk as Category B; although the EC135 pilot had taken avoiding action, safety margins had still been much reduced below the norm.

Cause: A late sighting by the EC135 pilot.

Degree of Risk: B.

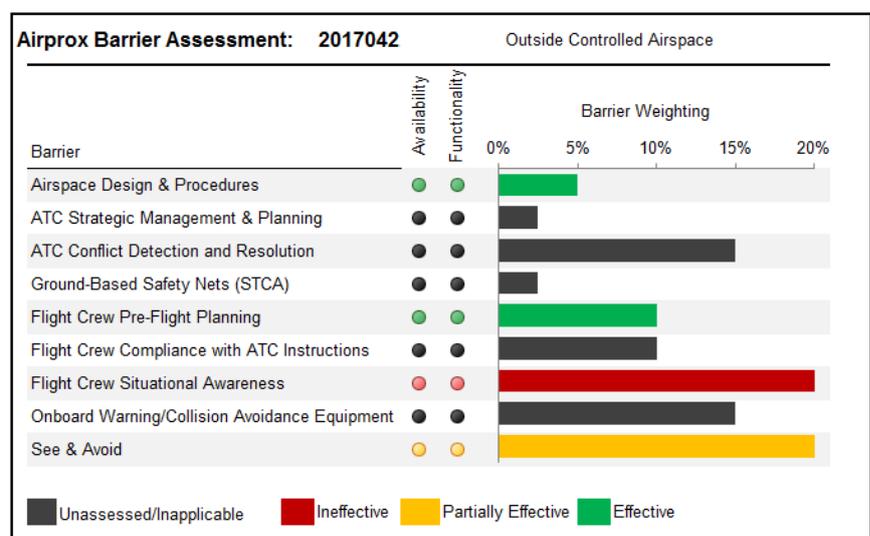
In assessing the effectiveness of the safety barriers associated with this incident, the Board concluded that the key factors had been that:

Flight Crew Situational Awareness was assessed as **ineffective** because there was no information available to the EC135 pilot to warn him about the motor-glider.

Onboard Warning/Collision Avoidance System was assessed as **inapplicable** because the EC135 was not fitted with a CWS.

See and Avoid was assessed as **partially effective** because although the EC135 pilot took avoiding action, it was later than ideal.
