AIRPROX REPORT No 2017065

Date: 11 Apr 2017 Time: 1510Z Position: 5116N 00054W Location: 5nm west Farnborough

PART A: SUMMARY OF INFORMATION REPORTED TO UKAB

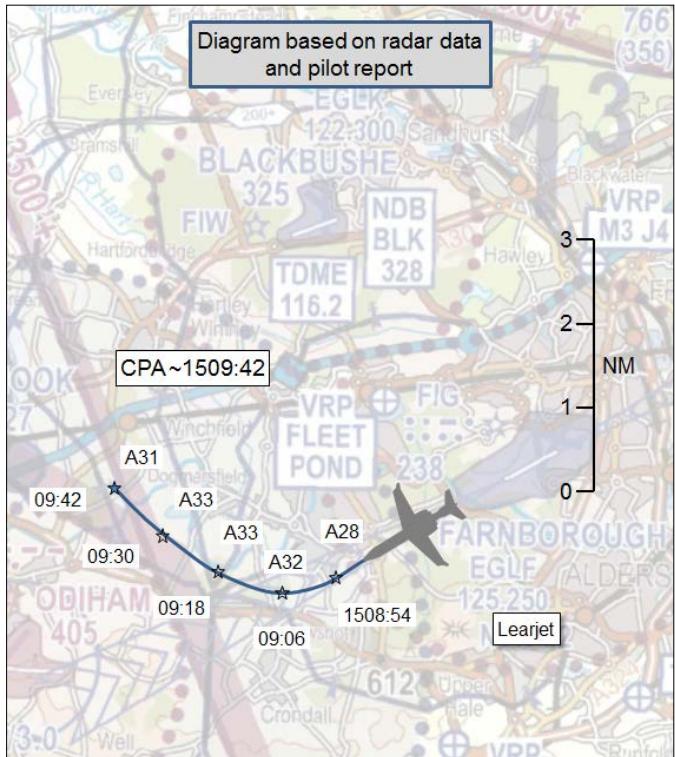
THE LEARJET PILOT reports departing from Farnborough, under a Basic Service from London Control, he thought. Initial Farnborough clearance was to climb to 2400ft, fly runway heading [RW24] to 2nm and then turn right on to 285°. On handover to Farnborough Radar he was cleared to route direct to the CPT VOR [310°/21nm from Farnborough] and climb to 3400ft. After he had completed the right turn, and as the aircraft rolled wings level, he saw 3 paragliders at a range of 2-400m in the 12 o'clock at the same level. He disconnected the autopilot, descended, turned away from the paragliders and informed London and Farnborough of the incident.

He assessed the risk of collision as 'High'.

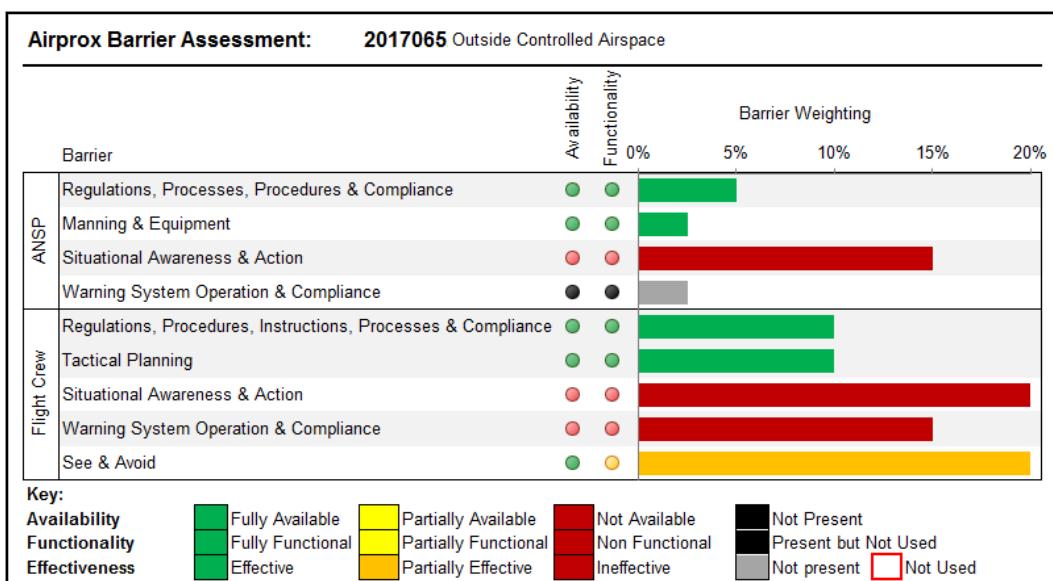
Safety Barrier Assessment⁴

Situational Awareness and Action were assessed as **ineffective** because the paragliders did not appear on the radar displays.

Situational Awareness and Action were assessed as **ineffective** because the Learjet pilot was not previously aware of the paragliders' presence.

Warning System Operation and Compliance were assessed as **ineffective** because the paraglider pilots most likely did not carry a TAS or a means of alerting the Learjet TCAS.

See and Avoid were assessed as **partially effective** because the Learjet pilot did not see the paragliders until at a late stage.
