**AIRPROX REPORT No 2017078**

Date: 27 Apr 2017 Time: 0908Z Position: 5043N 00250W Location: Lyme Bay North

**PART A: SUMMARY OF INFORMATION REPORTED TO UKAB**

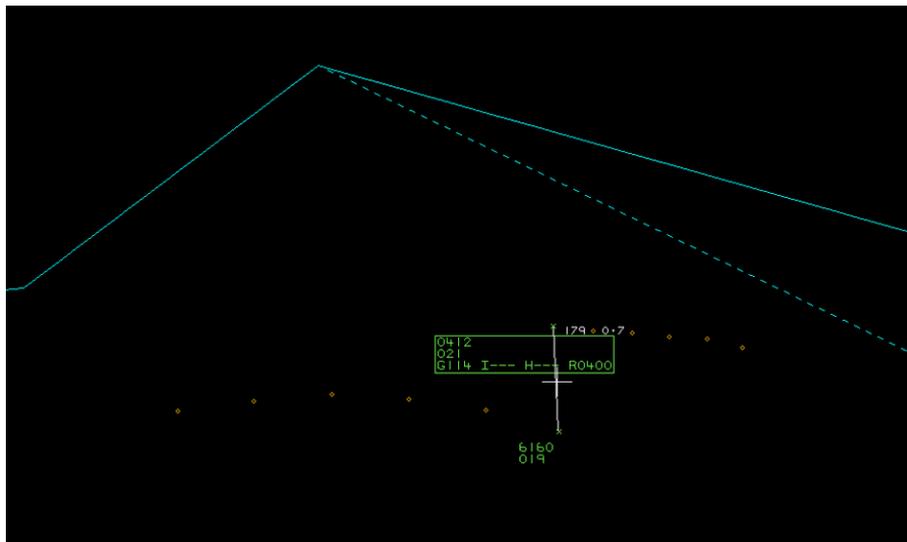
Figure 1 below shows the DA40 within the EG D012 range complex heading west as the FA20 turns away, presumably in response to the TCAS RA, and the aircraft pass each other with a CPA of 200ft V and 0.7nm H.

Figure 1 – CPA of 200ft V, 0.7nm H

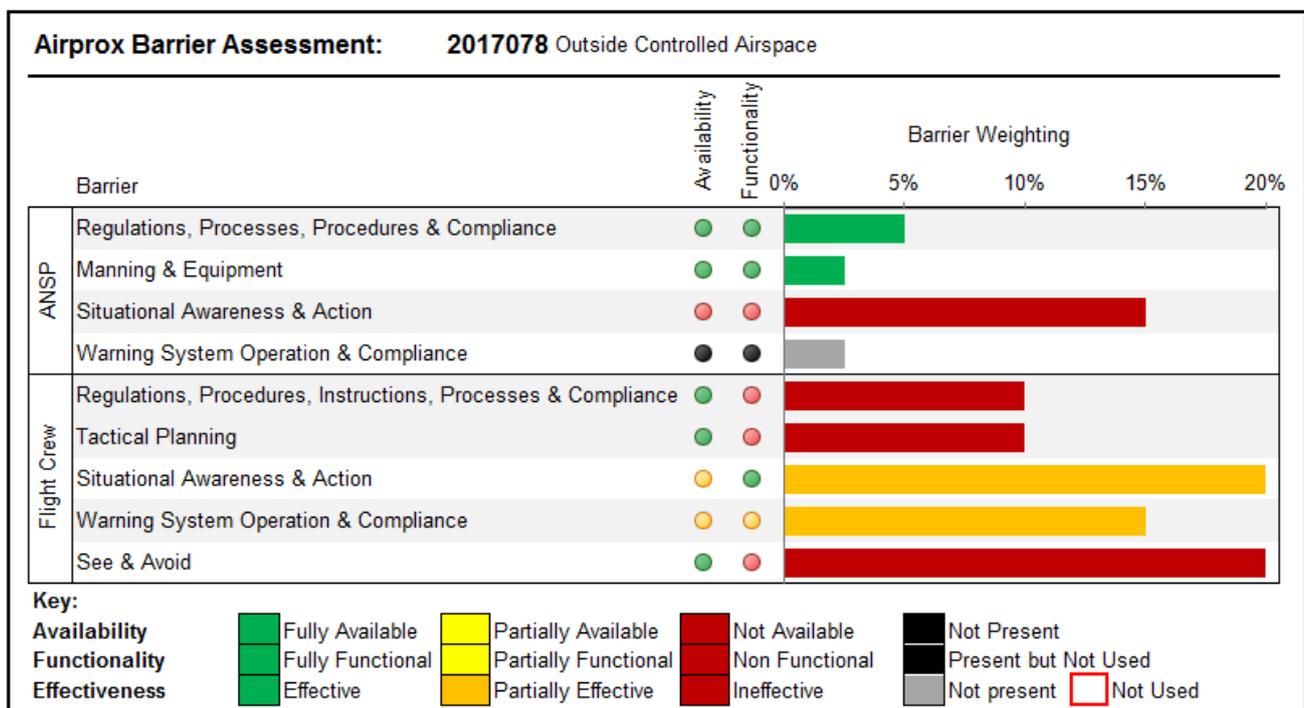
**Situational Awareness and Action** were assessed as **ineffective** because the Plymouth LARS controller did not have a secondary or primary radar track for the DA40.

**Regulations, Processes, Procedures, Compliance and Instructions** were assessed as **ineffective** because the DA40 pilot entered EG D012 without clearance.

**Tactical Planning** was assessed as **ineffective** because the DA40 pilot did not follow his planned route.

**Situational Awareness and Action** were assessed as **partially effective** because the FA20 pilot received Situational Awareness only from his TCAS at a late stage.

**Warning System Operation and Compliance** were assessed as **partially effective** because the DA40 squawk was evident until shortly before CPA when the FA20 TCAS issued an RA without a preceding TA warning (which would otherwise have been expected given the closing geometry).

**See and Avoid** was assessed as **ineffective** because neither pilot saw the other aircraft.
