AIRPROX REPORT No 2017087

Date: 10 May 2017 Time: 1359Z Position: 5421N 00133W Location: Catterick

PART A: SUMMARY OF INFORMATION REPORTED TO UKAB

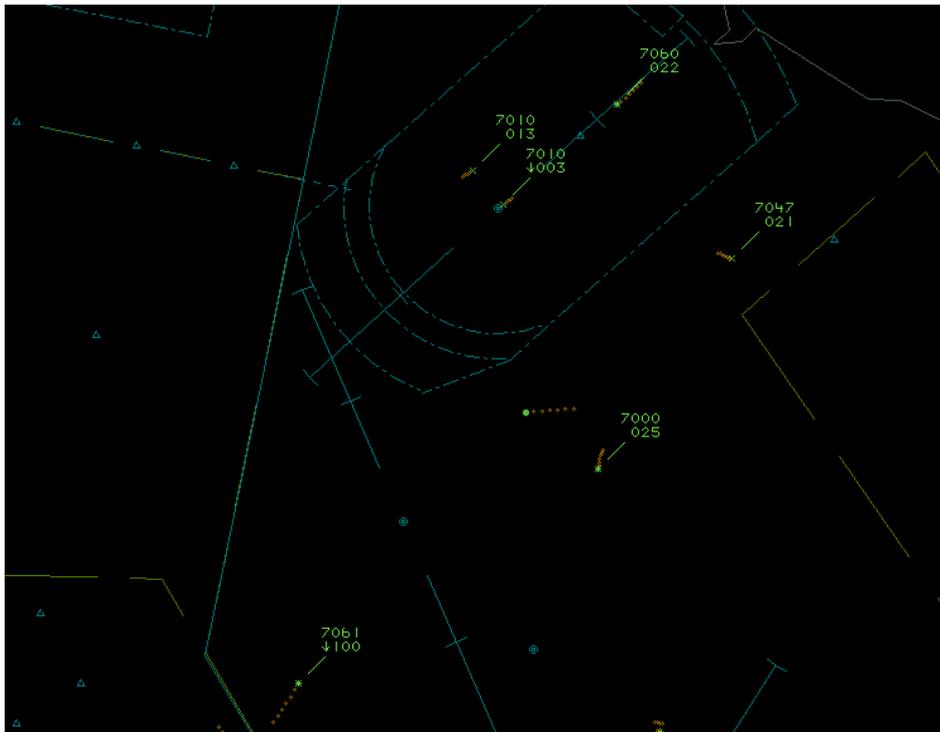
Figure 1 – 1356:50

The Airprox was reported by the FA20 pilot when it came into proximity with some paragliders approximately 10nm southwest of Durham Tees Valley airport. The FA20 was in receipt of a Traffic Service from Durham Radar. The paragliders were not known to be in receipt of any ATC service. The FA20 had been previously working Swanwick(Mil), until at 1356:50 (Figure 1), when the FA20 (code 7061) called Durham Radar and a Traffic Service was agreed. After asking what type of Approach the pilot would like, the controller issued a clearance to join VFR for a left hand circuit for RW23.

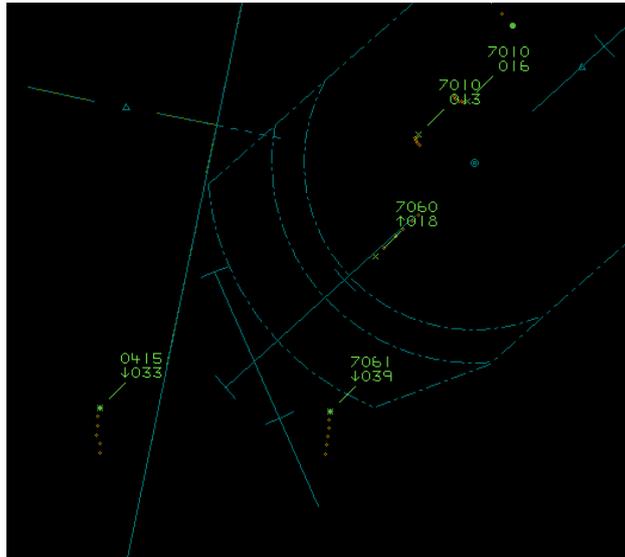
Figure 2- 1359:48

At 1359:48 (Figure 2) the FA20 had passed 4000ft. There was no evidence on the NATS radar recording of the paragliders and no report was made at the time by the crew of the FA20 about the Airprox.

ATSI also had access to the local radar recording from Durham Radar. On this radar there was evidence of some form of contact still ahead of the FA20 after it had passed 4000ft but the contacts were intermittent. There was further extensive evidence of such radar ‘clutter’ around the display, and the contacts observed close to the track of the FA20 had no discernible ‘history’ and remained an intermittent contact, suggesting they were interference known as anomalous propagation. But it was not possible to produce a copy of that screenshot for this report. The Durham controller had previously passed Traffic Information to the FA20 pilot about unknown aircraft operating outside controlled airspace. Under a Traffic Service the pilot was responsible for his own separation.

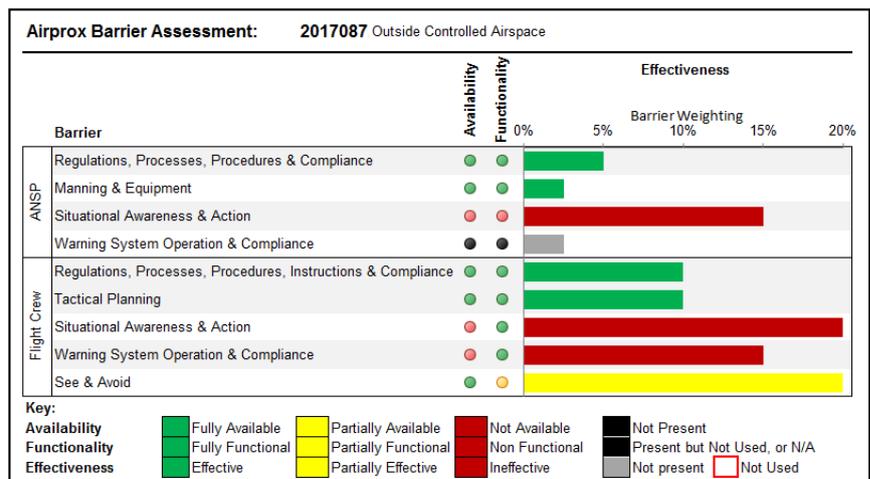
Safety Barrier Assessment³

In assessing the effectiveness of the safety barriers associated with this incident, the Board concluded that the key factors had been that:

Situational Awareness & Action was assessed as ineffective because the paragliders did not show on the radar, therefore the controller was not aware of them.

Situational Awareness & Action was assessed as ineffective because neither the FA20 pilot, nor the paraglider pilots had any information to tell them about the other.

Warning System Operation and Compliance was assessed as ineffective; although the FA20 had TCAS it would not have been able to warn him about the paragliders.

See and Avoid was assessed as partially effective; the FA20 pilot was not able to take avoiding action, although he could see that his vector would take him safely clear.
