**AIRPROX REPORT No 2017091**

Date: 14 May 2017 Time: 1140Z Position: 5315N 00051W Location: Darlton Glider Site

**PART A: SUMMARY OF INFORMATION REPORTED TO UKAB**

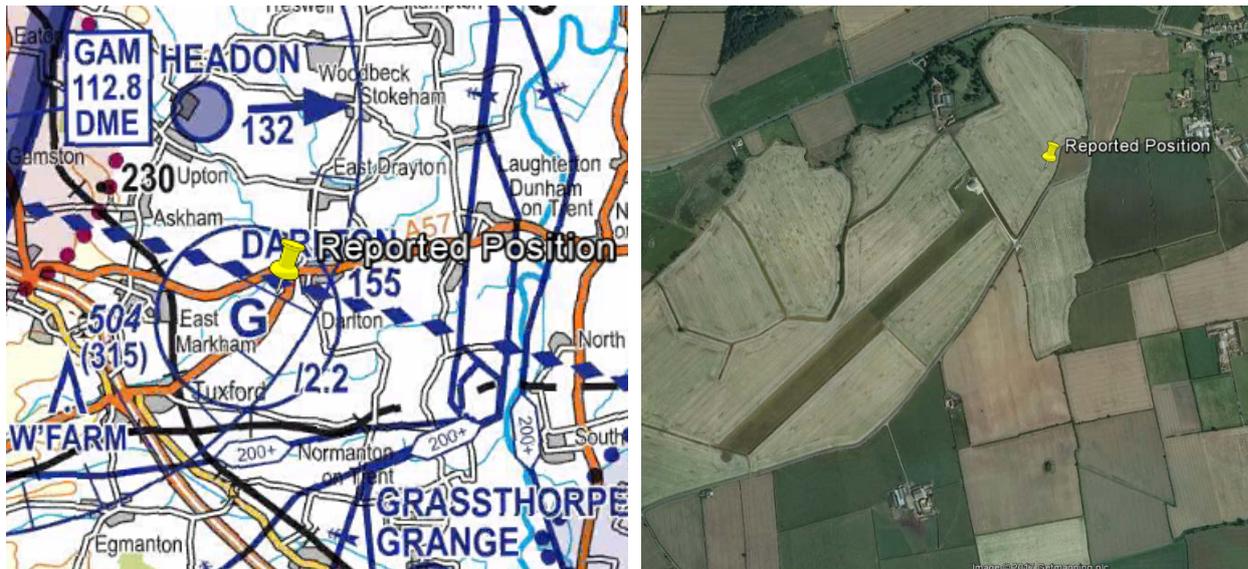
Figures 1 and 2: Reported Airprox Position

Figures 1 and 2 show the reported position of the Airprox, almost overhead the Darlton glider site.
