**AIRPROX REPORT No 2017099**

Date: 25 May 2017 Time: 1221Z Position: 5203N 00053W Location: 3nm W Milton Keynes

**PART A: SUMMARY OF INFORMATION REPORTED TO UKAB**

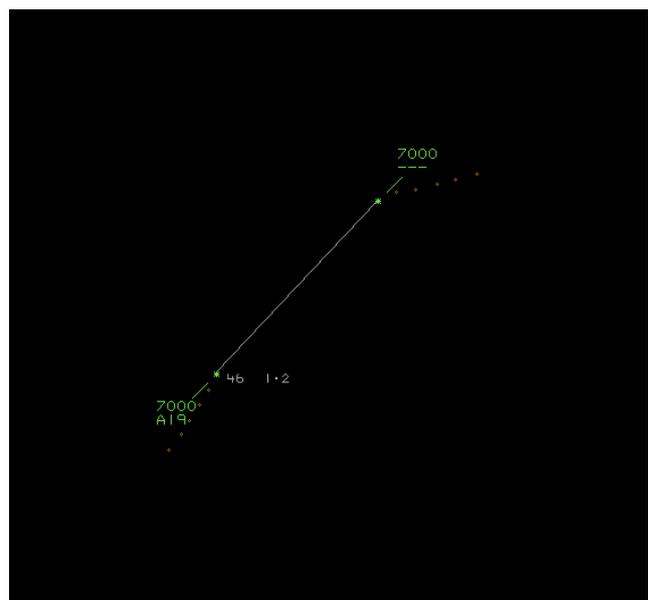
Figure 2 – 1220:20

The Oxford Radar Controller instructed the pilot to select transponder code 4520, (Oxford Radar Conspicuity), and agreed, at 1220:20, to provide a Basic Service (Figure 2).

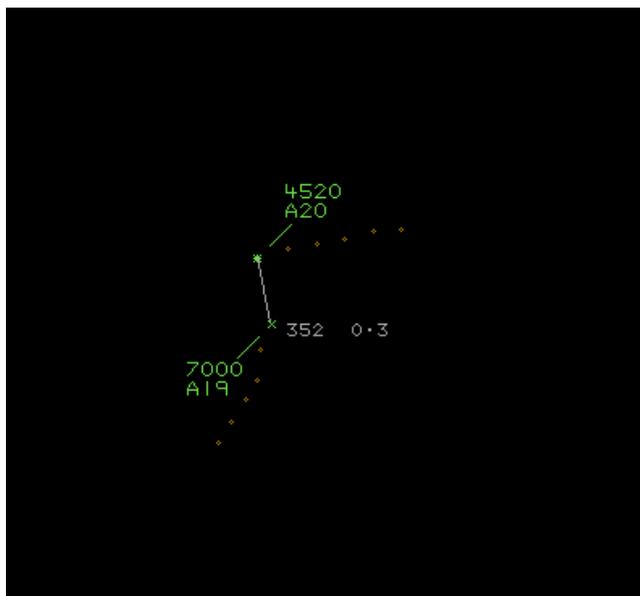
Figure 3 – 1220:40

At 1220:40, the Sportcruiser transponder code was observed to change to 4520 (Figure 3).

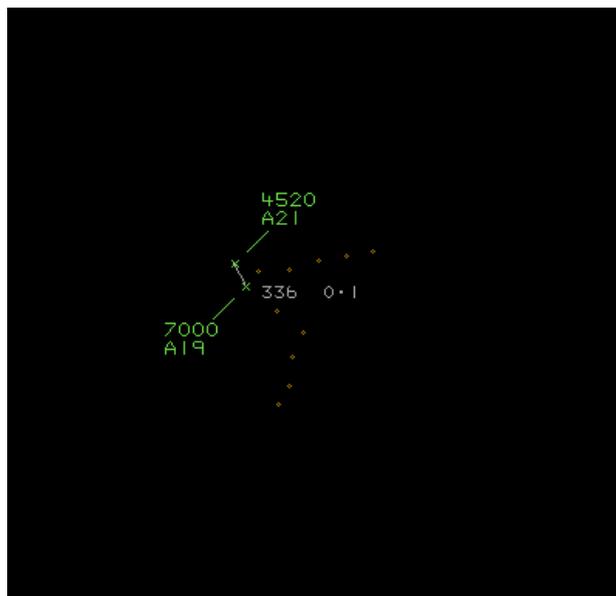
Figure 4 – 1220:51

CPA took place at 1220:51, just after the PA28 was observed to have made a left turn taking it towards the Sportcruiser, having previously been maintaining a track which would have taken it behind the Sportcruiser. The aircraft were separated by less than 0.1nm laterally and 200ft vertically (Figure 4).
