AIRPROX REPORT No 2017127

Date: 25 Jun 2017 Time: 1637Z Position: 5200N 00209W Location: Tewkesbury

PART A: SUMMARY OF INFORMATION REPORTED TO UKAB

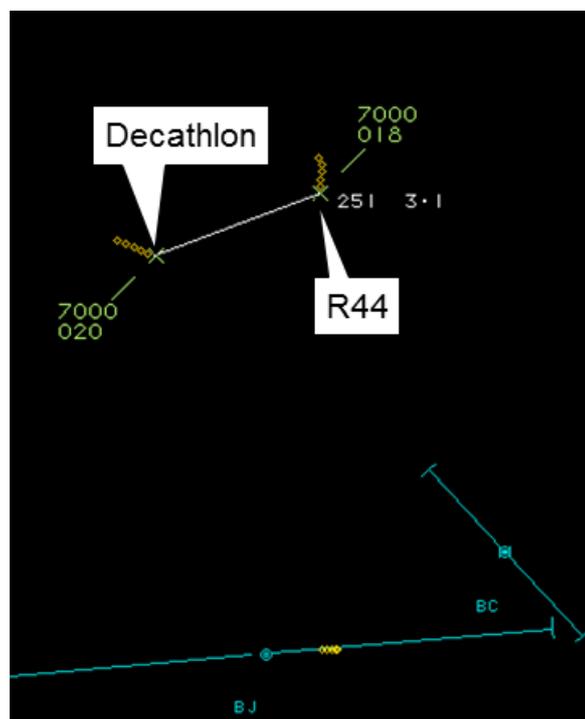
Figure 1 – 1636:00

The R44 pilot was returning to Gloucestershire but had not yet called the Gloucestershire controller advising this. The Gloucestershire controller was providing a combined Aerodrome and Approach Control Service, without reference to surveillance-derived information. Figure 1 shows the situation at 1636:00, with the Decathlon 7nm north of Gloucestershire Airport.

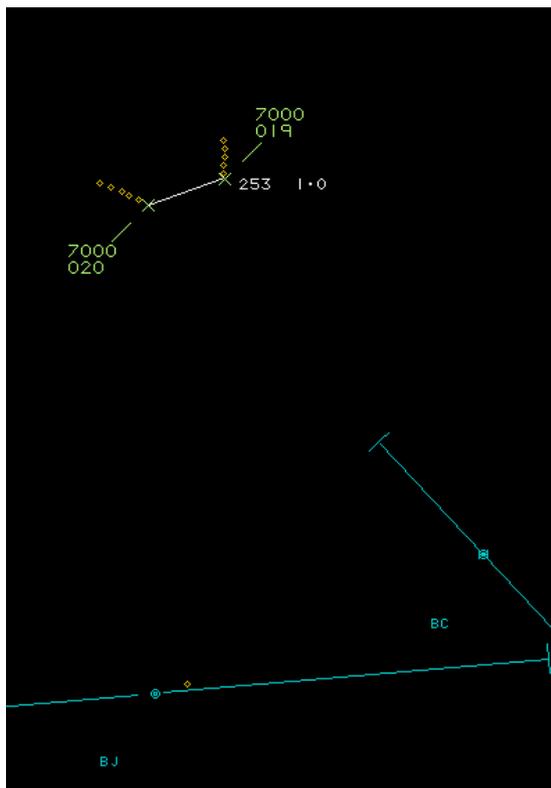
Figure 2 – 1637:00

Neither pilot spoke to the Gloucestershire controller until after CPA. Figures 2 & 3 show the situation as it continued to develop.

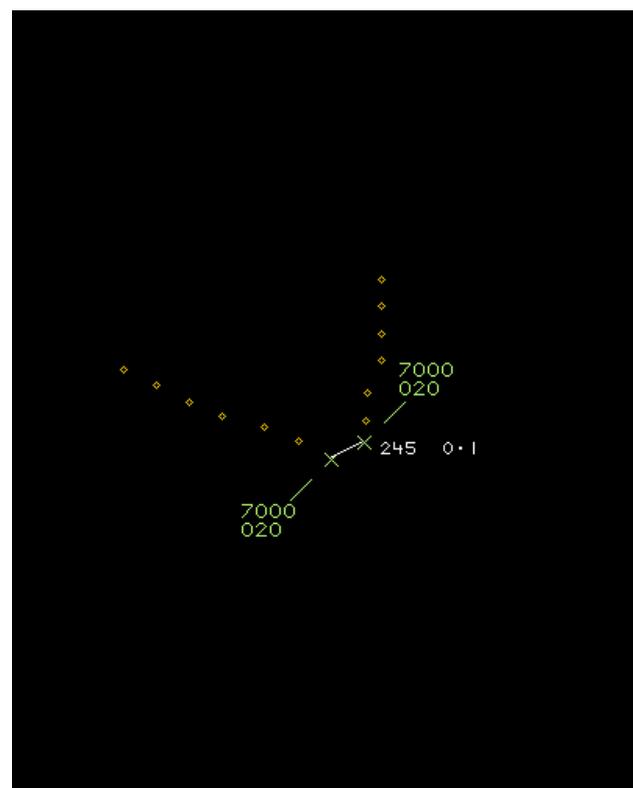
Figure 3 – 1637:22

CPA took place at 1637:26, 6nm north-northeast of Gloucestershire Airport, with the aircraft separated by 100ft vertically and less than 0.1nm laterally.

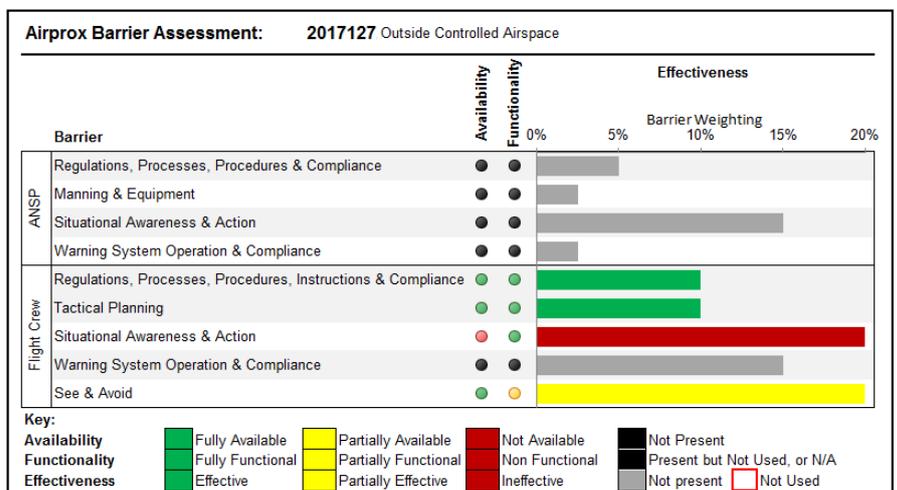
Situational Awareness and Action were assessed as **ineffective** because no information was available to the pilots from on-board or off-board sensors, and no action was taken until very shortly before CPA.

See and Avoid were assessed as **partially effective** because the Decathlon pilot only saw the R44 at about CPA, effectively a non-sighting, and the R44 pilot saw the Decathlon at a very late stage.
