**AIRPROX REPORT No 2017134**

Date: 22 Jun 2017 Time: 1115Z Position: 5058N 00256W Location: Merryfield airfield

**PART A: SUMMARY OF INFORMATION REPORTED TO UKAB**

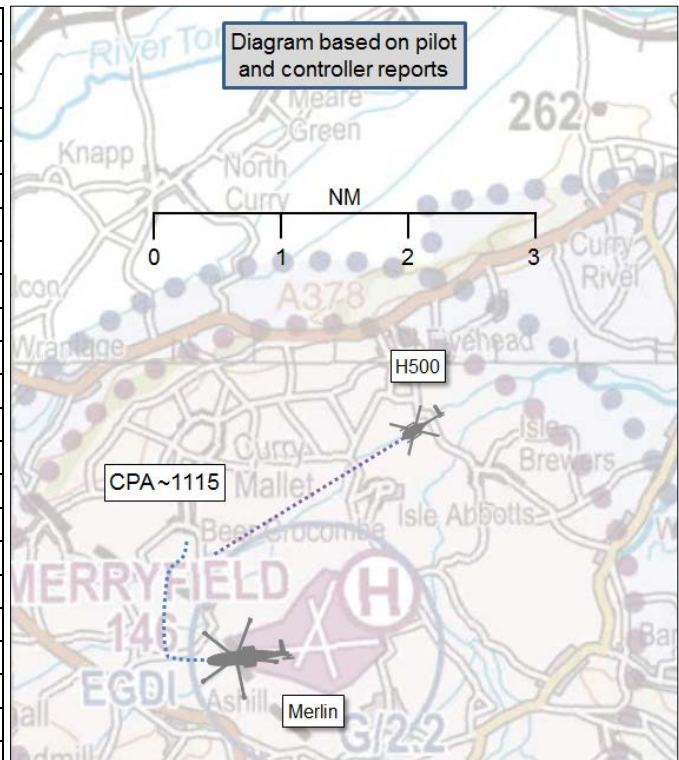
**THE MERLIN PILOT** reports that the crew were conducting an academic circuit to Merryfield RW27R. Having levelled off crosswind, the Handling Pilot (HP) started to turn right downwind when the TAS alerted the crew to another aircraft in the 2 o'clock position at the same level. The crew immediately saw the other aircraft converging on a constant bearing at a range of approximately 100m. The HP reversed the turn to increase separation. ATC were contacted immediately and they confirmed the aircraft was not on their frequency despite being in the ATZ. The sortie was subsequently completed without further incident.

**THE HUGHES 500 PILOT** reports that he did not consider this to be an Airprox. However, for the sake of the form, they were tracking home and were just west of the Currey Rivel ridge-line when they observed a Merlin at 1nm in the climb crossing them from southeast to northwest. As they were above and behind it no action was deemed necessary.

the cause of the Airprox was that the Hughes 500 pilot flew through the Merryfield ATZ and into conflict with the Merlin.

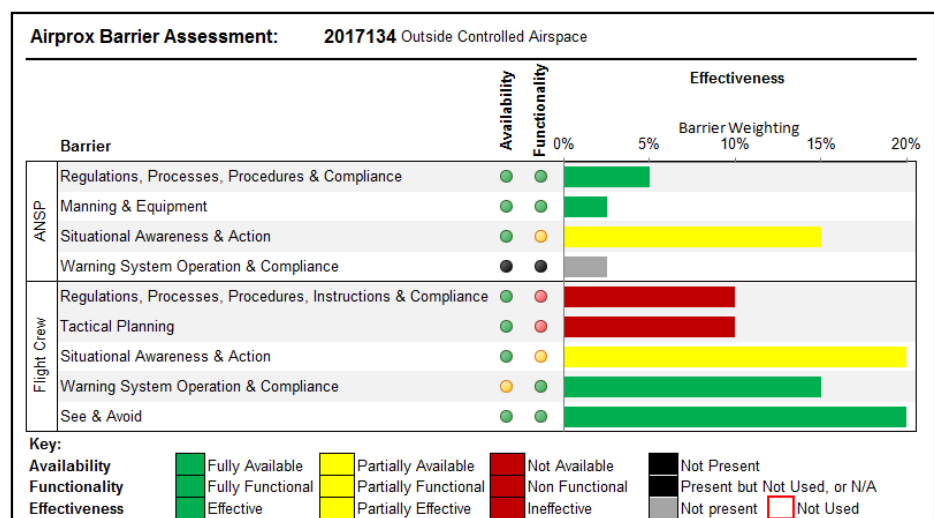
**Situational Awareness and Action** were assessed as **partially effective** because the controllers were not aware of the potential conflict between the two aircraft until the Merryfield Aerodrome controller observed the H500. The H500 did not show initially on the Yeovilton Radar display.

**Regulations, Processes, Instructions, Procedures and Compliance** were assessed as **ineffective** because the H500 pilot did not seek, or obtain, permission to enter the Merryfield ATZ.

**Tactical Planning** was assessed as **ineffective** because the H500 pilot did not plan to route clear of Merryfield airfield.

**Situational Awareness and Action** were assessed as **partially effective** because ATC were unable to issue early Traffic Information to the Merlin pilot.
