**AIRPROX REPORT No 2017135**

Date: 29 Jun 2017 Time: 0030Z Position: 5006N 00351W Location: 11nm SW Start Point

**PART A: SUMMARY OF INFORMATION REPORTED TO UKAB**

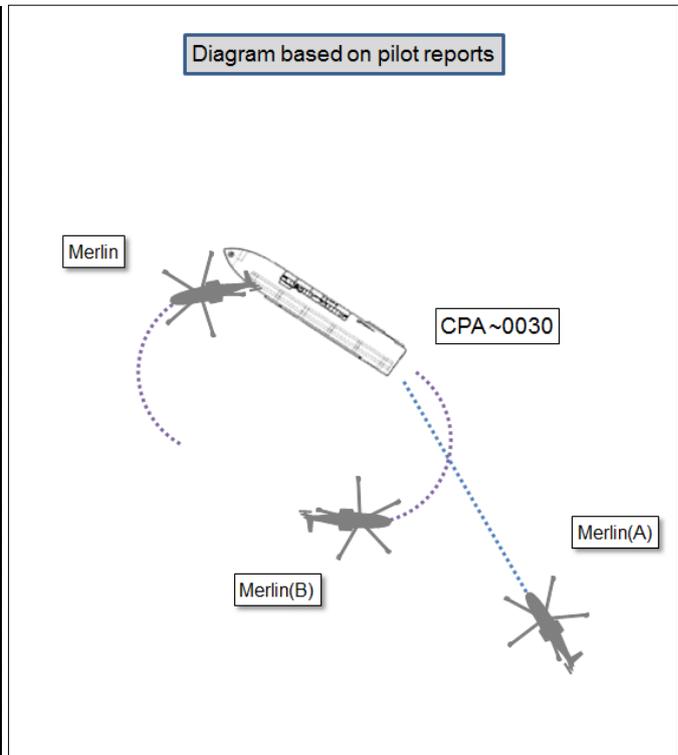
**THE MERLIN(A) PILOT** reports conducting conventional night deck landings to HMS Ocean. The aircraft was positioned for a Ship Controlled Approach (SCA) while under a NATO Advisory service. Much of the marshalling was conducted with the aircraft IMC but, during the descent to 200ft, VMC was regained. At 1.5nm the descent was begun as usual, although both pilots felt the closure angle was more obtuse than R165<sup>1</sup>. At approximately 250ft, the PF (in the right seat) commented that he thought he could see another aircraft in the right 2.30 position. The PM (left seat) flicked his NVGs down and saw Merlin(B) at approximately 200m range. This was brought to the attention of the controller who called an immediate avoiding turn to the right. The crew elected not to take this due to the close proximity of the other aircraft on the right, believing that this would have decreased the safe separation between the two aircraft. The controller then called an avoiding turn to the left, by which time another Merlin aircraft in the visual circuit had come sufficiently close to the left side of the aircraft to cause the crew not to take that action either. Although the controller then called for a climb to 2000ft, the crew had identified both Merlin aircraft in the circuit, and elected to maintain safe separation visually rather than climb back into cloud. The crew were aware of both Merlins in the visual circuit but had expected the controller to have ensured the circuit was clear for their approach. The pilot noted that the workload was sufficient to keep crew stimulated, but not over-worked, and that light levels were poor, with about 0.5mLux predicted and GRN<sup>2</sup> met conditions.

intercepted the glide path indicators, the navigation lights were changed from steady bright to flashing bright and the upper anti col light turned from red to off in accordance with normal ship procedures. Shortly after this, the TAS audio sounded and, 3secs later, Merlin(A) passed down the left side, about 10 rotor spans away and proceeded between their aircraft and [another Merlin] at the end of the downwind leg. The Merlin(B) crew commented that it was strange that an aircraft would overshoot from an SCA through the circuit. They were given no explanation from FLYCO as to what had just occurred and continued with their Conventional Deck Landing training. Having read the DASOR and spoken to the Merlin(A) aircraft commander, the Merlin(B) pilot noted that had the instructions given by the controller been followed then a collision with either his aircraft or the other Merlin in the circuit would have been highly likely. He stated that they were thankful the experienced crew in Merlin(A) looked before following the instructions given.

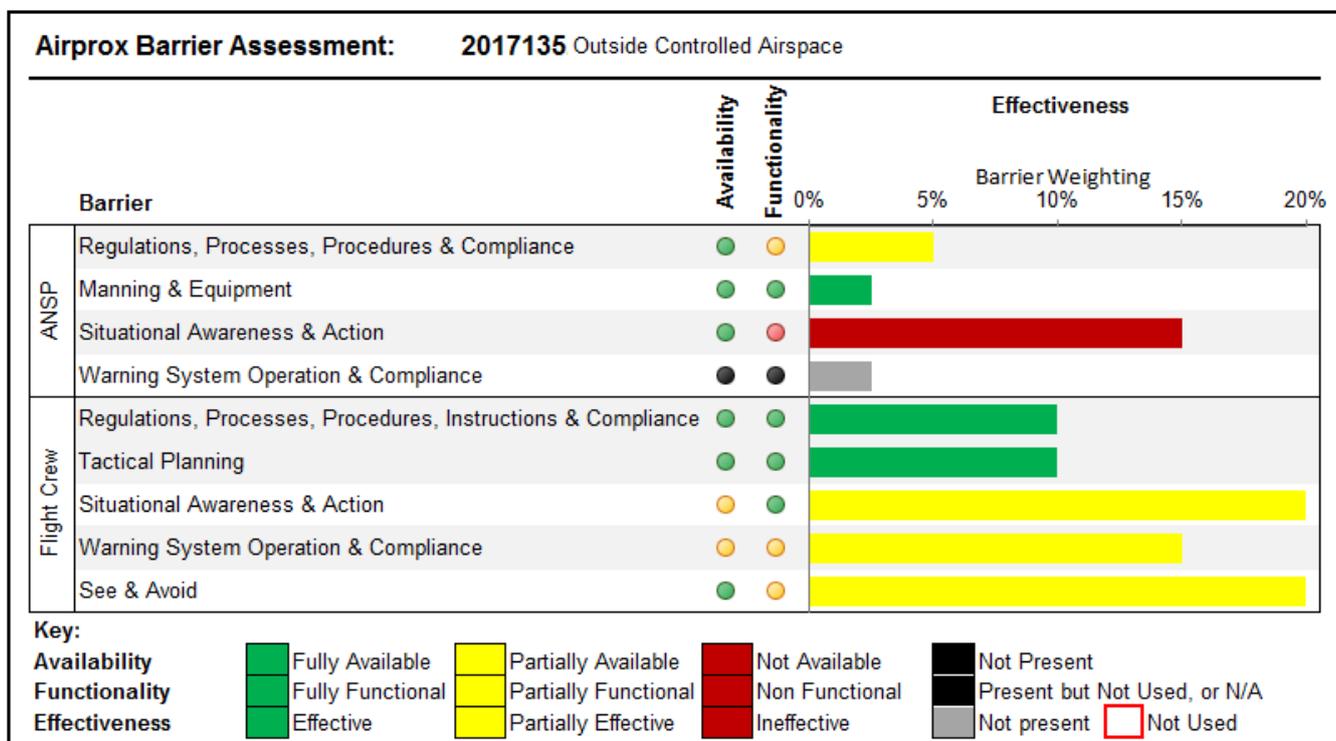
Safety Barrier Assessment<sup>5</sup>

**Regulations, Processes, Procedures and Compliance** were assessed as **partially effective** because the missed 2nm call compromised the controllers' SA.

**Situational Awareness and Action** were assessed as **ineffective** because the controller first directed the Merlin(A) pilot to overshoot towards Merlin(B), and then towards the other Merlin in the visual circuit.

**Situational Awareness and Action** were assessed as **partially effective** because neither Merlin crews were aware of the proximity of the other until at a late stage; the Merlin(A) crew did not have specific SA on the location of Merlin(B), and the Merlin(B) crew only knew that Merlin(A) was somewhere on the approach until his TAS alerted only 3 seconds before the Merlin(A) passed.

**Warning System Operation and Compliance** were assessed as **partially effective** because only one Merlin was equipped with TAS (Merlin(B)), which did alert but at a point when effective avoiding action may have been compromised.

**See and Avoid** were assessed as **partially effective** because the Merlin crews saw each other at a late stage, and only the Merlin(A) pilot was able to conduct effective avoiding action.
