**AIRPROX REPORT No 2017142**

Date: 05 Jul 2017 Time: 1233Z Position: 5305N 00402W Location: Llanberis Pass

**PART A: SUMMARY OF INFORMATION REPORTED TO UKAB**

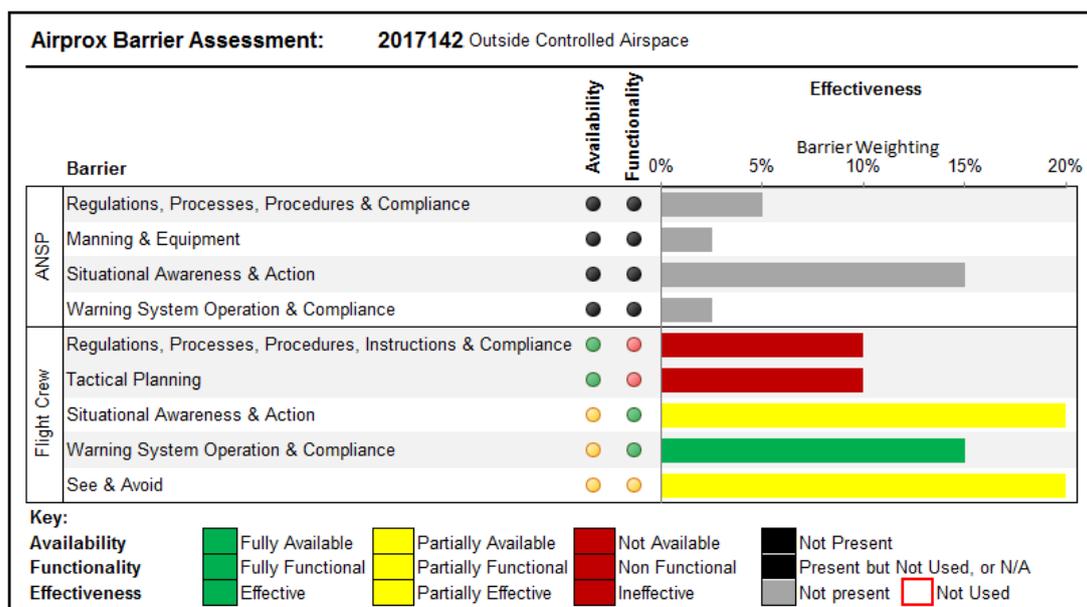
**Regulations, Processes, Procedures, Instructions and Compliance** were assessed as **ineffective** because the UK Low Flying System regulation for the Snowdonia MFTA was ambiguous.

**Tactical Planning** was assessed as **ineffective** because in the execution of his plan, the F15 pilot mistook the Llanberis Pass for the Nant Ffrancon Pass, which he had planned to fly along.

**Situational Awareness and Action** were assessed as **partially effective** because the F15 pilot did not have specific SA about the Griffin helicopter prior to entering the Llanberis Pass.

**Warning System Operation and Compliance** were assessed as **effective** although only the Griffin was equipped with a TAS.

**See and Avoid** were assessed as **partially effective** because neither crew had the opportunity to see the other until at a late stage, due to the geometry of the F15 unmasking from terrain, such that the sightings were later than desirable.
