AIRPROX REPORT No 2017162

Date: 13 Jul 2017 Time: 1322Z Position: 5138N 00113W Location: 10nm S Oxford airport

PART A: SUMMARY OF INFORMATION REPORTED TO UKAB

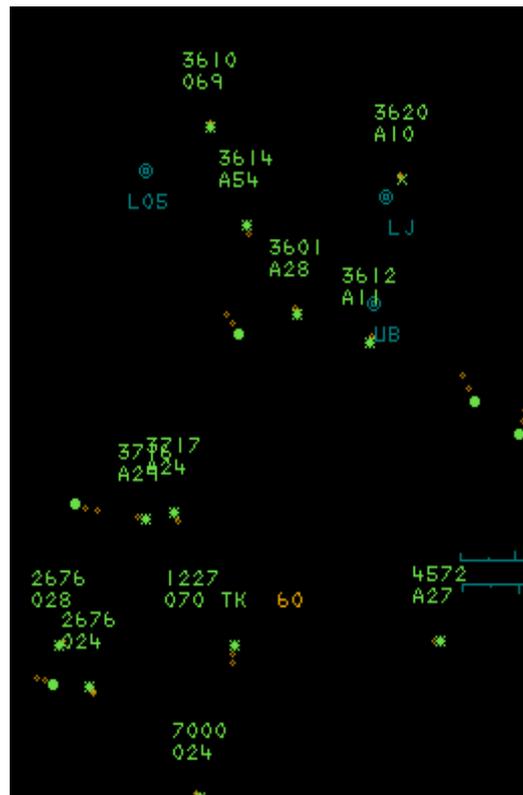
Figure 1 – 1319:10 (Puma 3610; C510 1227).

At 1319:10, the C510 pilot checked in with Oxford Radar (transponder code 1227) and advised the controller that they were descending to altitude 6000ft on QNH 1021hPa. The controller advised that he would provide vectors for the ILS RW19, and issued an instruction to leave Compton heading north (Figure 1).

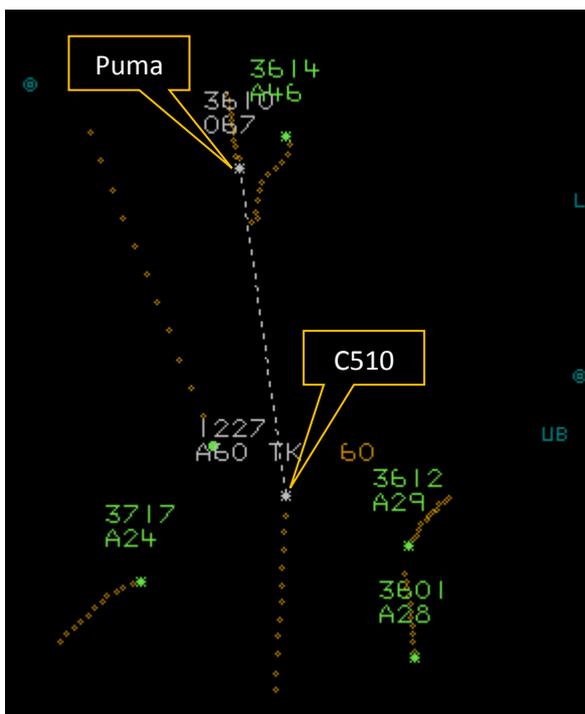
Figure 2 – 1321:30.

The telephone call concluded at 1321:30 at which point the controllers believed coordination agreement had been reached, that the Puma would maintain not below FL70 until 3nm separation was achieved between the two aircraft. However, the Puma was now displayed as being at FL67 (Figure 2).

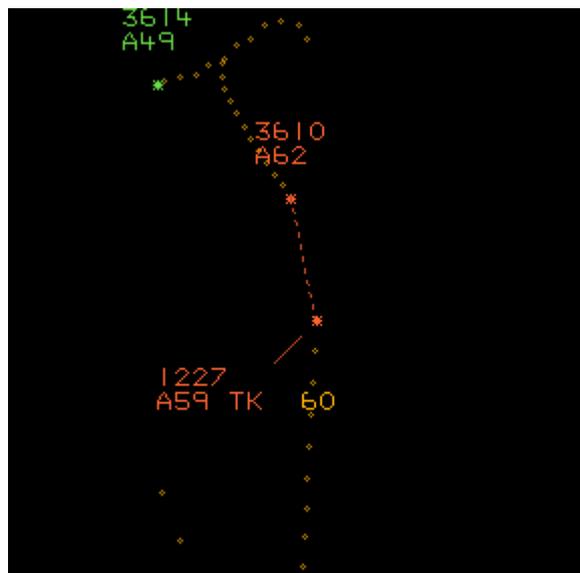
Figure 3 – 1322:10.

At 1322:10 the Oxford controller advised the C510 pilot that they were trying to coordinate and passed Traffic Information on the Puma as 12 o'clock, at a range of 2nm, at 6200ft, together with an instruction to turn right immediately heading 100°. The Benson controller was then heard passing Traffic Information to the Puma pilot on the C510 as fast moving traffic 12 o'clock and advised a right turn to avoid (Figure 3).

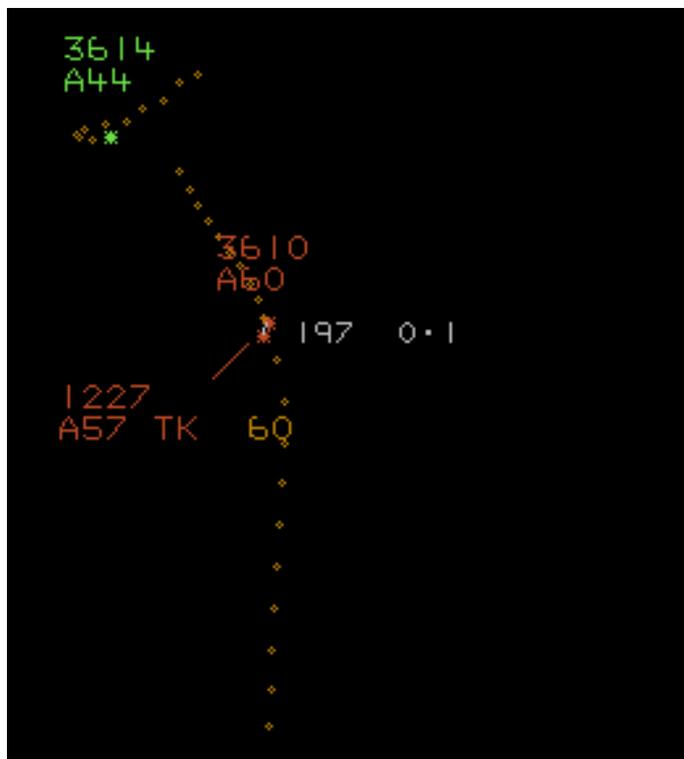
Figure 4 – 1322:23.

At 1322:23 CPA took place; the C510 pilot reported visual with the Puma and advised the Oxford controller that they had turned left and were now descending (Figure 4).

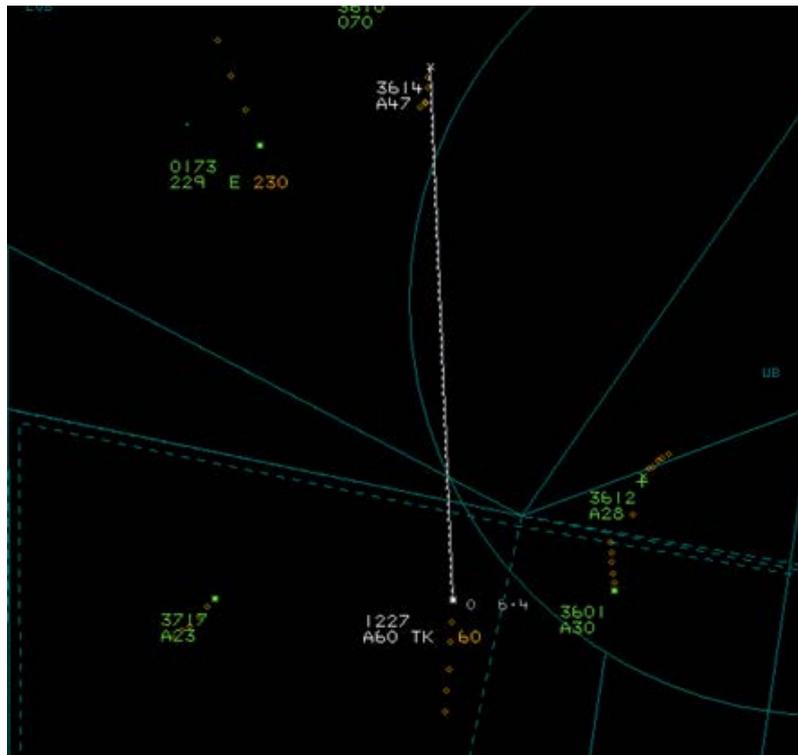
Figure 5: Geometry at 1321:04 (Puma 3610; C510 1227).

At 1321:04 (Figure 5), the Benson Approach Controller made a request to the Puma pilot to maintain not below FL70 for coordination with Oxford. The Puma pilot responded that the air-test was complete and the aircraft was ready for recovery but did not agree with the controller's request.

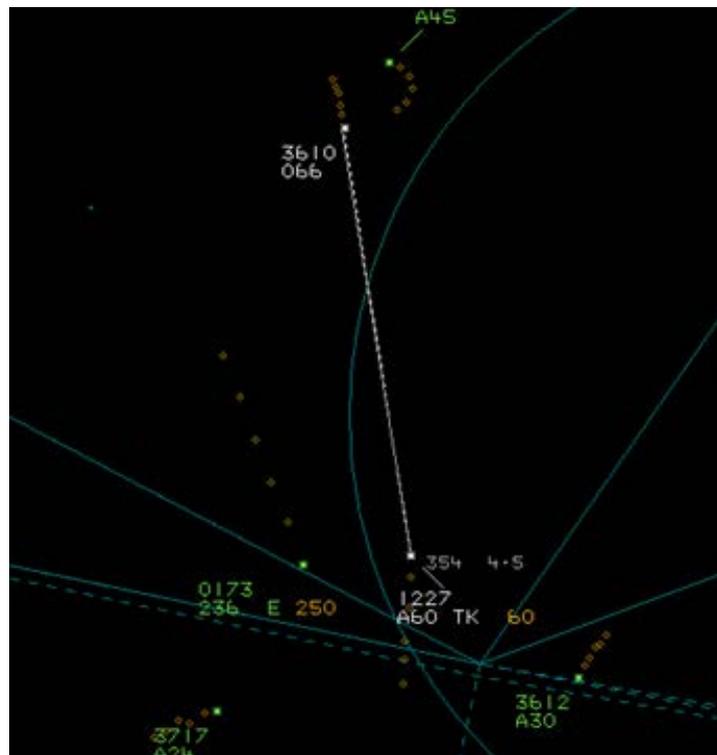
Figure 6: Geometry at 1321:37 (Puma 3610; C510 1227).

At 1321:37 (Figure 6), the Benson Approach Controller began passing a message to a Tutor pilot also on frequency in order to effect coordination.

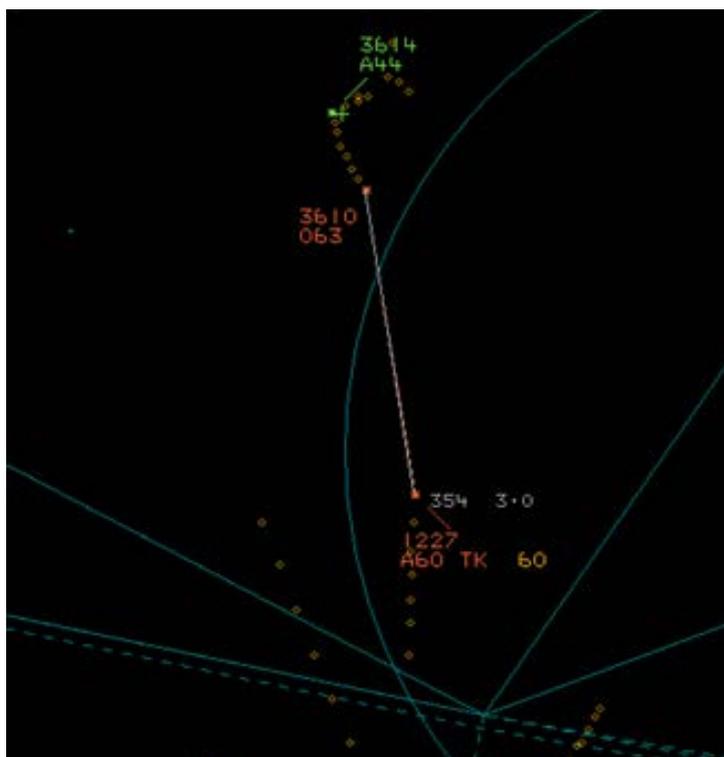
Figure 7: Geometry at 1321:50 (Puma 3610; C510 1227).

At 1321:50 (Figure 7), the Benson Approach Controller informed the Puma pilot that the fast-moving traffic would shortly be passing and that he would give a descent instruction once the traffic was clear. The controller was referring to the C510, which was the aircraft he was trying to achieve coordination against; however, the Puma pilot had already commenced a descent

inbound to Benson without notifying the controller². The Puma pilot responded that the aircraft was at 6500ft and not able to climb to FL70 due to controlled airspace restrictions above.

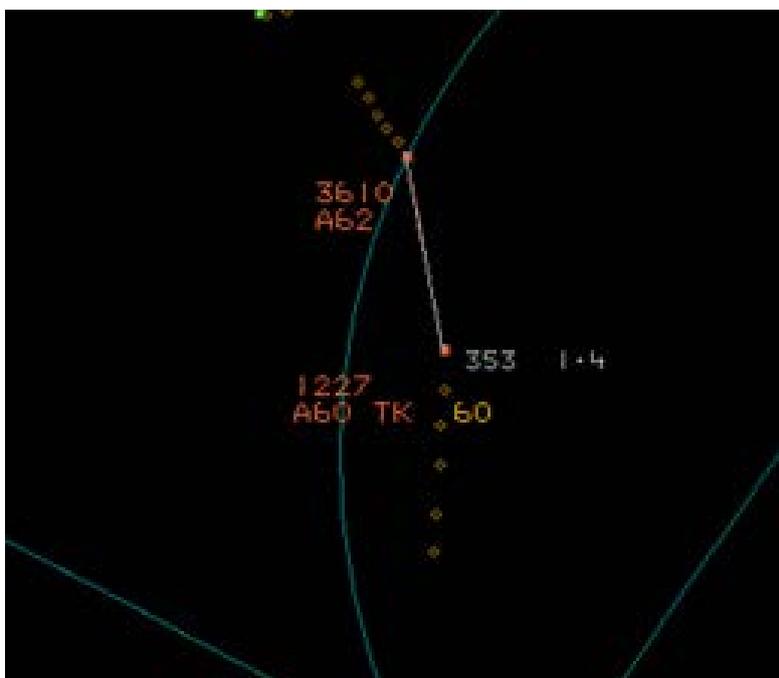
Figure 8: Geometry at 1322:10 (Puma 3610; C510 1227).

At 1322:10 (Figure 8), the Benson Approach Controller suggested a right turn onto heading 270° in order for the Puma to avoid the C510 (believed to still be attempting to comply with the coordination). Traffic Information was passed to the Puma pilot as “south of you, range of one mile and 300ft below.

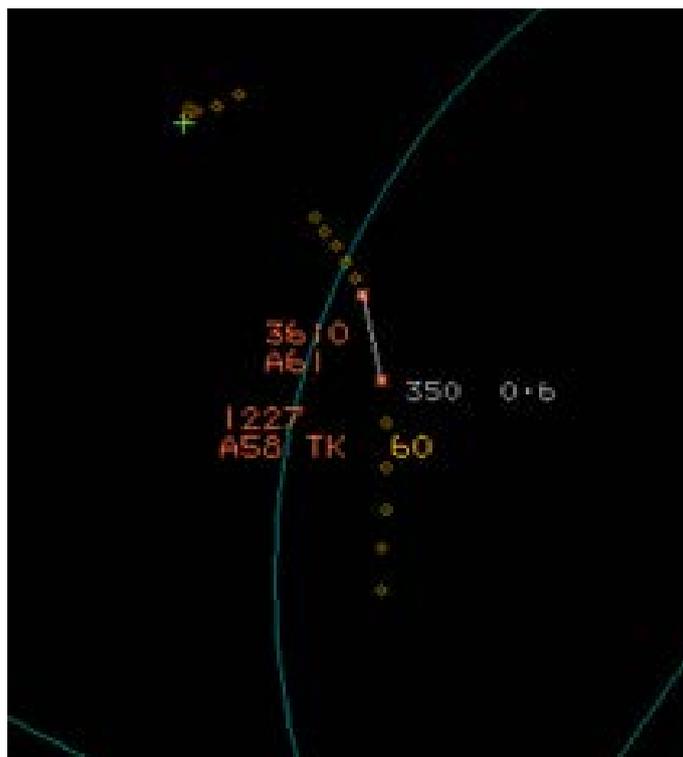
Figure 9: Geometry at 1322:18 (Puma 3610; C510 1227).

At 1322:18 (Figure 9), the Puma pilot reported visual with the C510 traffic.

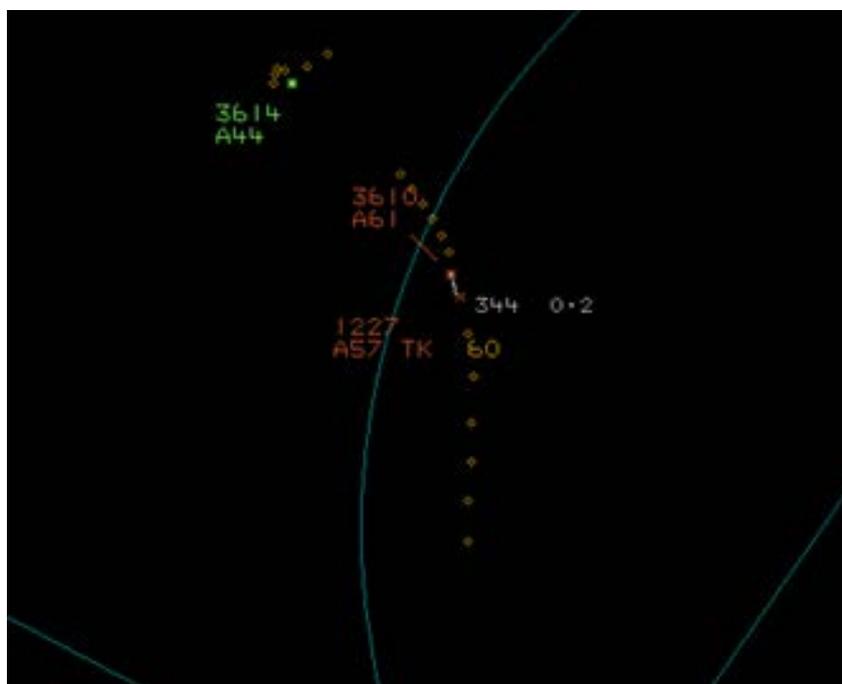
Figure 10: Geometry at 1322:19 (Puma 3610; C510 1227).

At 1322:19 (Figure 10), the Puma and C510 passed at a recorded CPA of 0.2nm and 400ft.
