AIRPROX REPORT No 2017208

Date: 25 Aug 2017 Time: 1500Z Position: 5135N 00052W Location: 3nm SW Booker

PART A: SUMMARY OF INFORMATION REPORTED TO UKAB

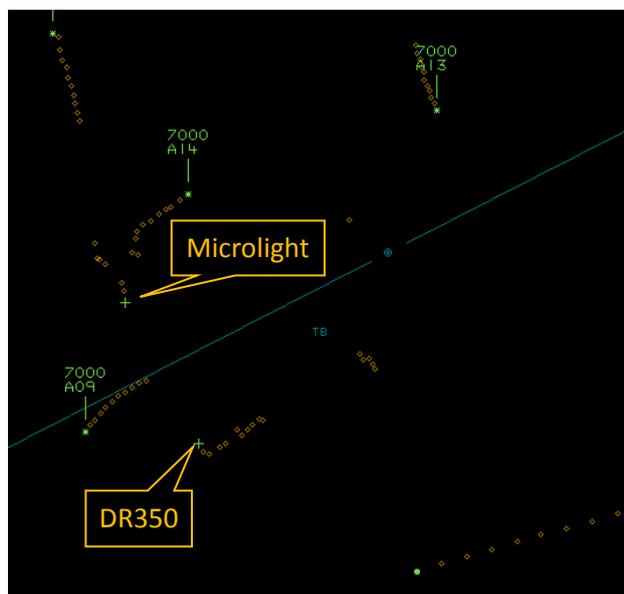
Figure 1 – 1459:21

The contact believed to be the DR350 was first observed intermittently on radar at 1458:40. At 1459:21, and consistent with the pilot’s report, the aircraft was observed to turn to the northwest. The other aircraft had been observed maintaining a south-southeasterly track for a sustained period of time prior to this (Figure 1). Figure 2 shows the situation at 1459:46.

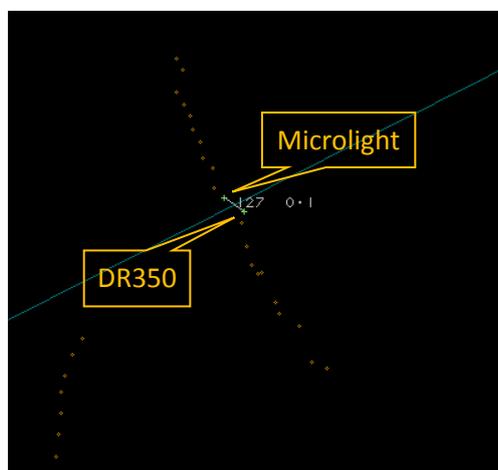
Figure 3 – CPA 1500:03

CPA took place at 1500:03 (Figure 3). Only the lateral distance could be measured (<0.1nm).

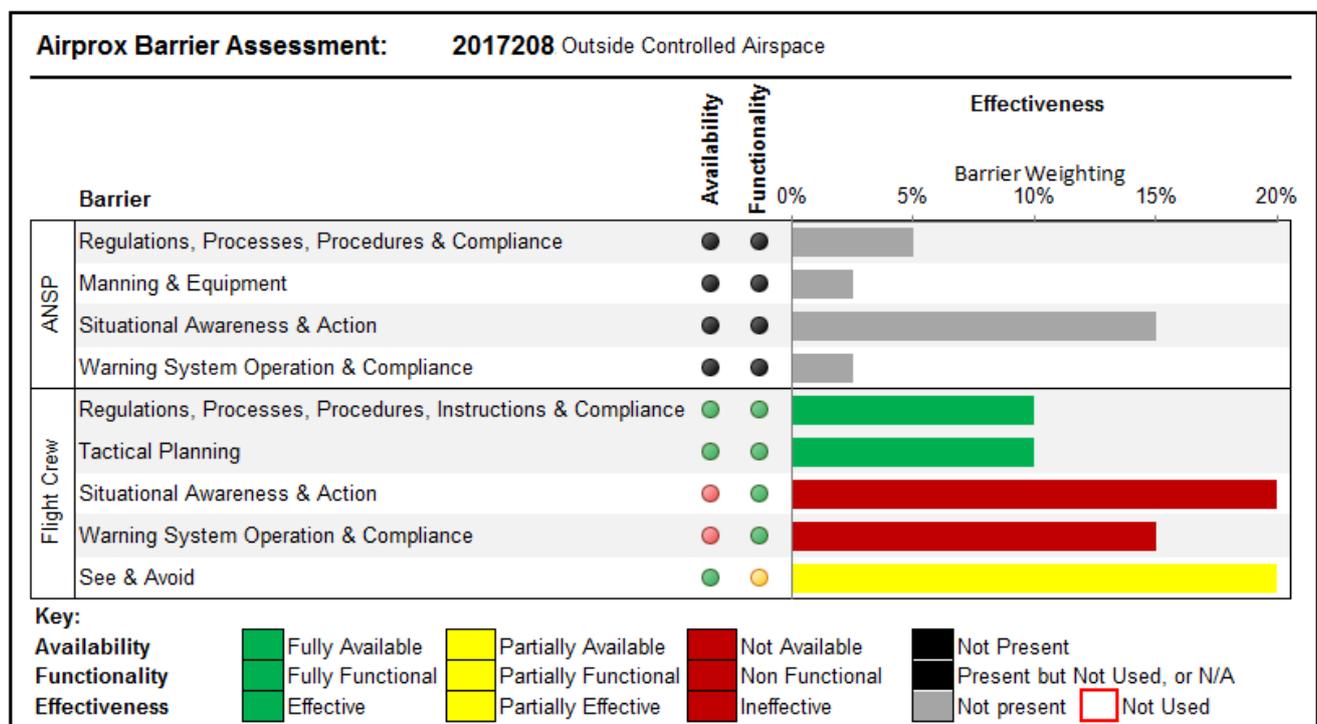
Situational Awareness and Action were assessed as **ineffective** because neither pilot was aware of the other until at a late stage.

Warning System Operation and Compliance were assessed as **ineffective** because the DR350 PowerFLARM did not detect the microlight, which, given the lack of any secondary radar indications, was considered likely not to have been fitted with any means of electronic conspicuity.

See and Avoid were assessed as **partially effective** because the DR350 pilot at least was able to see the microlight in time to take avoiding action at a late stage.
