## AIRPROX REPORT No 2017220

Date: 10 Sep 2017 Time: 0946Z Position: 5214N 00143W Location: Snitterfield gliding site

### PART A: SUMMARY OF INFORMATION REPORTED TO UKAB

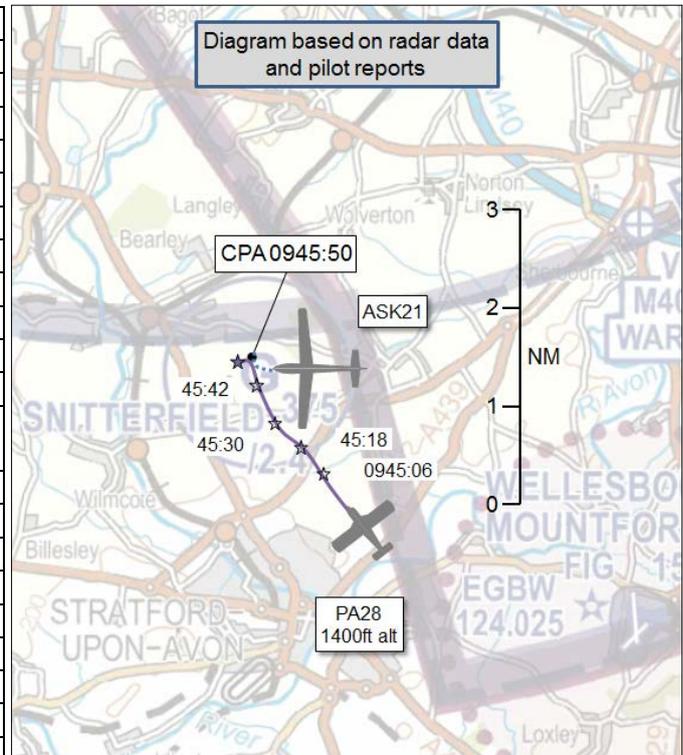
**THE ASK21 INSTRUCTOR** reports that following a normal winch-launch flown by the pupil, and an early release to stay clear of cloud, he noticed a PA28 aircraft very close to cloud base on a closing heading. He took control immediately and took avoiding action by executing a highly-banked right-hand turn. As he turned, he noticed the PA28 pilot also took avoiding action in a highly-banked turn to his left. The instructor commented that the purpose of the training flight was largely circuit practice due to the low cloud base of 1200-1400ft, and noted that the winch-operator confirmed that the PA28 would also have been at very high risk from the cable had the glider released later.

**THE PA28 PILOT** reports that on departing Wellesbourne Mountford he requested confirmation of whether the Snitterfield glider site was active, to which he was advised that it wasn't. Because it was notified as not active he chose to take a more direct route. Once in close proximity to the Snitterfield overhead, he saw a glider in his 2 o'clock. On sighting it he took immediate evasive action and banked left to avoid collision. On banking left, he then saw the glider on his left side, continuing in the opposite direction. He completed a full 360° orbit and continued en-route.

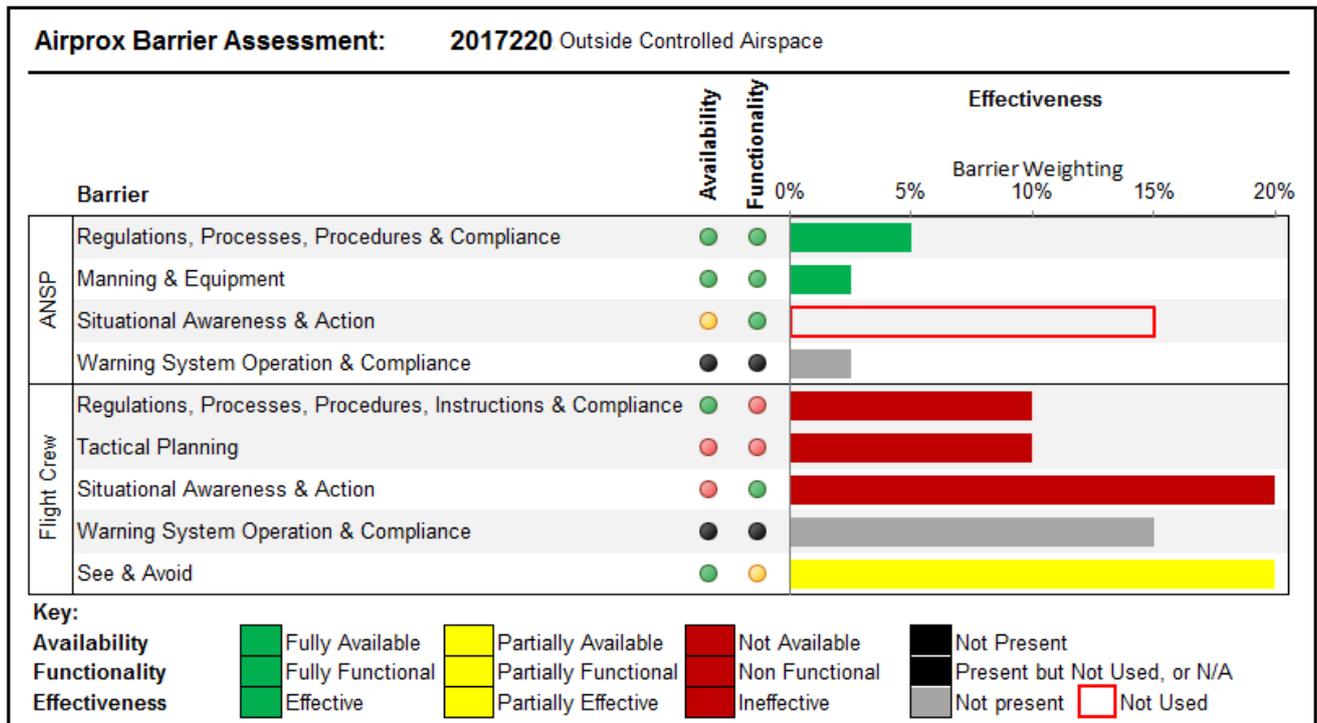
In assessing the effectiveness of the safety barriers associated with this incident, the Board concluded that the key factors had been that:

#### **ANSP:**

**Situational Awareness and Action** were assessed as **not used** because London Information could not be aware of the converging tracks of the glider and PA28.

#### **Flight Crew:**

**Regulations, Processes, Procedures, Instructions and Compliance** were assessed as **ineffective** because the PA28 pilot inadvertently flew through a promulgated and active glider site.

**Tactical Planning** was assessed as **ineffective** because the PA28 pilot based his planned route on incorrect information regarding the status of Snitterfield glider site.

**Situational Awareness and Action** were assessed as **ineffective** because neither pilot had situational awareness on the other aircraft prior to CPA.

**See and Avoid** were assessed as **partially effective** because each pilot only saw the other aircraft at a late stage and had to take emergency avoiding action.
