**AIRPROX REPORT No 2017244**

Date: 08 Oct 2017 Time: 1121Z Position: 5339N 00003W Location: 3nm SE Ottringham

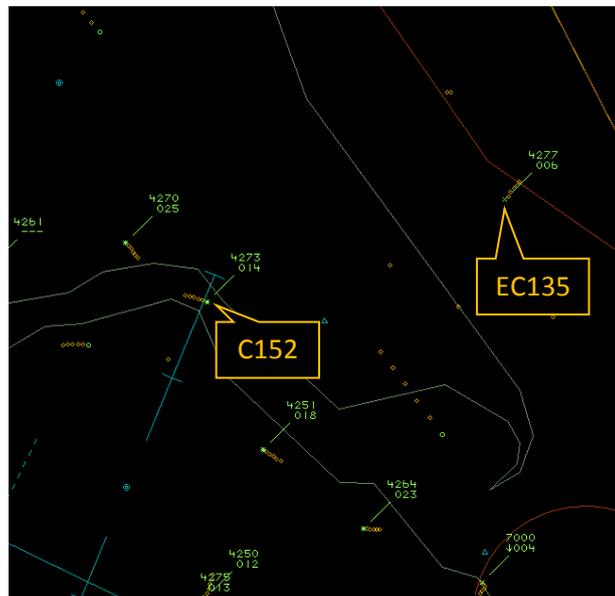
Figure 1 – 1115:38. Note levels indicated are FL (system QNH 1020)

The EC135 pilot did not call again until 1115:38, Figure 1, when he advised Director that he 'was complete', was routing back to Humberside, and requested a climb to 1500ft.

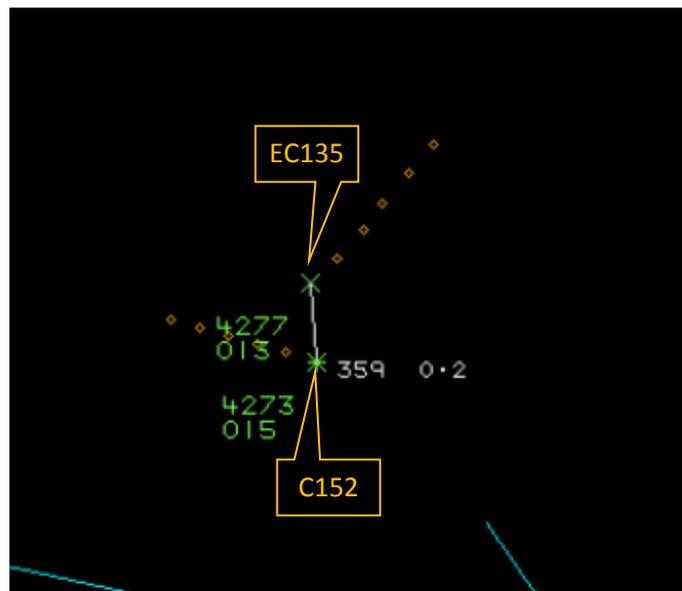
Figure 2 – 1120:57

CPA between the EC135 and the C152 took place at 1120:57, with the aircraft separated by 0.2nm laterally and 200ft vertically, Figure 2.

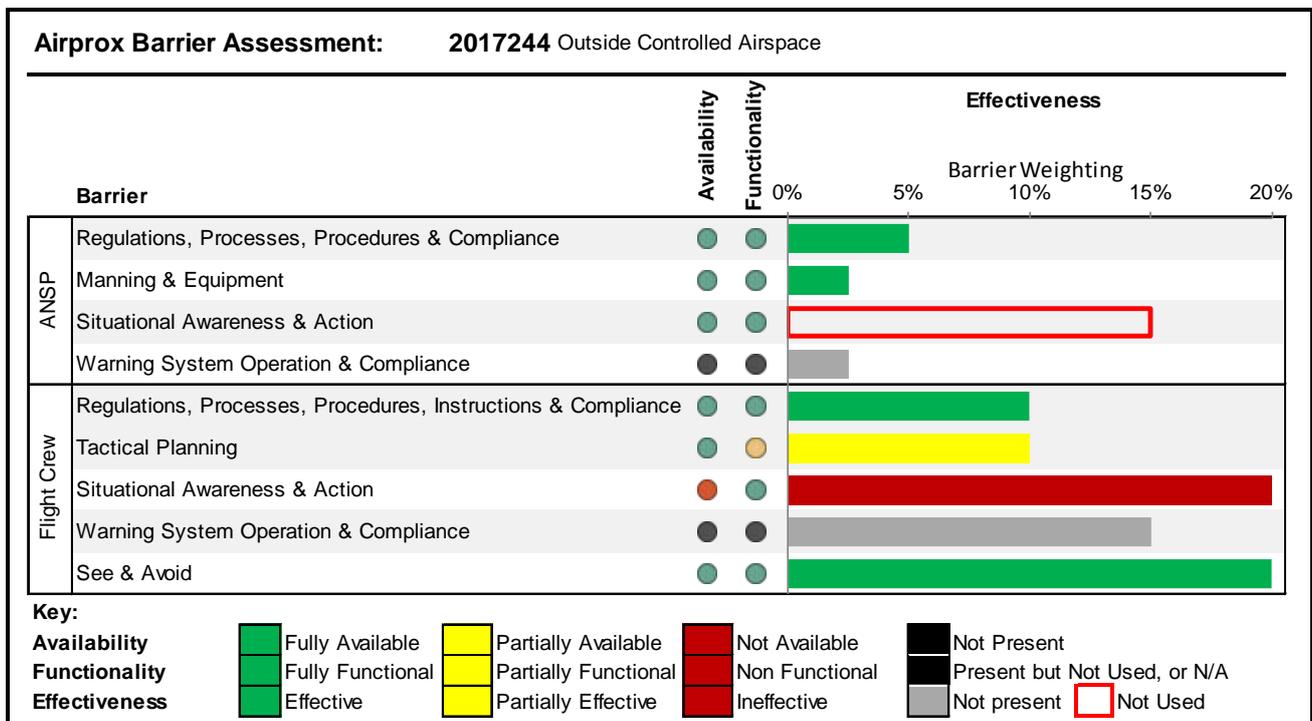
**Situational Awareness and Action** were assessed as **not used** because the Humberside controller was not required to monitor the aircrafts' positions under a Basic Service.

**Tactical Planning** was assessed as **partially effective** because the EC135 pilot appeared not to have a robust plan for his selection of ATS; he appeared to have expected a higher degree of service on recovery, had been in receipt of a Traffic Service on his outbound flight but had not terminated it when going en-route, and had accepted the unrequested provision of a Basic Service for his inbound flight.

**Situational Awareness and Action** were assessed as **ineffective** because neither pilot was aware of the other's position until shortly before CPA, when the EC135 pilot saw the C152.
