**AIRPROX REPORT No 2017277**

Date: 14 Dec 2017 Time: 1514Z Position: 5139N 00101W Location: 4nm NE RAF Benson

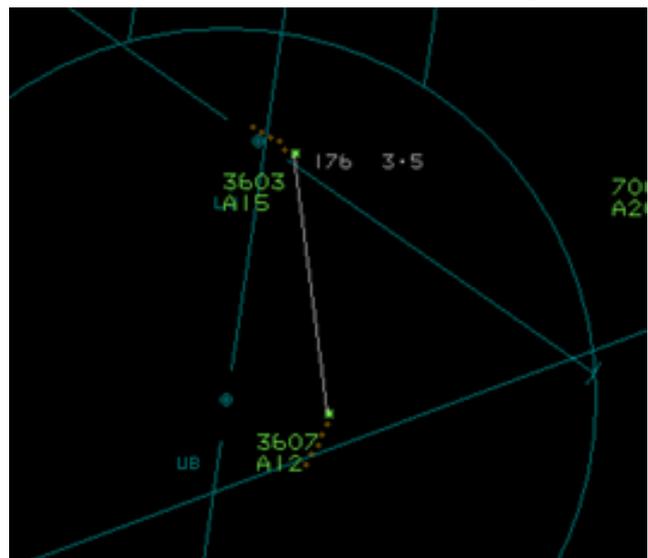
Figure 1: Geometry at 15:13:06

At 15:13:06 (Figure 1), the EC135 pilot first contacted the Benson Zone Controller during his end of downwind leg departure, requesting a Basic Service.

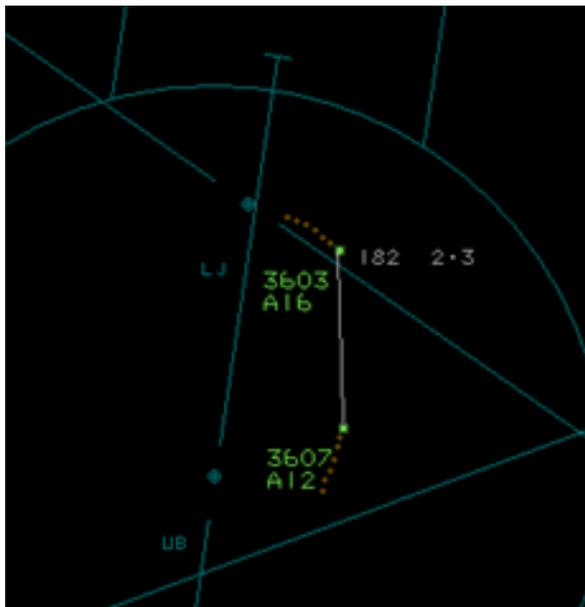
Figure 2: Geometry at 15:13:27

At 15:13: 27 (Figure 2), the Benson Zone Controller acknowledged the EC135 pilot's transmission of current altitude (1200ft).

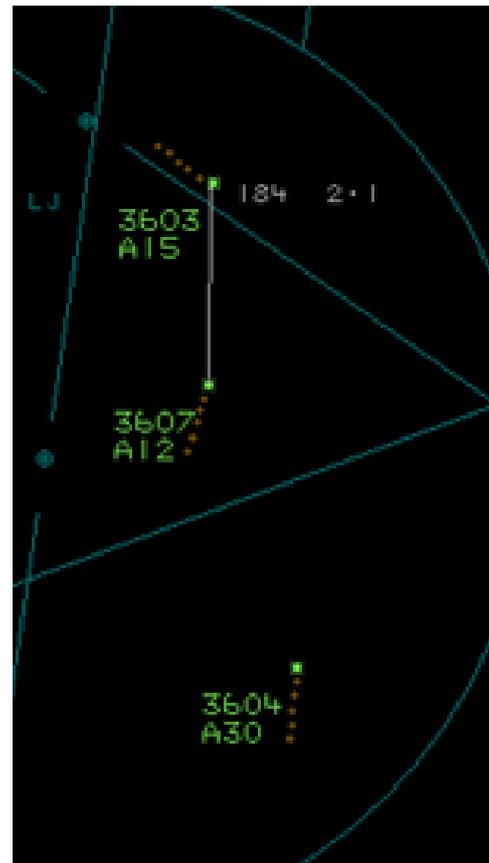
Figure 3: Geometry at 15:13:32

At 15:13:32 (Figure 3), the Benson Zone Controller passed Traffic Information on the R44 to another aircraft (squawk 3604) crossing the MATZ and receiving a Traffic Service. The pilot acknowledged the Traffic Information at 15:13:40.

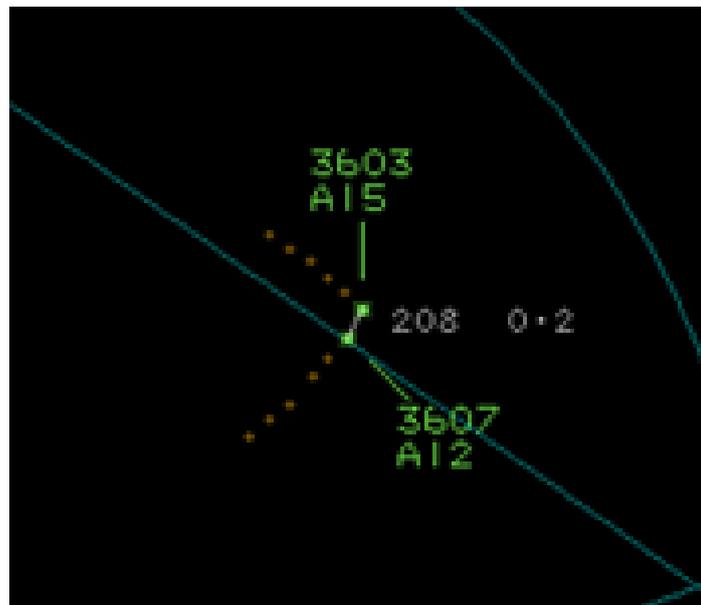
Figure 4: Geometry at 15:14:12

At 15:14:12 (Figure 4), The Benson Zone Controller passed Traffic Information on the R44 to the EC135 pilot as '12 o'clock, half a mile, crossing left right ahead, indicating 300ft above'. The EC135 pilot responded that he had seen the R44 fly over him and declared an Airprox. Traffic Information was not passed to the R44 pilot.
