AIRPROX REPORT No 2017280

Date: 28 Dec 2017 Time: 1255Z Position: 5155N 00005W Location: 10nm NE Luton Airport

PART A: SUMMARY OF INFORMATION REPORTED TO UKAB

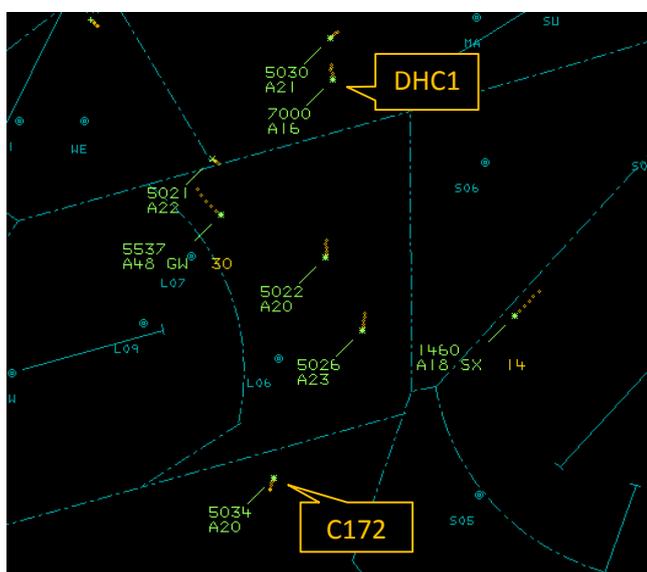
Figure 1 – 1250:00

At 1250:00 the DHC1 was observed to be manoeuvring to the north of the Luton CTA, 14nm north of the C172 (Figure 1).

The Board then discussed the C172 pilot's report of the Airprox. Members commented that the narrative of the event that he perceived as the Airprox did not correlate with that provided by the DHC1 pilot or as observed on radar replay. The other aircraft approached from his 11 o'clock but was reported by him as 1 o'clock; the Mode C indications were that the C172 was slightly higher than the DHC1, but the C172 pilot reported being below the other aircraft; the Airprox aircraft passed within 0.1nm on radar and 'closer [than he'd been] to another aircraft, apart from information, in 40 years of professional flying' by the DHC1 pilot, yet the C172 pilot reported taking early avoiding action, and that 'he was far enough away that he could not observe any minor detail, such as colour, type or registration. He could only see a darkish, single-engine, low-wing aircraft'; and that the risk of collision was 'None'. Members eventually concluded that whilst these disparities may have been due to errors in recollection from a busy instructor, taken as a whole, it was more likely that the C172 pilot had not seen the DHC1 and had instead perceived one of the aircraft squawking 5022 or 5026 (see Figure 1) as the Airprox aircraft.

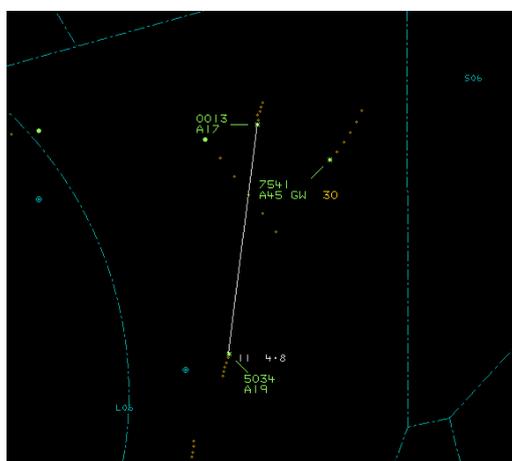
Figure 2 – 1253:30

By 1253:30, the DHC1 had tracked further south and was observed to be transponding code 0013 (Aircraft operating outside of Luton Controlled Airspace and monitoring Luton Radar Frequency) (Figure 2). CPA took place at 1255:02 with the aircraft separated by less than 0.1nm laterally and 100ft vertically (Figure 3).

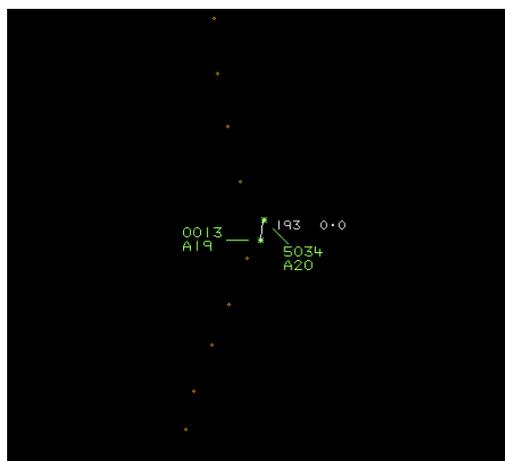
Figure 3 – 1255:02

The radar sweep after CPA showed the DHC1 at 2100ft altitude and the C172 at 1900ft altitude.
