AIRPROX REPORT No 2017047

Date: 02 Apr 2017 Time: 1358Z Position: 5131N 00215W Location: Halfpenny Green (elev 283ft)

PART A: SUMMARY OF INFORMATION REPORTED TO UKAB

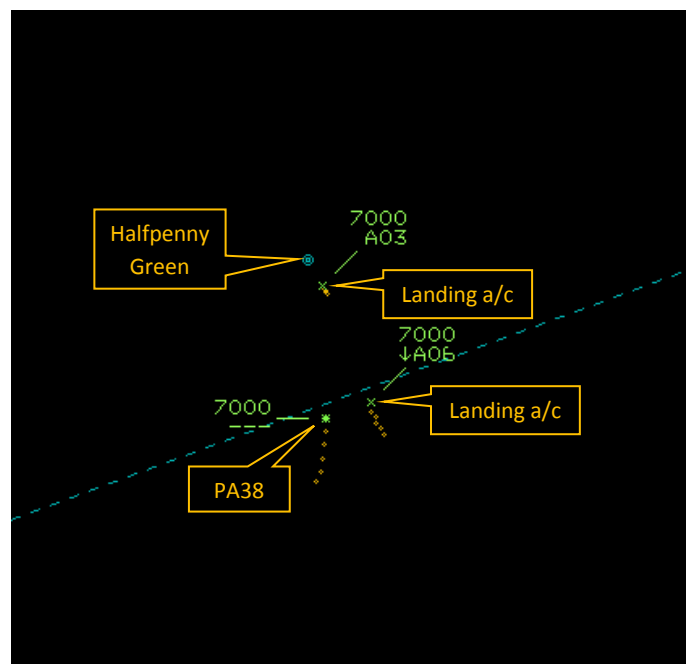
Figure 1 – 1356:15

The PA38 was inbound to the airfield from the south, and the pilot reported overhead at 1356:15. Although the PA38 could not be positively identified on the radar replay, by a process of elimination, the contact labelled as the PA38 in Figure 1, is considered, with a high degree of confidence, to be that aircraft.

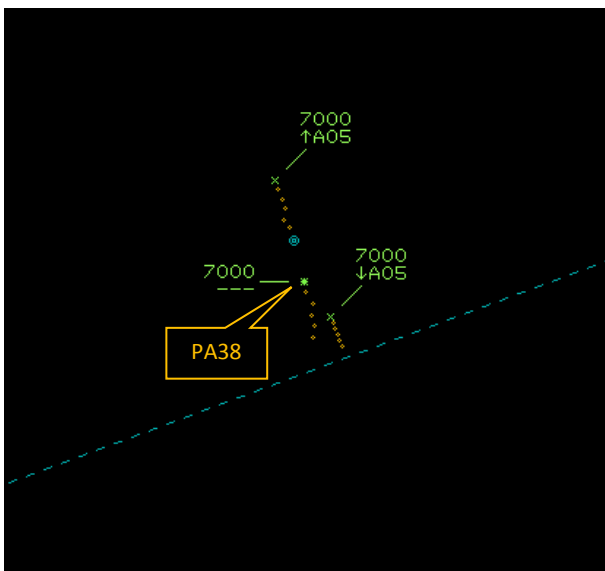
Figure 2 – 1356:54

The DA40 was number 3 in a sequence of 6 departures during this period, and, at 1356:54, the pilot reported ready and was asked by the AFISO to report lining up in turn (Figure 2).

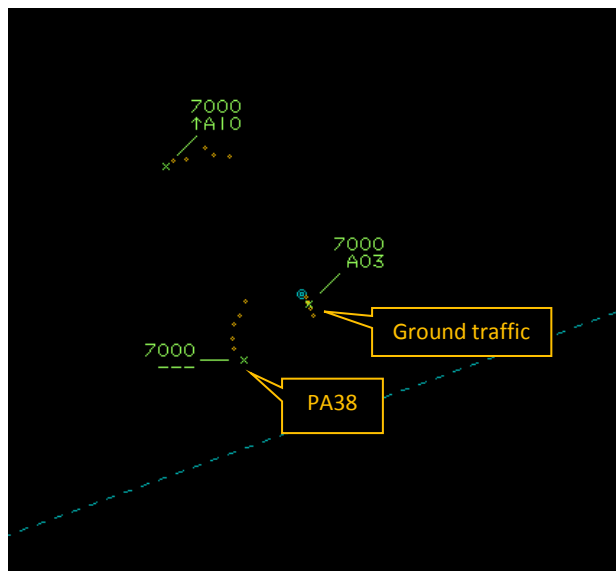
Figure 3 – 1357:40

At 1357:40, following two preceding departures, the DA40 pilot was advised by the AFISO that he could take-off at his discretion (Figure 3).

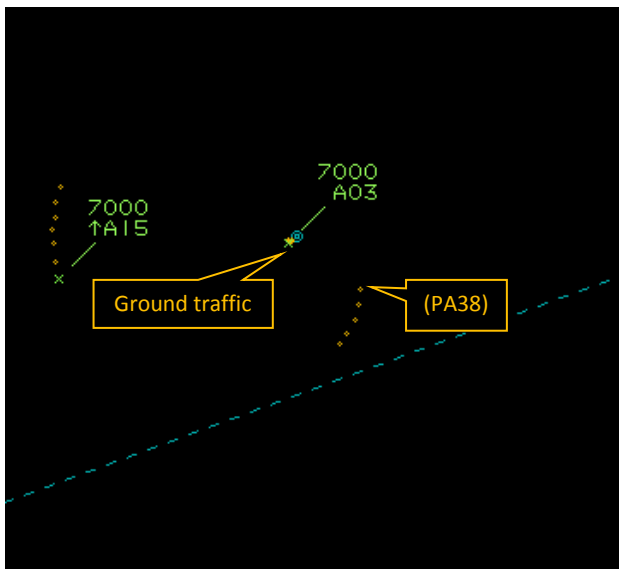
Figure 4 – 1358:42

No further calls were made by the PA38 pilot, and, at 1358:42, radar contact was lost (Figure 4).

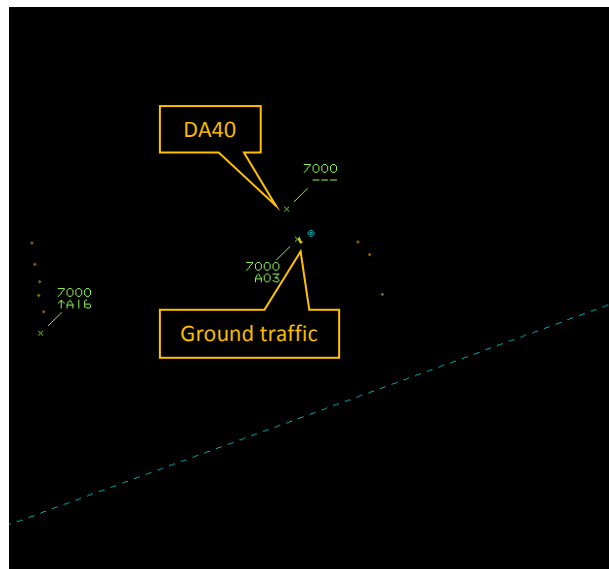
Figure 5 – 1358:56

At 1358:56, the DA40 appeared on the radar replay, but radar contact with the PA38 had not been re-established (Figure 5).

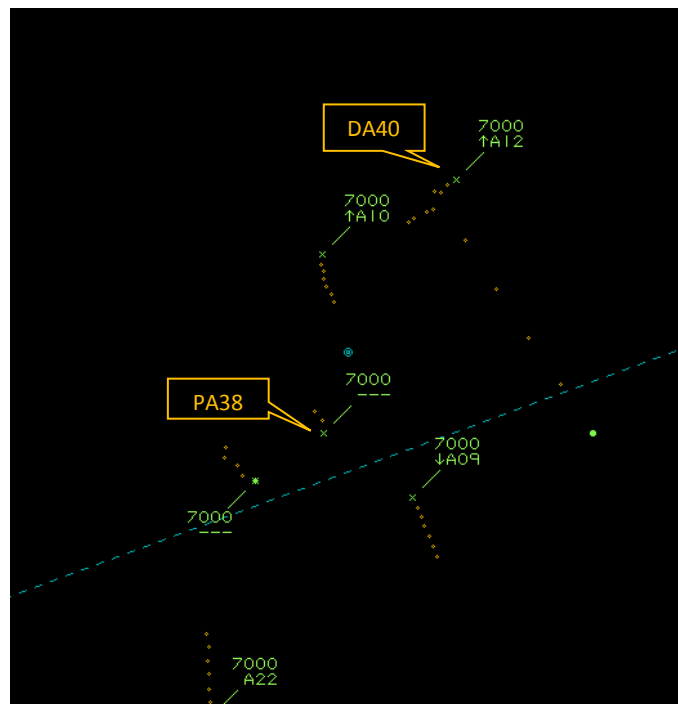
Figure 6 – 1400:30

At 1359:45, the PA38 pilot reported downwind, although the aircraft was not visible on the radar replay. At 1400:30, a contact appeared on the radar replay which could not be positively identified, but which was considered to be, with a high degree of confidence, the PA38 (Figure 6).

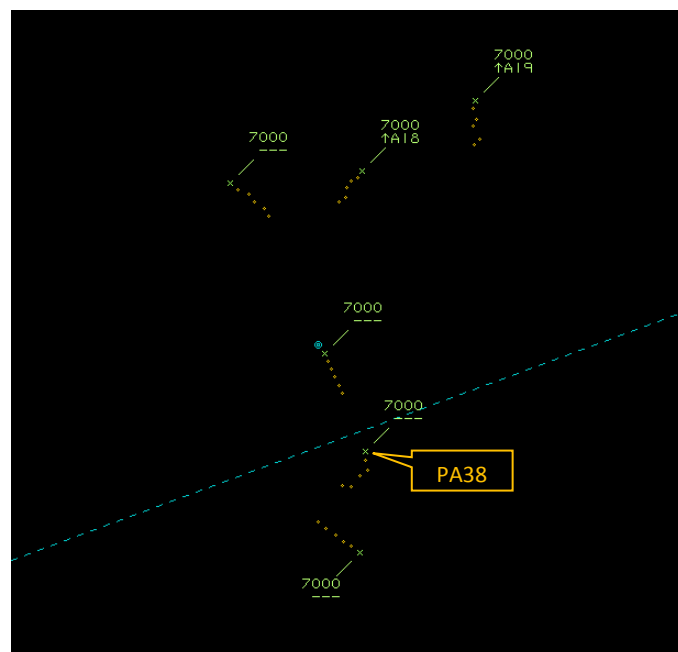
Figure 7 – 1401:28

At 1401:28, the PA38 pilot reported on final approach and was advised that the runway was occupied (Figure 7).

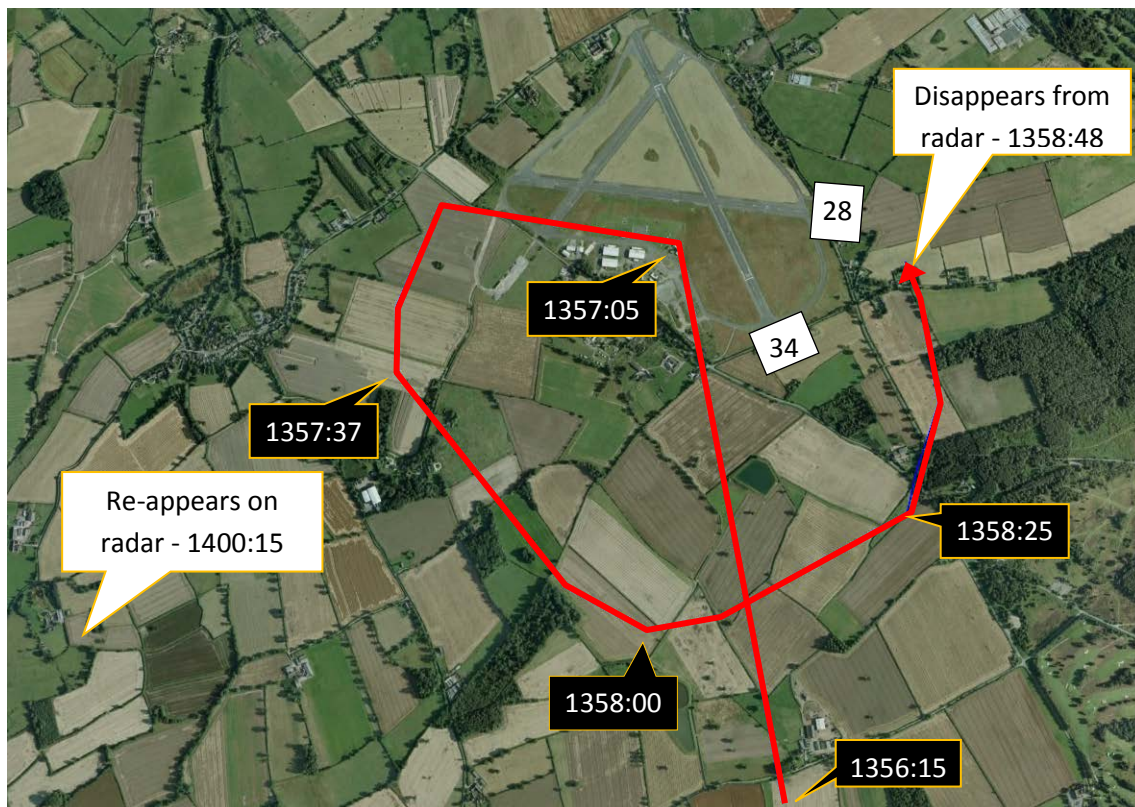
Figure 8 – recorded track of contact believed to be the PA38

In analysing this incident, with the evidence available from the radar replay, and having spoken to one of the AFISO on duty at the airfield that day, ATSI believe there is sufficient information to suggest that the PA38 pilot may have made his initial approach to RW28 and not to the runway in use, which was RW34. This is based on the following points:

- The track of the aircraft, and its subsequent disappearance from radar for over 2 minutes, in an area where the secondary radar contacts with other aircraft were visible at reported altitudes as low as 300ft (airfield elevation 283ft), (Figure 8).

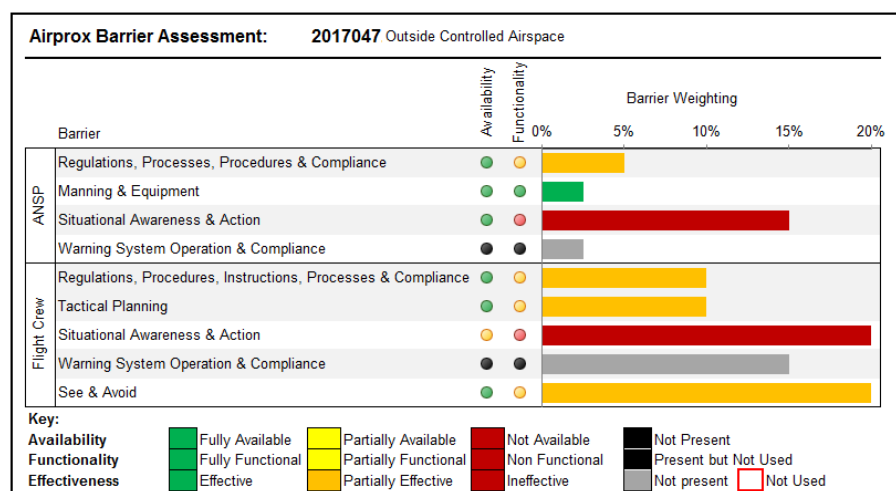
In assessing the effectiveness of the safety barriers associated with this incident, the Board concluded that the key factors had been that:

Regulations, Processes, Procedures and Compliance were assessed as **partially effective** because the AFISO did not pass information on other traffic.

Situational Awareness and Action were assessed as **ineffective** because the AFISO did not detect the conflict.

Regulations, Processes, Procedures, Compliance and Instructions were assessed as **partially effective** because the PA38 pilot most likely did not remain above 1300ft on the deadside.

Tactical Planning was assessed as **partially effective** because the PA38 pilot most likely did not fly the overhead join correctly.

Situational Awareness and Action were assessed as **ineffective** because the PA38 pilot had information that the DA40 was getting airborne but did not integrate with it.

See and Avoid were assessed as **partially effective** because neither pilot saw the other aircraft until a late stage.
