AIRPROX REPORT No 2018010

Date: 22 Jan 2018 Time: 1930Z Position: 5058N 00256W Location: Merryfield airfield

PART A: SUMMARY OF INFORMATION REPORTED TO UKAB

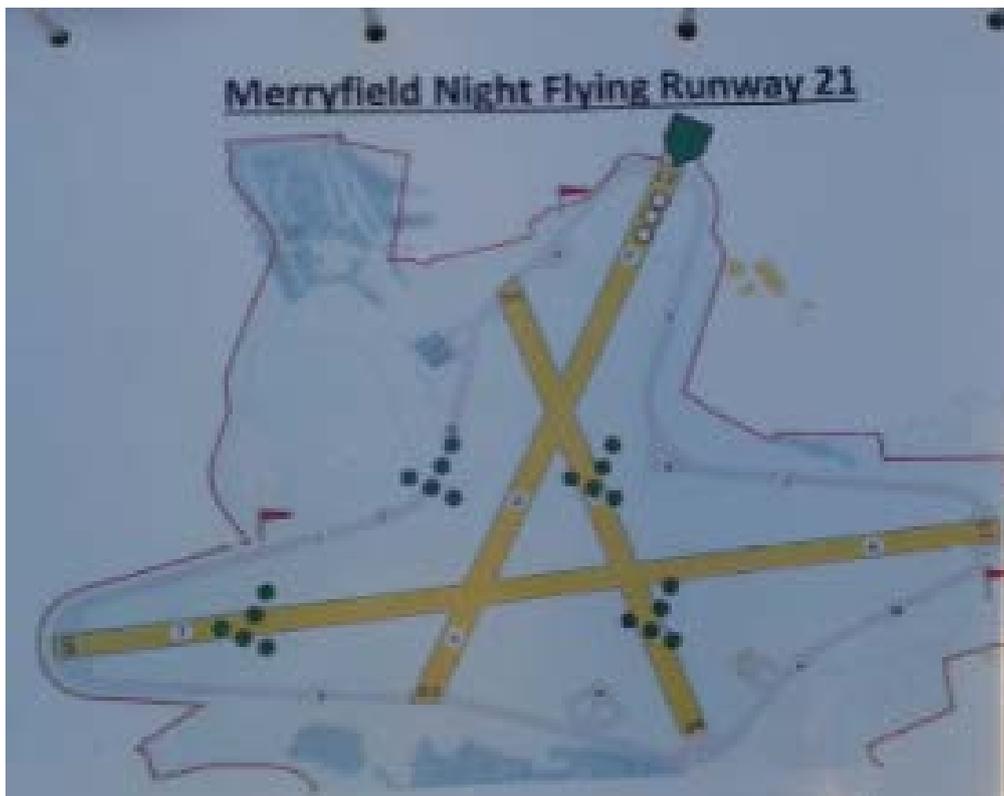
Figure 1 Night flying map RW21

THE MERRYFIELD DATCO reports that they were expecting a relatively high volume of aircraft to use Merryfield for night flying. It had been decided in the night flying brief that all Wildcat aircraft would complete right-hand circuits to two T's established on the most western end of RW09, and between spots B and C, respectively. A Merlin aircraft conducting load-lifting training serials was to conduct left-hand circuits to a T positioned on spot A. The duty runway was RW21 and, at the time of the incident, conditions were good VMC, colour code blue, QFE 1014hPa with southwesterly winds of approximately 10kt. The TAL lights used for the three T's were serviceable; however, due to a lack of bases, the three TALs that would routinely denote the start of the duty runway for night flying were absent. At 1928, the Merlin was in the left-hand circuit to the 'black' T on spot A, and the Wildcat was in the right-hand circuit to RW21. The Merlin pilot reported 'final, gear down' and was given 'black left, cleared to land' by the Aerodrome controller. Shortly after this clearance was given, the Wildcat pilot called 'final, runway 21'. At this point, the Aerodrome controller issued a 'continue' to the Wildcat pilot, while they both tried to sight their position in the air. After this, the Wildcat pilot called, saying they were 'going around'. The pilot also issued an apology on R/T, saying that he believed that he had gone through the centreline of the other aircraft that was on final (the Merlin) to the black T (left-hand circuit). At this point, as the Wildcat pilot executed his 'go around', it became apparent that the aircraft both himself and the Aerodrome controller were visible with and believed to be the Merlin, was in fact the Wildcat. Due to the lower frequency sound of the rotor head, they could both hear the Merlin and could not see the distinctive Wildcat anti-collision lights. It was only when the Wildcat drew level with them that it became apparent that their previous position had been obscuring the Merlin from their sight. After the Wildcat pilot issued the apology, the pilot of the Merlin said on frequency that they believed it was probably an Airprox. The Wildcat pilot replied by saying that they were visual (with the Merlin) throughout, and that they would be happy to not file an Airprox if the Merlin pilot was. The Merlin pilot then replied that they would call the other pilot to discuss it, and that was the end of the exchange regarding the matter. Both aircraft continued to operate at Merryfield without further incident. He was stood behind the Aerodrome controller throughout the incident and heard all R/T exchanges through the loudspeaker.

1. The student pilot misidentified the taxiway as the runway.
2. The runway was not lit in accordance with the Merryfield DAM.
3. Without suitable equipment the Merryfield controllers were not able to act as an effective barrier.

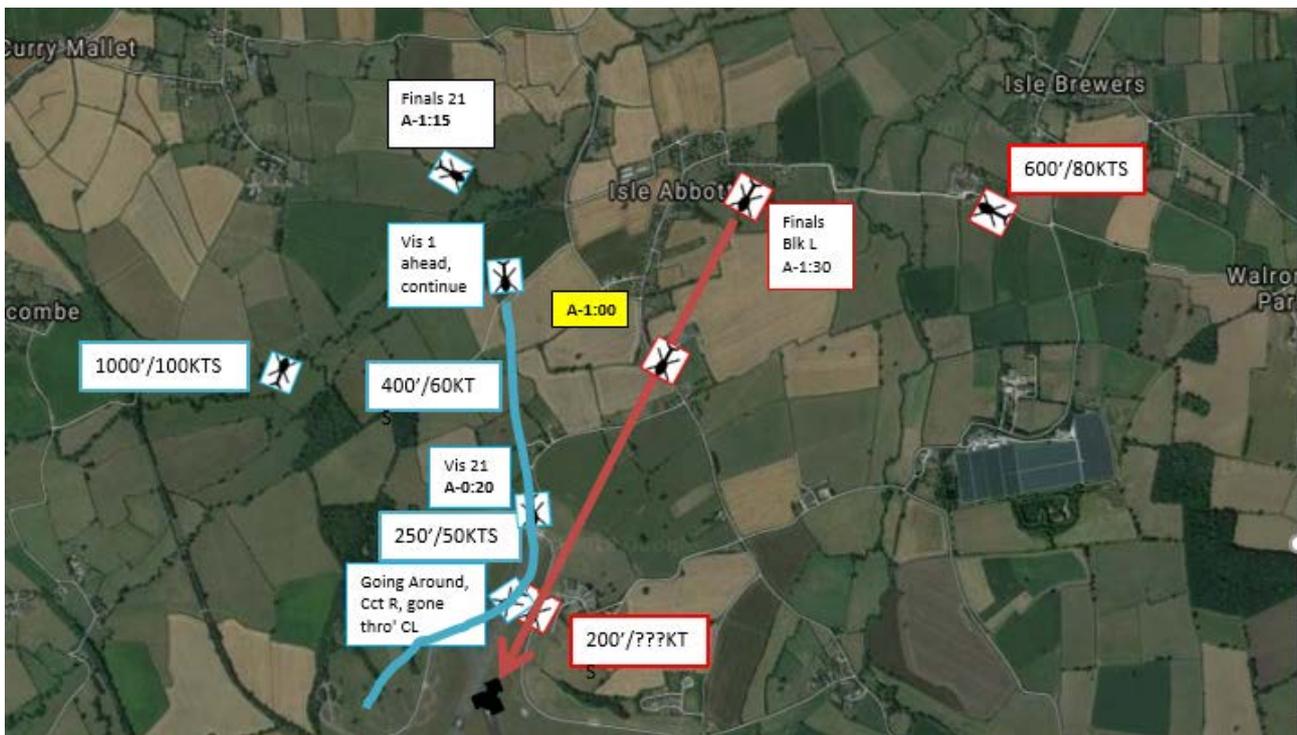
Figure 2 Schematic from pilot reports [red-Merlin; blue Wildcat].

THE WILDCAT PILOT reports that during a night conventional approach to Duty RW21 from the right-hand circuit at Merryfield the pilot under instruction encroached the 25m runway sterile area and continued into the left-hand circuit whilst trying to identify the unlit duty runway. This was coincidental with a Merlin conducting an approach to a NATO 'T' in the left-hand circuit at the same height and slightly slower speed. The QHI in the left seat was visual with the Merlin throughout and took control when it became apparent that the handling pilot had misidentified the adjacent taxiway to the east of

the duty runway as the runway itself and due to this was converging on the Merlin which would have been unsighted to him. The QHI then recovered the aircraft to the right-hand circuit and made a radio call to inform the Merlin crew of the incursion. It is estimated that the 2 aircraft were 100m laterally displaced and 75ft in height (Wildcat higher) at the closest point. This incident was exacerbated by the following factors: 1. The handling pilot flew a non-standard curved approach which contributed to his misidentifying the duty runway. 2. In contravention to the Merryfield Defence Airfield Manual Annex Q Ch7 Para 6.5 the duty runway was not lit with 3 white Tactical Approach Lighting System (TALS)² to indicate the runway centreline. 3. The Wildcat white landing lamp is ineffective above approximately 200ft due to the narrow beam width and low intensity.

Cause: The Wildcat instructor allowed the student pilot to fly into conflict with the Merlin.

Recommendation: Merryfield controllers are equipped to detect the position of traffic in the visual circuit at night.
