AIRPROX REPORT No 2018013

Date: 25 Jan 2018 Time: 1300Z Position: 5249N 00042W Location: Saltby Glider Site

PART A: SUMMARY OF INFORMATION REPORTED TO UKAB

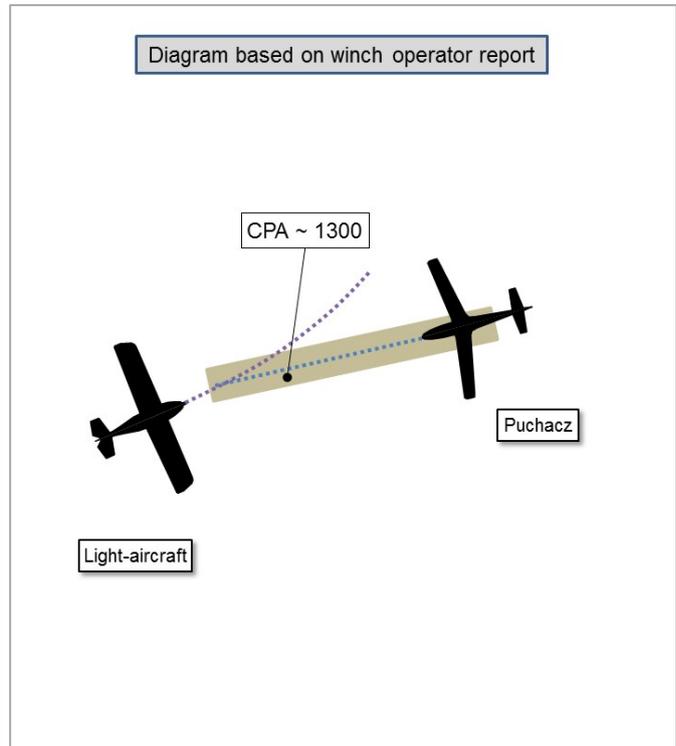
THE WINCH OPERATOR reports being located at the western end of RW25. The Puchacz being launched had just released at the top of the tow (at about 1700ft QFE). Almost immediately after the winch cable had been released, an aircraft crossed the airfield below the level of the glider and the winch cable. The aircraft was about 200m from the glider and winch cable. The aircraft had approached from the WSW and was heading ENE. Therefore, the aircraft came from behind the right side of the winch and flew almost overhead before flying away and to his left. He was not in a position where he could see any registration but it was a small high-wing aircraft similar in appearance to a C42. The incident was also seen by the Duty Instructor who was standing at the launch point.

An Airprox was reported when a Puchacz and a light-aircraft flew into proximity at about 1300 on Thursday 25th January 2018 overhead Saltby Glider Site. The Puchacz pilot was operating under VFR in VMC and not under a service. The light-aircraft pilot could not be traced.

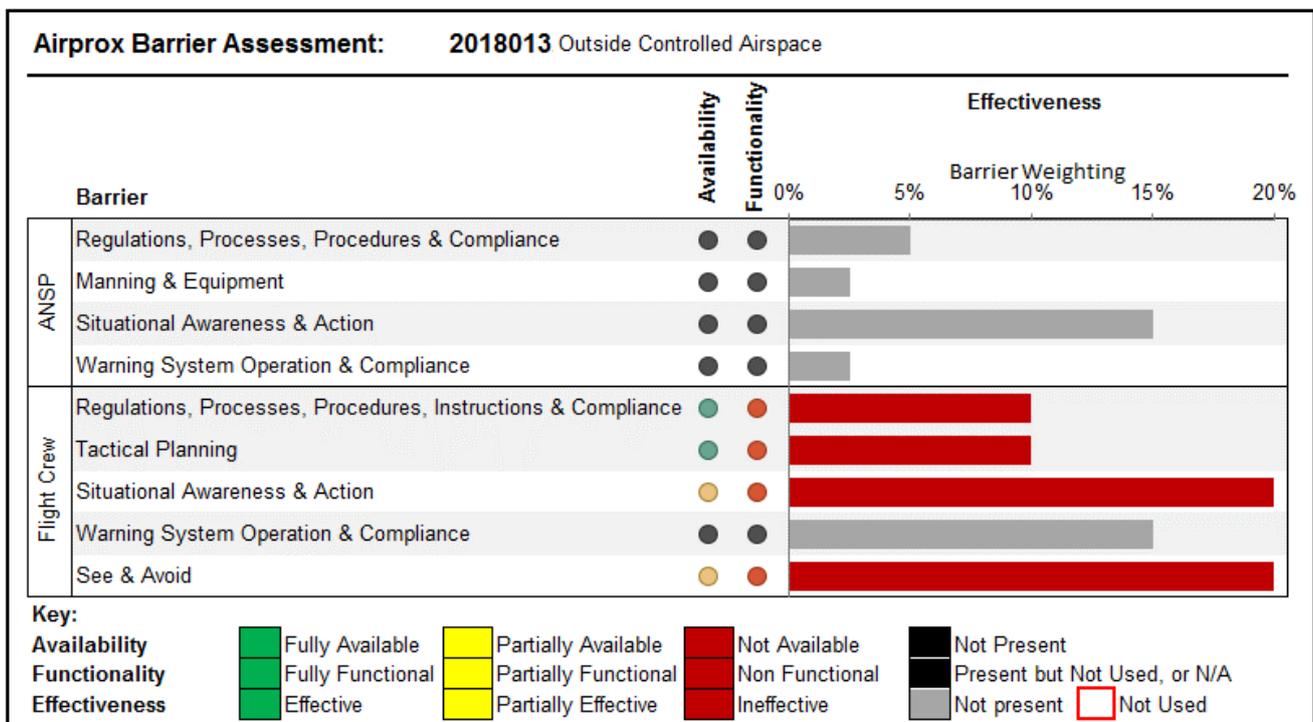
In assessing the effectiveness of the safety barriers associated with this incident, the Board concluded that the key factors had been that:

Regulations, Processes, Procedures, Instructions and Compliance were assessed as **ineffective** because the light-aircraft pilot did not avoid the pattern of traffic at a promulgated and active glider site.

Tactical Planning was assessed as **ineffective** because the glider site was marked on the maps yet the light-aircraft pilot did not plan his route to avoid the site by a sufficient margin.

Situational Awareness and Action were assessed as **ineffective** because the light-aircraft pilot would have had generic SA regarding the glider site from his chart but did not appear to have acted on that information.

See and Avoid were assessed as **ineffective** because the Puchacz pilot did not see the light-aircraft due to the angle of climb of his aircraft during the winch-launch, and the light-aircraft pilot probably did not see the Puchacz.
