AIRPROX REPORT No 2018014

Date: 19 Jan 2018 Time: 1513Z Position: 5157N 00032W Location: 15nm W Henlow

PART A: SUMMARY OF INFORMATION REPORTED TO UKAB

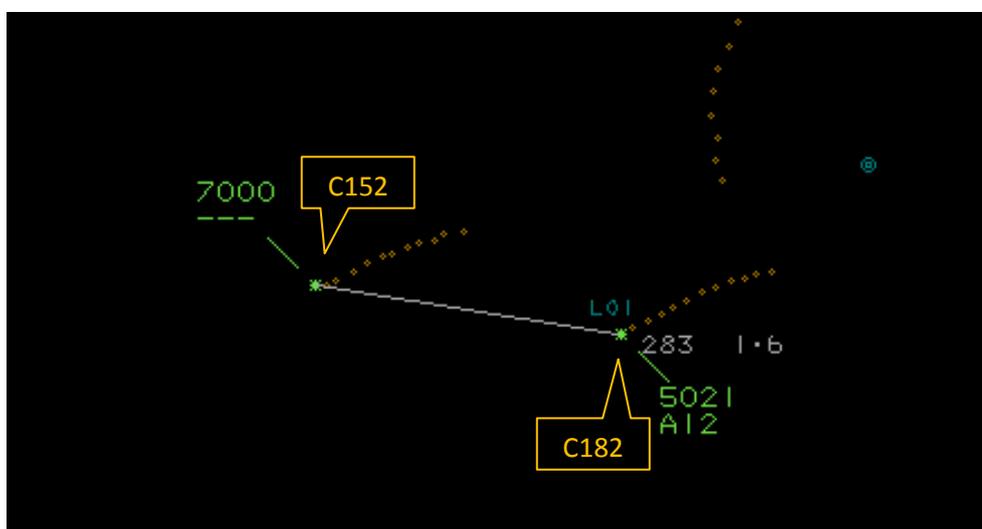
Figure 1 – 1509:39

At 1508:55 the C182 pilot contacted the Farnborough LARS North controller and requested a Basic Service. The service was agreed between the pilot and controller at 1509:22, and the controller provided the London QNH and issued a transponder code of 5021. The transponder code was first visible on radar at 1509:39 (Figure 1).

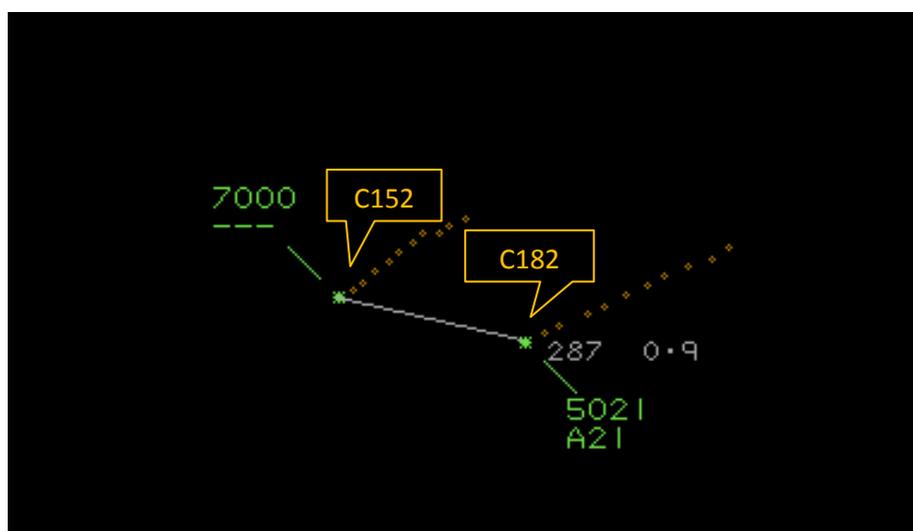
Figure 2 – 1512:32

Both aircraft flew converging headings, with the C182 catching up slightly with the C152 by 1512:32 (Figure 2).

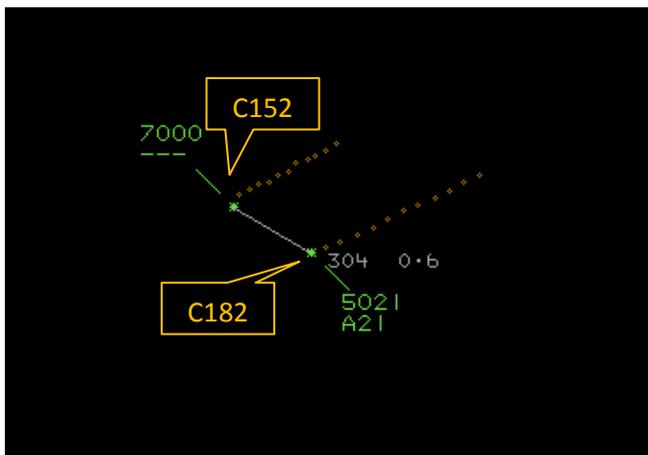
Figure 3 – 1513:11

At 1513:11 (Figure 3), the C152 turned left towards the track of the C182. At this point the Farnborough LARS North controller was giving Traffic Information to another aircraft.

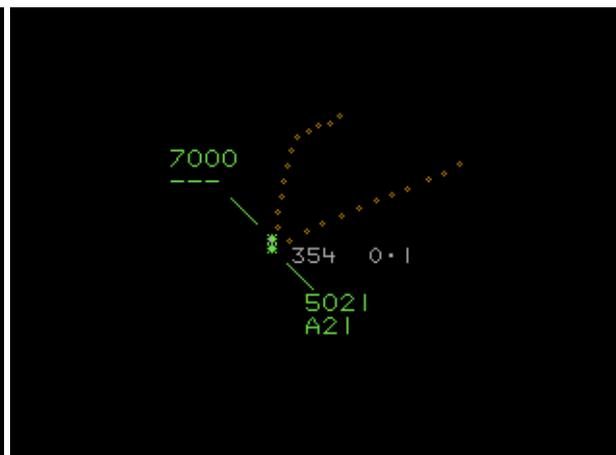
Figure 4 – 1513:35

CPA as seen on the radar, occurred at 1513:35 (Figure 4) with separation of 0.1nm between the two aircraft.

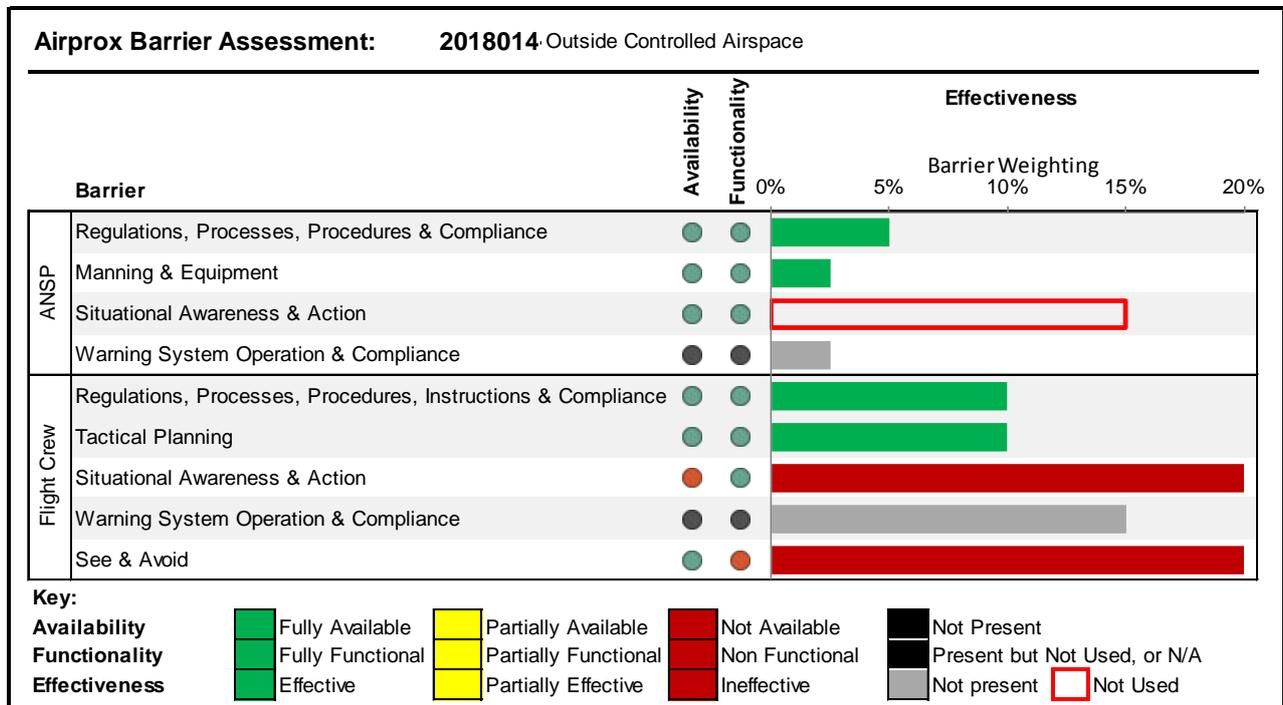
Situational Awareness and Action were assessed as **not used** because in providing a Basic Service the Farnborough controller was not required to give Traffic Information.

Situational Awareness and Action were assessed as **ineffective** because neither pilot had any knowledge that the other was in the area.

Warning System Operation and Compliance were assessed as **not present** because neither aircraft was fitted with a CWS.

See and Avoid were assessed as **ineffective** because neither pilot saw the other in time to take any avoiding action.
