AIRPROX REPORT No 2018025

Date: 21 Feb 2018 Time: 1556Z Position: 5232N 00218W Location: 1.5nm W Halfpenny Green

PART A: SUMMARY OF INFORMATION REPORTED TO UKAB

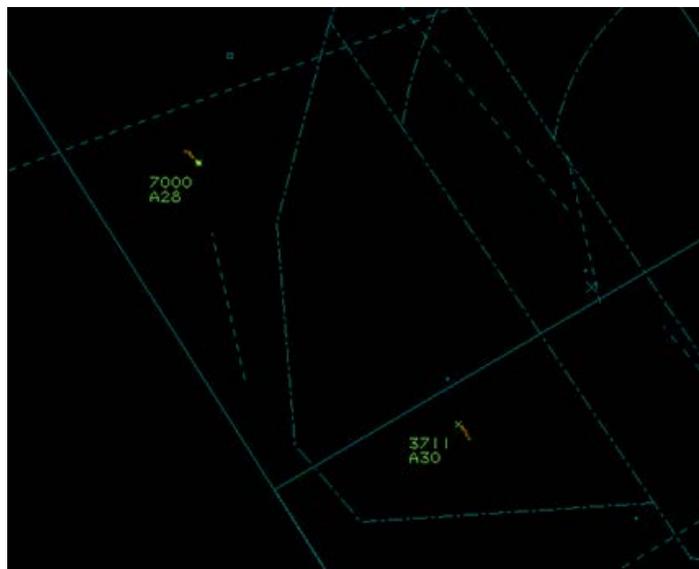
At 15:47:53 (Figure 1), the Brize LARS Controller informed the Squirrel pilot that radar contact had been lost and he was now in receipt of Basic Service (BS). The Controller then attempted a radio check but received no response from the pilot.

Figure 1: Squirrel (3711) when Brize LARS Controller lost radar contact.

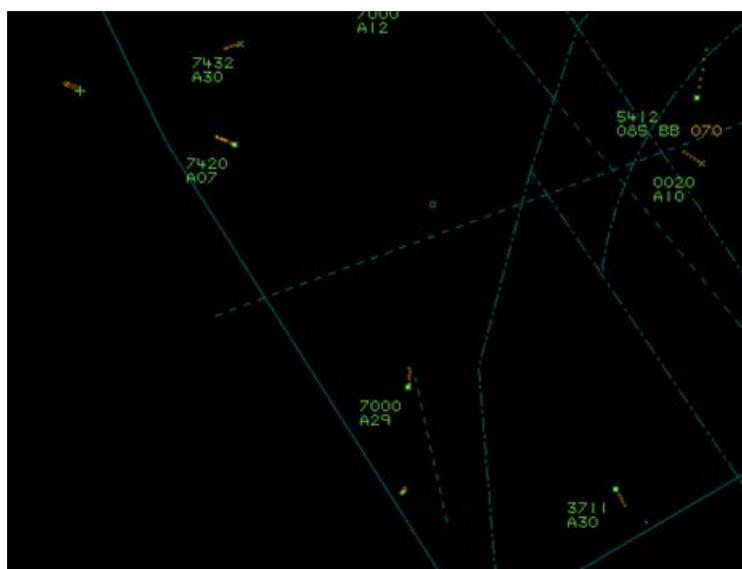
At 15:49:25 (Figure 2), the Brize LARS Controller instructed the Squirrel pilot to squawk 7000 and free-call Shawbury, the planned next agency.

Figure 2: Squirrel (3711) at 15:49:25.

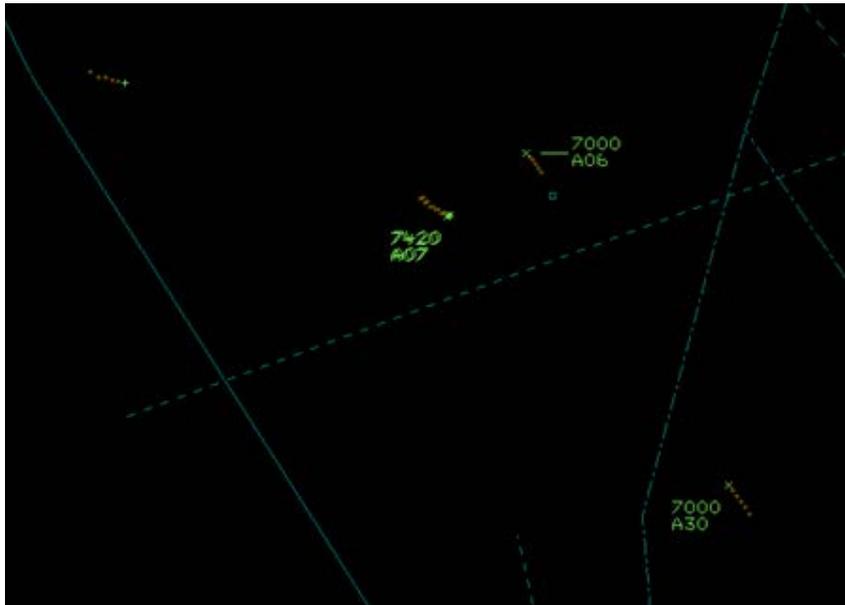
At 15:52:19 (Figure 3), the Squirrel was seen to change from transponder code 3711 to 7000. Shortly after, the Brize LARS Controller spoke to the Shawbury Approach Controller and established that the Squirrel pilot had not yet called on their frequency.

Figure 3: Squirrel (7000) at 15:52:19.

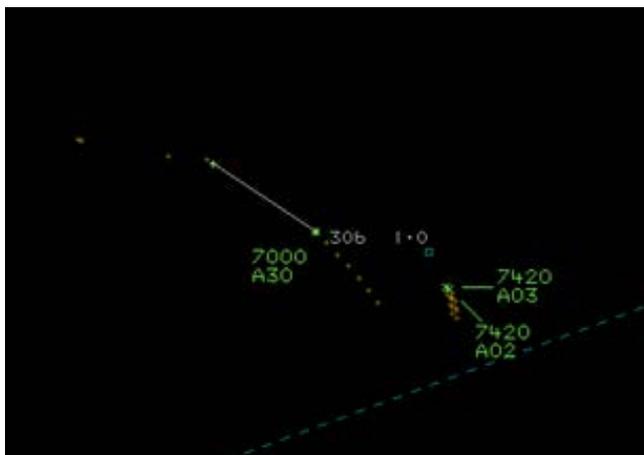
At 15:55:39 (Figure 4), the Squirrel and traffic believed to be the light aircraft had 1nm lateral separation.

Figure 4: Geometry at 15:55:39

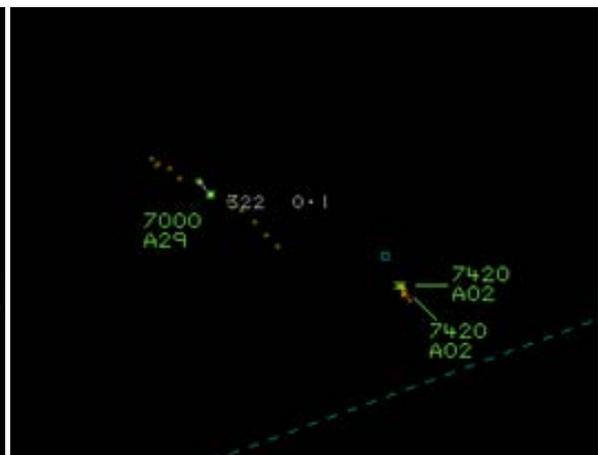
Figure 5: Geometry at 15:55:56

At 15:55:56 (Figure 5), the Squirrel and traffic believed to be the light aircraft were at their lateral CPA as the two tracks crossed. The Squirrel pilot was not in communication with Brize or Shawbury ATC at the time.

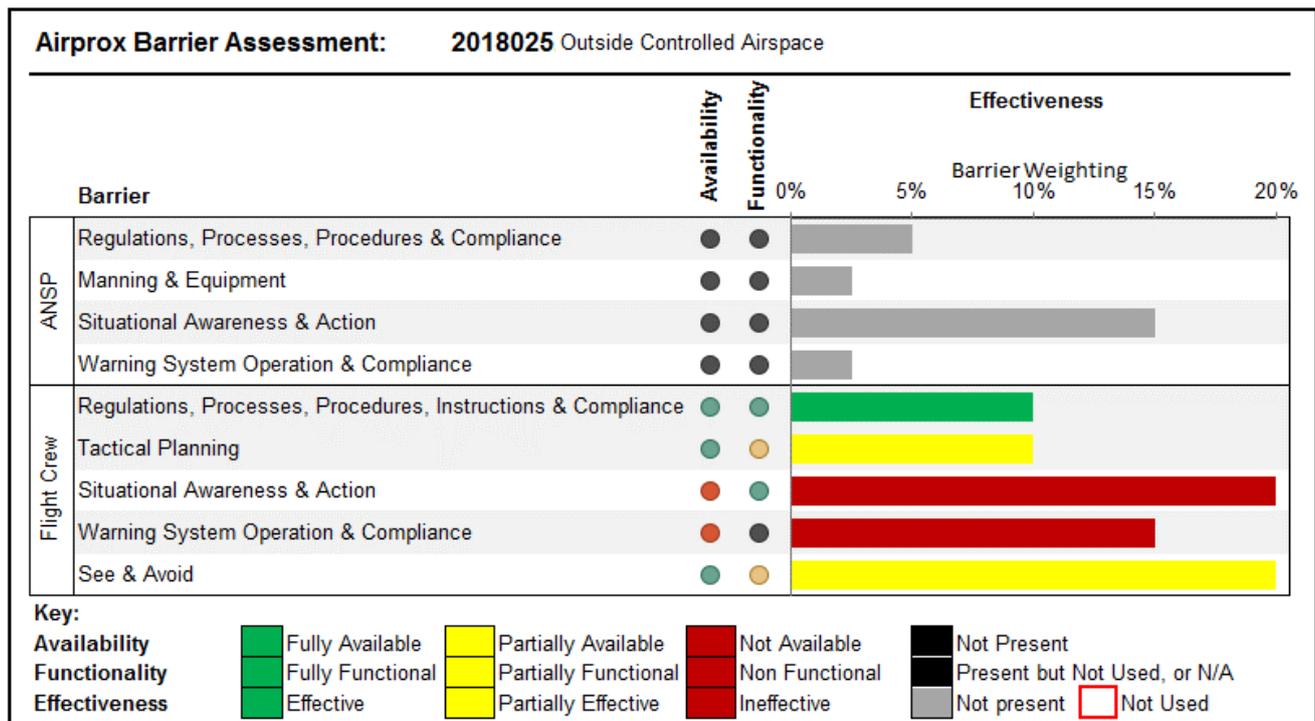
Tactical Planning was assessed as **partially effective** because the collision mitigation provided by the Traffic Service was rendered ineffective by the Squirrel crew operating outside surveillance and R/T coverage of the Brize Radar controller.

Situational Awareness and Action were assessed as **ineffective** because the Squirrel crew were not aware of the converging light-aircraft.

Warning System Operation and Compliance were assessed as **ineffective** because the lack of SSR transponder squawk from the light-aircraft rendered the Squirrel's TAS ineffective.

See and Avoid were assessed as **partially effective** because although avoiding action was taken, the Squirrel Instructor saw the light-aircraft at a late stage, and the light-aircraft pilot saw the Squirrel even later, if at all.
