AIRPROX REPORT No 2018031

Date: 07 Feb 2018 Time: 1045Z Position: 5228N 00020E Location: 9nm NW Mildenhall

PART A: SUMMARY OF INFORMATION REPORTED TO UKAB

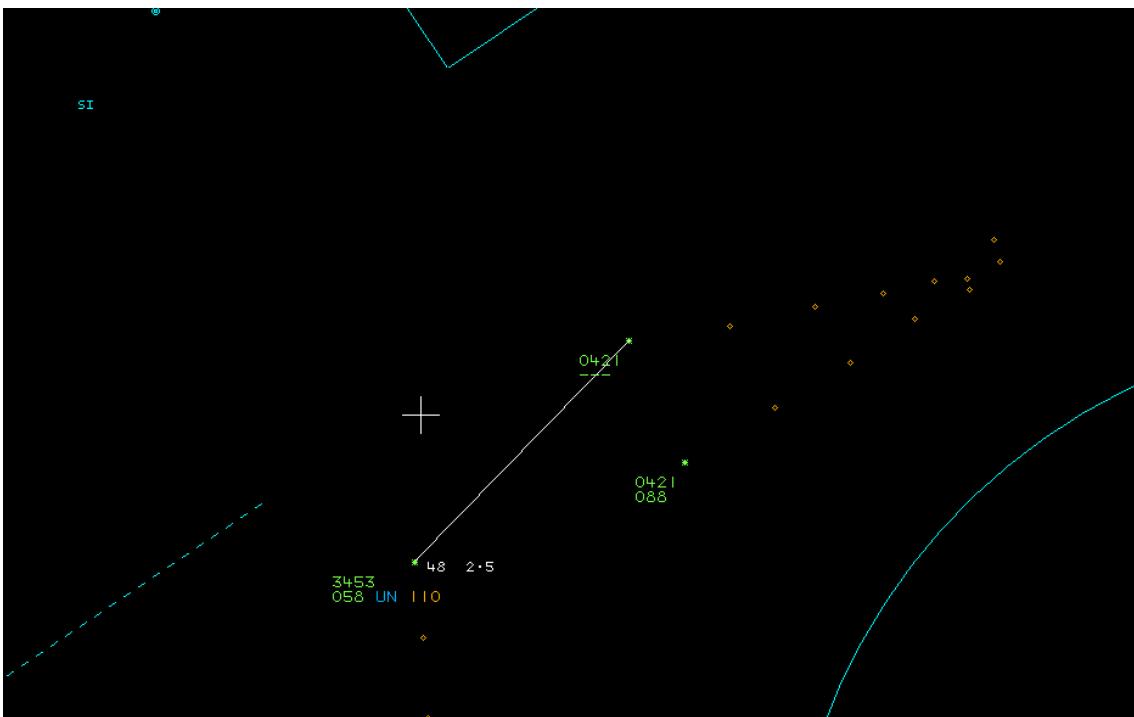
Figure 1: 1045:17

Figure 1 (1045:17) shows the situation at the time when the RC135 pilot reported responding to the TCAS RA. Although the Airprox F15's altitude is not displayed on the radar, this does not necessarily imply that the aircraft was not transmitting Mode C information but could instead be the result of radar display filtering due to a high rate of change. The second, southerly, F15 could equally have been perceived as a threat by the RC135 TCAS and so it is not possible to determine which F15 caused the TCAS RA in the RC135 system.

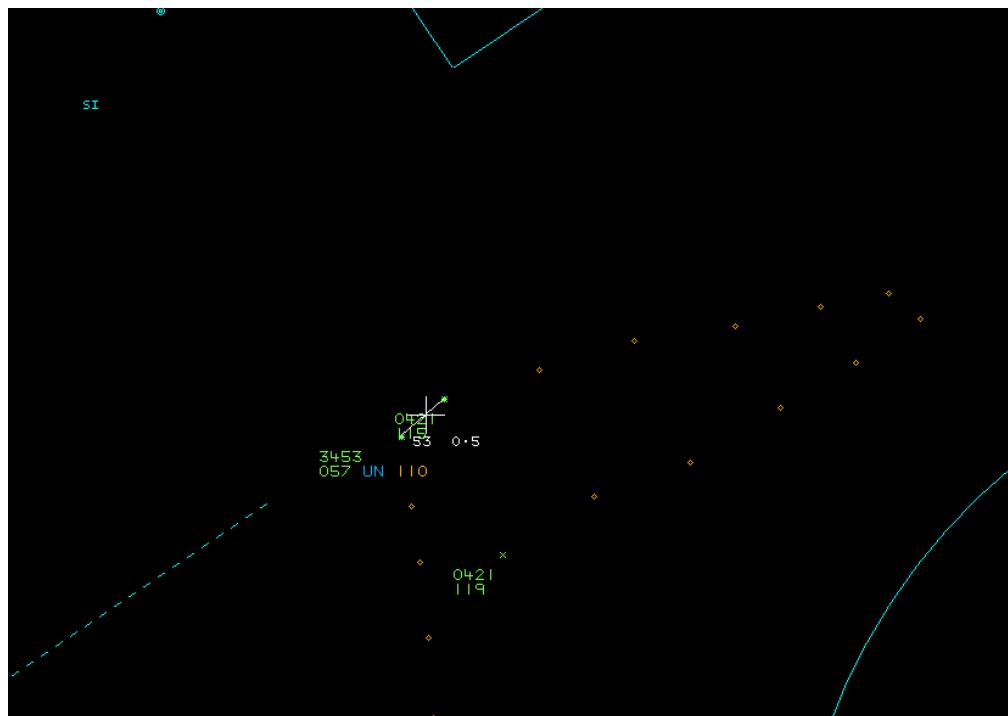
Figure 2:1045:21

Figure 2 (1045:21) shows the closest displayed lateral separation between the RC135 and the northerly F15. Interpolation of the tracks indicates that the F15 came within 0.2nm laterally to the RC135.
