AIRPROX REPORT No 2018046

Date: 08 Apr 2018 Time: 1331Z Position: 5612N 00326W Location: Kinross

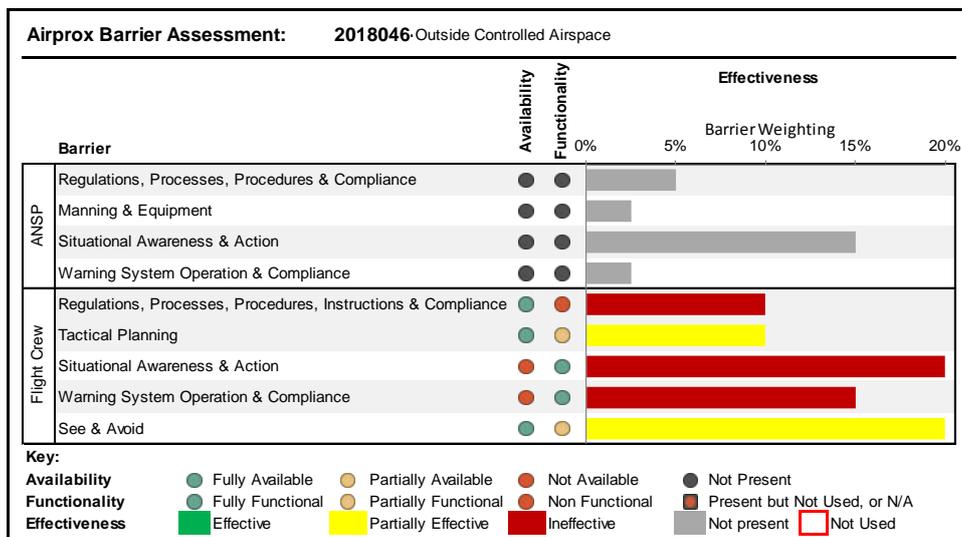
Safety Barrier Assessment²

Regulations, Processes, Procedures, Instructions and Compliance were assessed as **ineffective** because the glider pilot flew through the promulgated and active Balado microlight site.

Tactical Planning was assessed as **partially effective** because the glider pilot did not sufficiently avoid the microlight site.

Situational Awareness and Action were assessed as **ineffective** because neither pilot had any information on the other aircraft.

Warning System Operation and Compliance were assessed as **ineffective**; although the glider was fitted with FLARM, the microlight was not.

See and Avoid were assessed as **partially effective**, both pilots managed to take avoiding action, albeit late.
