AIRPROX REPORT No 2021087

Date: 16 Jun 2021 Time: ~1500Z Position: 5147N 00043W Location: Halton ATZ

PART A: SUMMARY OF INFORMATION REPORTED TO UKAB

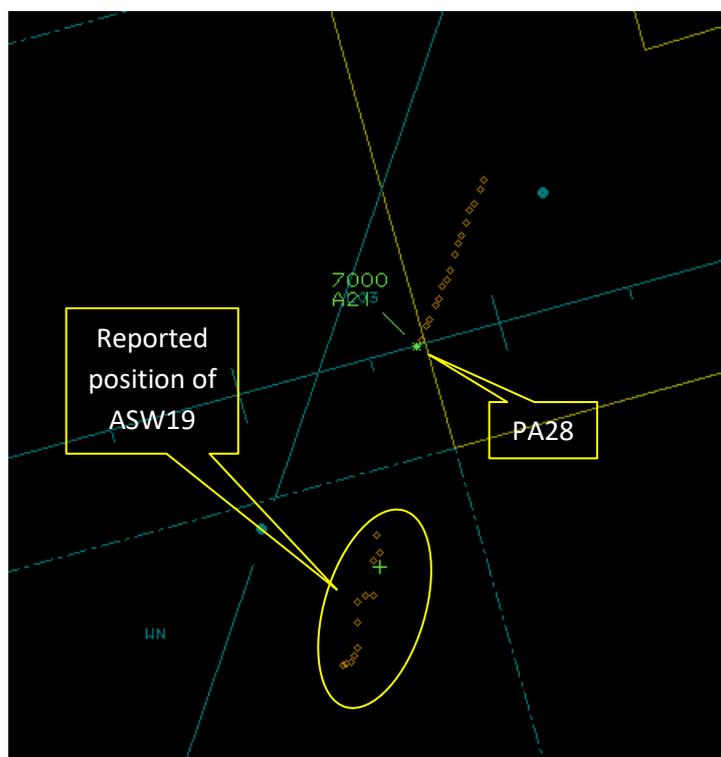
Figure 1 - 1458:45

An analysis of the NATS radar replay was undertaken, which showed the PA28 tracking southwest at an altitude of 2100ft. Halton airfield elevation is marked on the 1:250,000 VFR chart as 369ft, placing the PA28 within the lateral and vertical confines of the Halton ATZ. A number of primary radar returns were visible in the area reported by the ASW19 pilot (see Figure 1), but no stable tracks could be correlated with the glider's position. The glider pilot was unable to provide a GPS log file of their flight.
