AIRPROX REPORT No 2021088

Date: 13 Jun 2021 Time: 1112Z Position: 5134N 00042E Location: Southend CTR

PART A: SUMMARY OF INFORMATION REPORTED TO UKAB

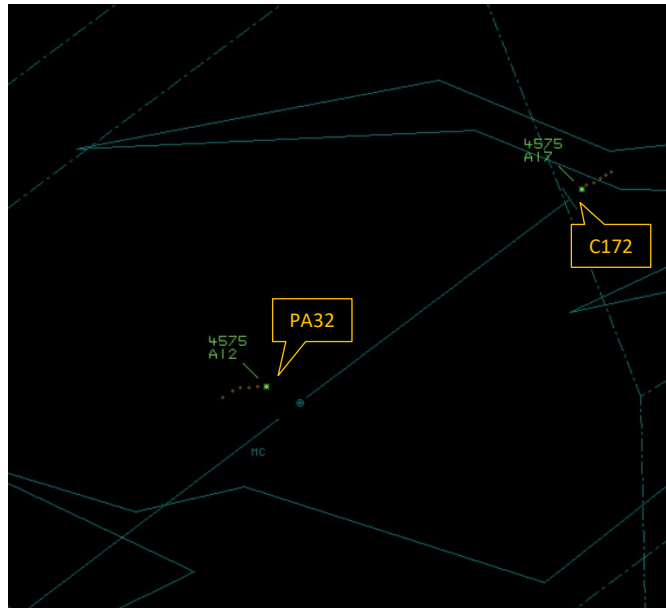
Figure 1 – 1111:18

pilot replied “er, we are ready for base – sorry, we’re early downwind now. We’ll report ready for base”. Then at 1111:18 the Tower controller asked the PA32 pilot “confirm in the right-hand circuit?”, to which the PA32 pilot replied “sorry, yes we’re doing a right-hand circuit” (Figure 1).

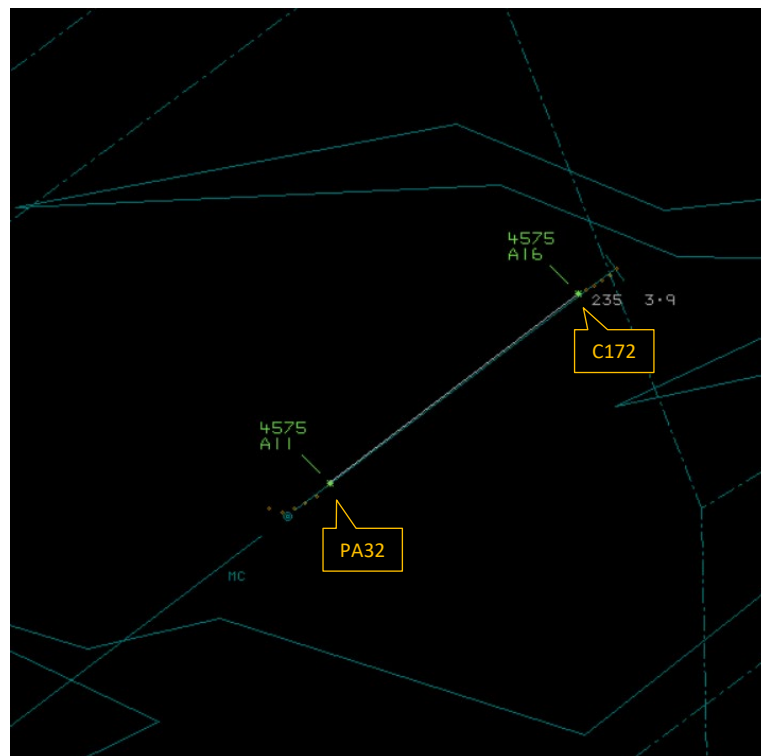
Figure 2 – 1111:48

At 1111:48 the Tower controller instructed the PA32 to “turn left towards the north. You’re tracking up final approach now”. The PA32 pilot did not respond (Figure 2).

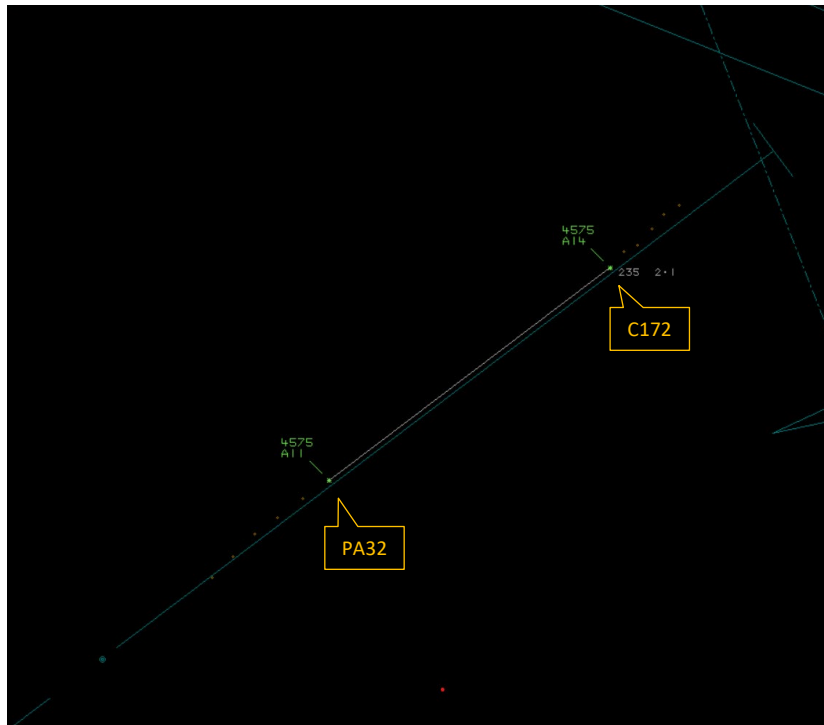
Figure 3 – 1112:10

At 1111:55 the controller repeated the instruction to the PA32 pilot *“turn left immediately towards the north”*, to which the PA32 pilot replied, *“sorry, say again”*. The controller repeated the instruction for the third time *“I say again, turn left north immediately, traffic inbound on the ILS on final”*, to which the PA32 pilot replied, *“turning left”* (Figure 3).

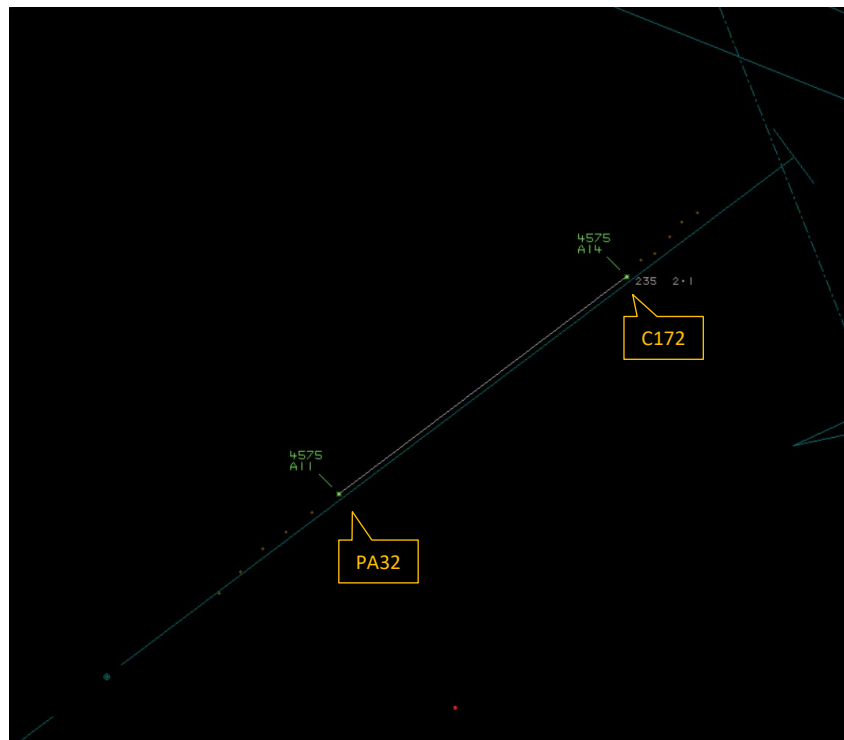
Figure 4 – 1112:20

The controller then advised the C172 pilot, at 1112:18 *“that PA32 now on the crosswind leg northbound”*, to which the C172 pilot replied *“yep, we’ve got him sir – thanks”* (Figure 4).

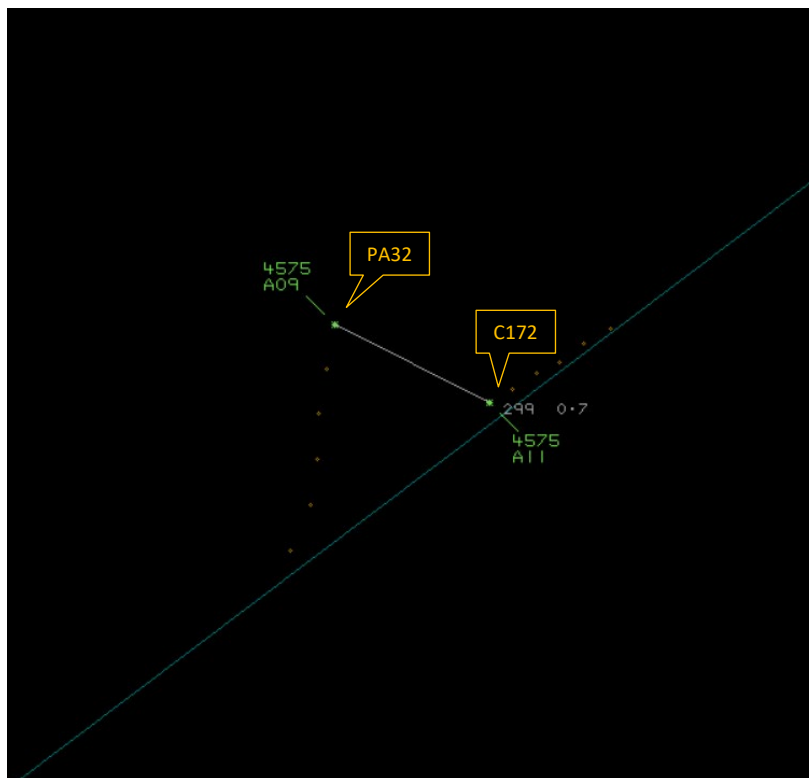
Figure 5 – CPA 1112:39

CPA occurred at 1112:39 with the aircraft separated by 0.7NM laterally and 200ft vertically, with the PA32 already in a turn away from final approach to the north (Figure 5).

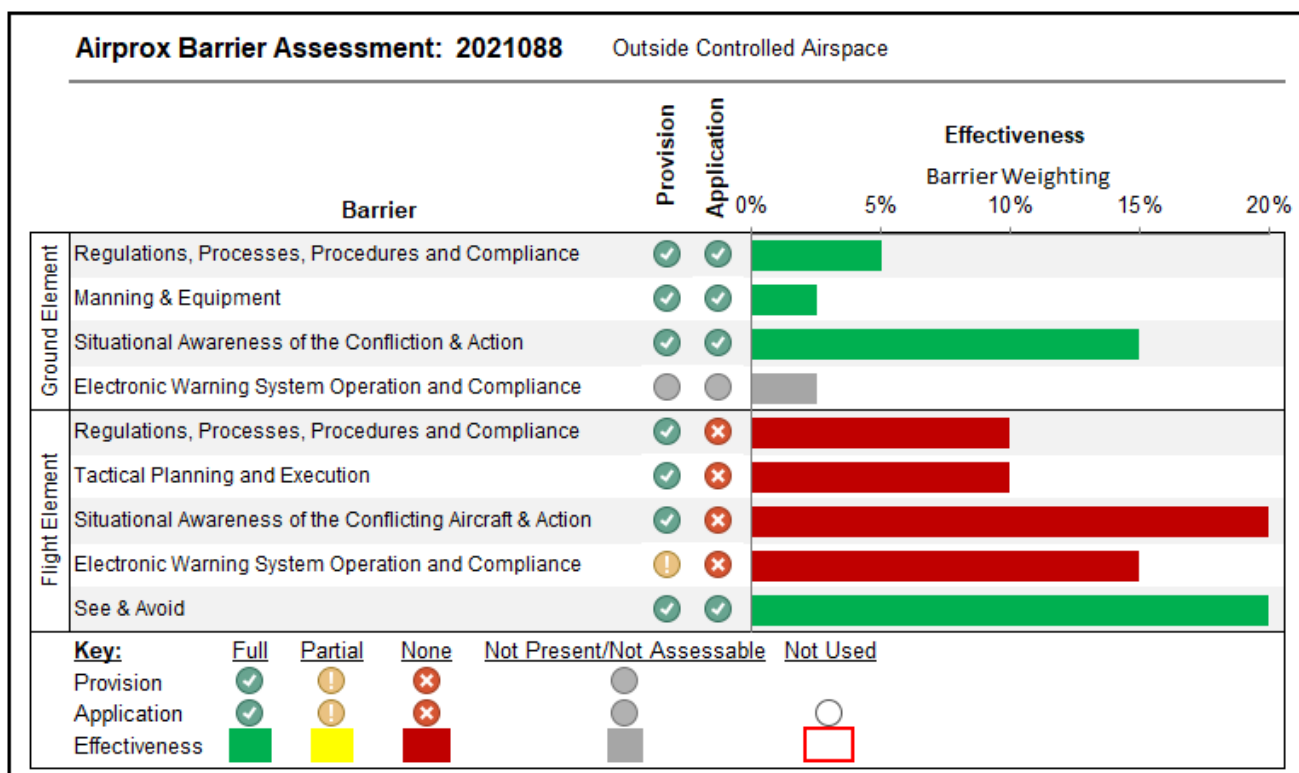
Regulations, Processes, Procedures and Compliance were assessed as **ineffective** because the PA32 pilot did not conform with the instructions from the Southend Tower Controller, and they broke their clearance limit.

Tactical Planning and Execution was assessed as **ineffective** because the PA32 pilot did not conform with the C172 already established ahead in the circuit. The PA32 pilot did not correctly fly the circuit pattern.

Situational Awareness of the Conflicting Aircraft and Action were assessed as **ineffective** because the PA32 pilot did not assimilate the communications from the C172 pilot or the Tower controller and therefore did not conform with the controller’s instructions.

Electronic Warning System Operation and Compliance were assessed as **ineffective** because the C172 pilot’s Sky Echo did not alert as expected.
