AIRPROX REPORT No 2021090

Date: 23 Jun 2021 Time: 0946Z Position: 5206N 00211W Location: 6NM S of Worcester

PART A: SUMMARY OF INFORMATION REPORTED TO UKAB

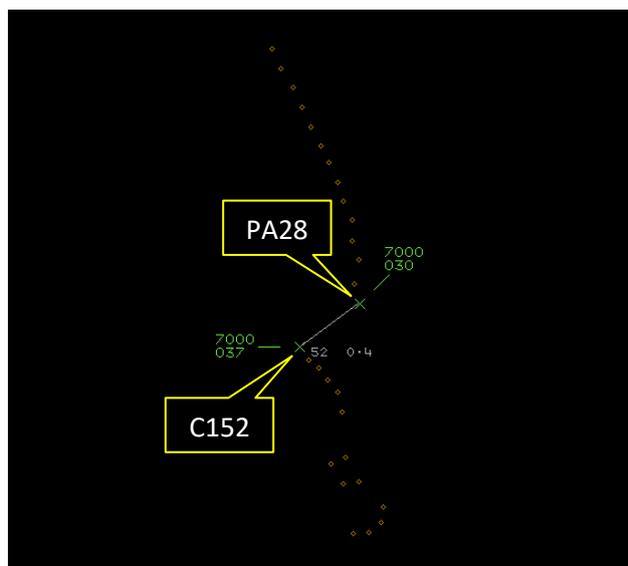
Figure 1 – 0946:07

An analysis of the NATS radar replay and GPS data provided by the PA28 pilot was undertaken. The NATS radars detected both aircraft on secondary radar and, intermittently, the PA28 on primary radar. All altitudes displayed on the radar are in Flight Levels – the QNH input to the radar processor was 1024hPa; aircraft altitude is derived by adding 300ft (11hPA x 27ft = 297ft) to the indicated Flight Levels. The PA28 was tracking in a southerly direction at an indicated altitude of 3200ft \pm 100ft. In the moments leading up to the Airprox, the C152 was manoeuvring to the south of the PA28 at 4100ft \pm 100ft. At 0946:07, the C152 entered a descending left turn; the aircraft were separated by 0.4NM and 700ft at this time (see Figure 1). The secondary radar track of the C152 was unstable throughout the period of the Airprox; however, the Mode C readout remained visible and showed the C152 descending to an altitude of 3400ft at CPA (see Figure 2).
