AIRPROX REPORT No 2021079

Date: 10 Jun 2021 Time: 1530Z Position: 5308N 00238W Location: 2NM south Oulton Park VRP

PART A: SUMMARY OF INFORMATION REPORTED TO UKAB

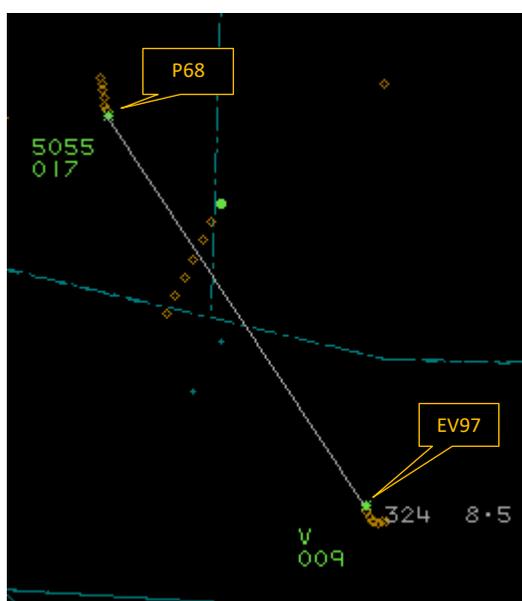
Figure 1 - 15:25.00

Between 15:23.10 and 15:25.00 the P68 pilot advised the controller that their westbound line was now complete and that they were going to be commencing a northwest–southeast line, which would be exiting and re-entering controlled airspace, the pilot then made a request which was unintelligible on the RTF recording [UKAB note: The P68 pilot stated in a telephone call to the UKAB Inspector that this was their request for a Traffic Service, which was agreed by the Liverpool controller]. The controller responded by passing Traffic Information to the pilot, on traffic unrelated to the Airprox. The first part of the response from the pilot was broken and unintelligible and then the pilot advised that were re-entering controlled airspace on their northwest bound run. The controller asked the pilot if part of their track would take the aircraft into the low-level corridor. The pilot responded with “*negative*” and apologised for inadvertently encroaching on the corridor during a previous run. The controller asked the pilot what the most easterly point of their new line would be. The pilot responded with “*negative*” and that this would be west to east, with the lines quite tight, and that there would only be 5 of them. The controller asked the pilot to confirm that this would be in their current vicinity, and the pilot confirmed that this was correct, and that they were just approaching their first run now. The controller advised the pilot that they could commence their run, and the pilot acknowledged (Figure 1).

At 15:25.00 the P68 pilot advised the controller that they were re-entering controlled airspace on their northwest bound run. The aircraft was observed to continue tracking south until 15:29.10, when the pilot requested a clearance to re-enter Liverpool Controlled Airspace. The pilot subsequently entered a left-hand orbit.

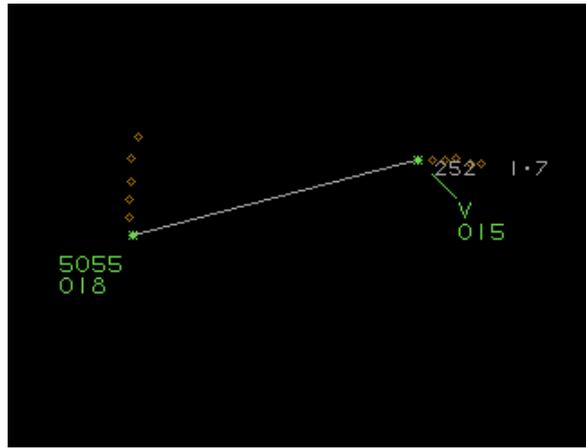
Figure 2 - 15:29.10

At 15:29.10 the P68 pilot requested entry back into controlled airspace, on a northwest to southeast track. The controller responded that the pilot was cleared to enter Liverpool controlled airspace and advised the pilot that they did not need to obtain a clearance to enter each time, and that the clearance was not above altitude 2000ft VFR. The pilot responded, “*cleared to enter controlled airspace, free run, not above altitude 2000ft VFR*”. The controller advised the pilot that it would be a Basic Service outside of controlled airspace as there was quite a bit of traffic around today (Figure 2).

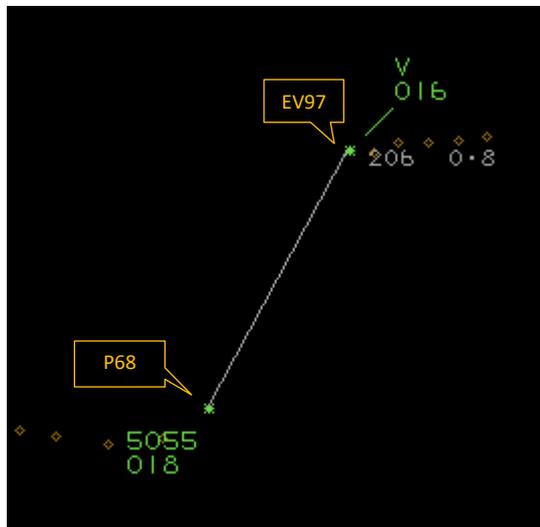
Figure 3 - 15:29.40

At 15:29.40 the controller passed Traffic Information “traffic north of you by half a mile indicating 1700ft”. The pilot responded, “traffic in sight.” The controller responded, “Basic Service, Basic Service.” The pilot acknowledged the Basic Service (Figure 3).

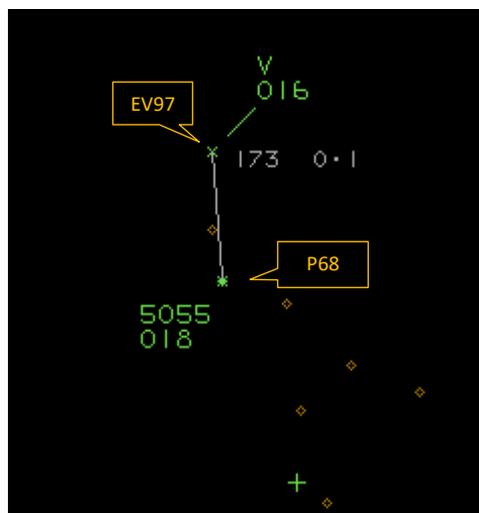
Figure 4 – CPA: 15:30.07

At 15:30.07 CPA occurred, the aircraft were separated by 0.1NM laterally and 200ft vertically (Figure 4).
