**AIRPROX REPORT No 2021081**

Date: 14 Jun 2021 Time: 1332Z Position: 5135N 00043W Location: Marlow

**PART A: SUMMARY OF INFORMATION REPORTED TO UKAB**

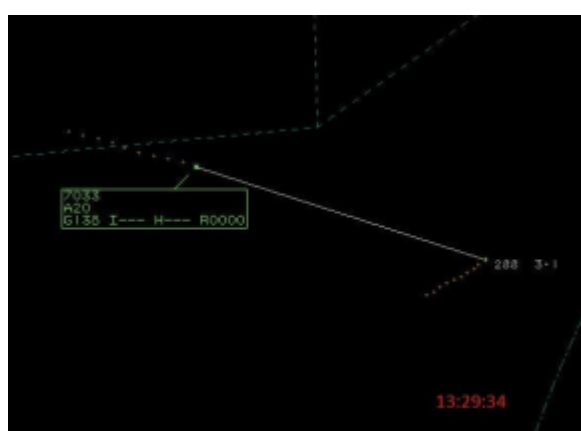
The Chinook, displaying Mode-A 7033, was on a VFR flight to cross the London CTR and transit the Heathrow overhead north-to-south. The pilot reported onto the Heathrow SVFR (LL SVFR) frequency at 13:29:34 (all times UTC) approaching Marlow, see Figure 1. An unknown primary return was tracking North East at a range of 3.1NM from [Chinook C/S]. Both aircraft were in Class G airspace below the London TMA, where the base of controlled airspace was 2500ft.

Figure 1: Chinook reported on LL SVFR frequency

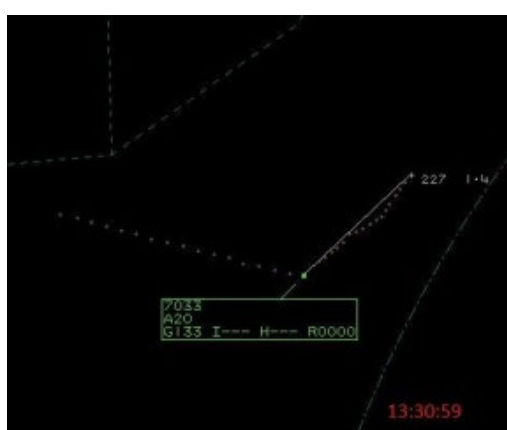
The LL SVFR controller responded, instructing the pilot to “squawk ident, QNH one-zero-one-nine, Basic Service, report your level?” The pilot readback Basic Service, the QNH and reporting their altitude as 2000ft. The LL SVFR controller continued to transmit to unrelated aircraft. At 13:30:59 the pilot reported “holding Marlow,” see Figure 2. The LL SVFR controller acknowledged.

Figure 2: Chinook reported holding at Marlow

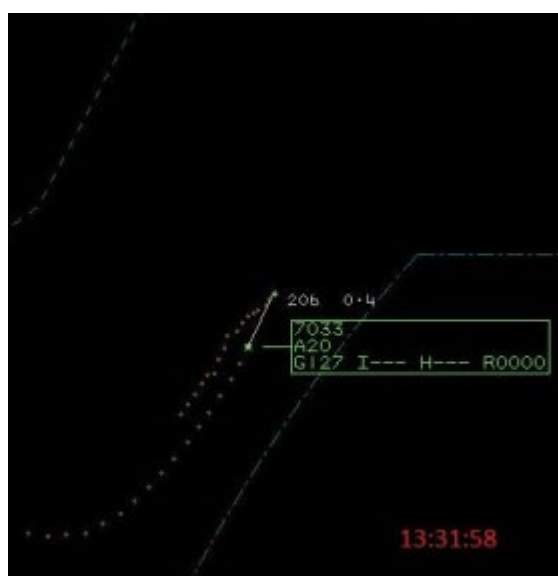
Closest Point of Approach occurred at 13:31:58 and was recorded on Multi-Track Radar as 0.4NM and 200ft (vertical element as later reported by the pilot of [Chinook C/S]), see Figure 3.

Figure 3 CPA between Chinook and unknown return  
Note: No reference to any traffic was made by the pilot at this point.
