AIRPROX REPORT No 2021084

Date: 15 Jun 2021 Time: 1111Z Position: 5254N 00050W Location: Barkestone-le-Vale

PART A: SUMMARY OF INFORMATION REPORTED TO UKAB

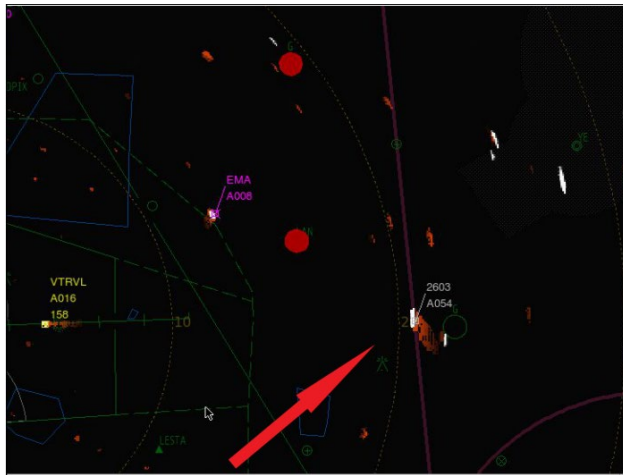
Figure 1

1109:20 The radar recording shows an aircraft squawking 2603 (believed to be the Prefect) passing west abeam of Saltby gliding site. The mode C indicates 5400ft descending with the aircraft tracking towards Langar (Figure 1). 1109:50 An aircraft displaying a 0033 squawk (believed to be the C208) is seen departing Langar on a north-easterly track. Mode C indicates 600ft with the aircraft climbing. At this point, the 2603 squawk is approximately 4.7NM southeast of Langar, still tracking towards and indicating 4300ft descending (Figure 2).

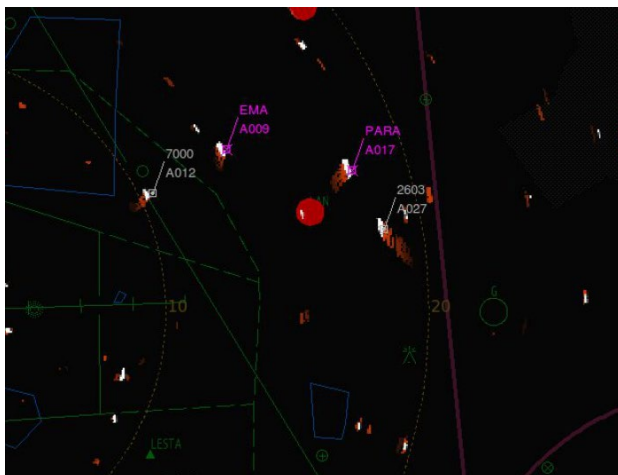
Figure 3

1110:35 Both aircraft have continued on their previous tracks with the 2603 squawk still descending, now indicating 2700ft and the Parachuting aircraft indicating 1700ft climbing (Figure 3). 1110:44 Radar recording shows both aircraft commencing right turns towards one another (Figure 4).

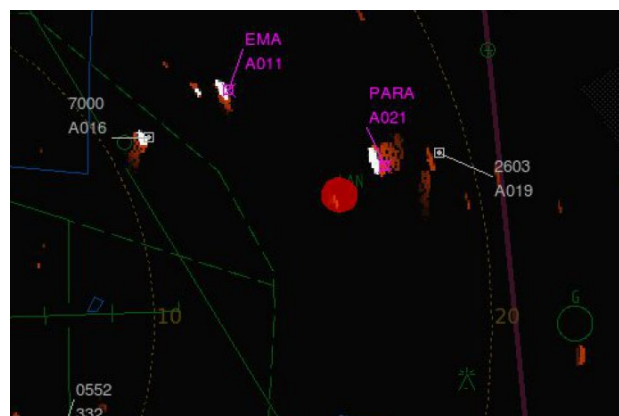
Figure 5

1110:50 The 2603 squawk is approximately 2.2NM east of Langar airfield. 1110:58 CPA occurs with both aircraft in right turns. The separation is 1.2NM and 100ft. The Parachuting aircraft appears to have spotted the 2603 squawk as the parachute aircraft's rate of turn appears to temporarily increase. The 2603 aircraft does not appear to increase their rate of turn, instead rolling out on a track of approximately 020° a short time later (Figure 5).

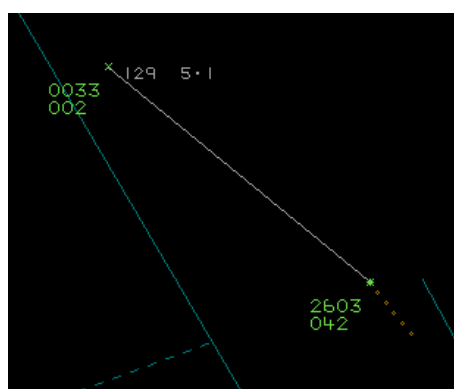
Figure 6: The C208 first appears on the NATS Radars. Separation is 5.1NM and 4000ft.

At the beginning of the provided radar recording the C208 is displayed and both the C208 and the Prefect are transiting west. Four seconds prior to the C208 displaying on radar, a formation had called recovery and were giving their position report to the controller.

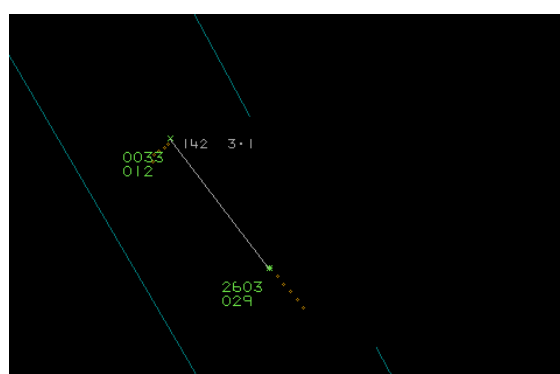
Figure 7: Traffic Information is passed to the Prefect.

Forty seconds after the C208 first appears on the NATS radar, Traffic Information and a turn is given to the Prefect pilot by Cranwell ATC. Separation had decreased to 3.1NM and 1700ft. Immediately prior to passing the Traffic Information to the Prefect, the controller was identifying and passing Traffic Information which was 0.5NM away to the freecalling formation.

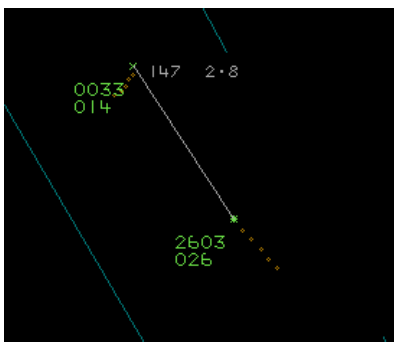
Figure 8: Prefect pilot reports that they are climbing.

Nine seconds later the Prefect pilot reports visual and taking the turn. Separation decreased to 2.8NM and 1200ft.

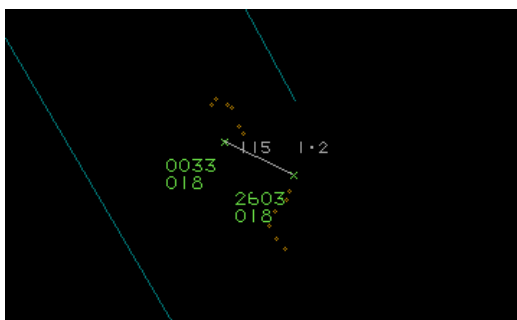
Figure 9: CPA was measured at 1.2NM and 0ft
